NATIONAL TRANSPORTATION SAFETY BOARD

AIRCRAFT ACCIDENT/INCIDENT SUMMARY REPORTS

NTSB/AAR-87/02/SUM

1. <i>Report No.</i> NTSB/AAR-87/02/SUM	2. <i>Government Accession No.</i> PB87-910408	3. <i>Recipient's Catalog No.</i>	
4. <i>Title and Subtitle</i> Aircraft Accident/Incident Summary Reports		5. <i>Report Date</i> June 30, 1987

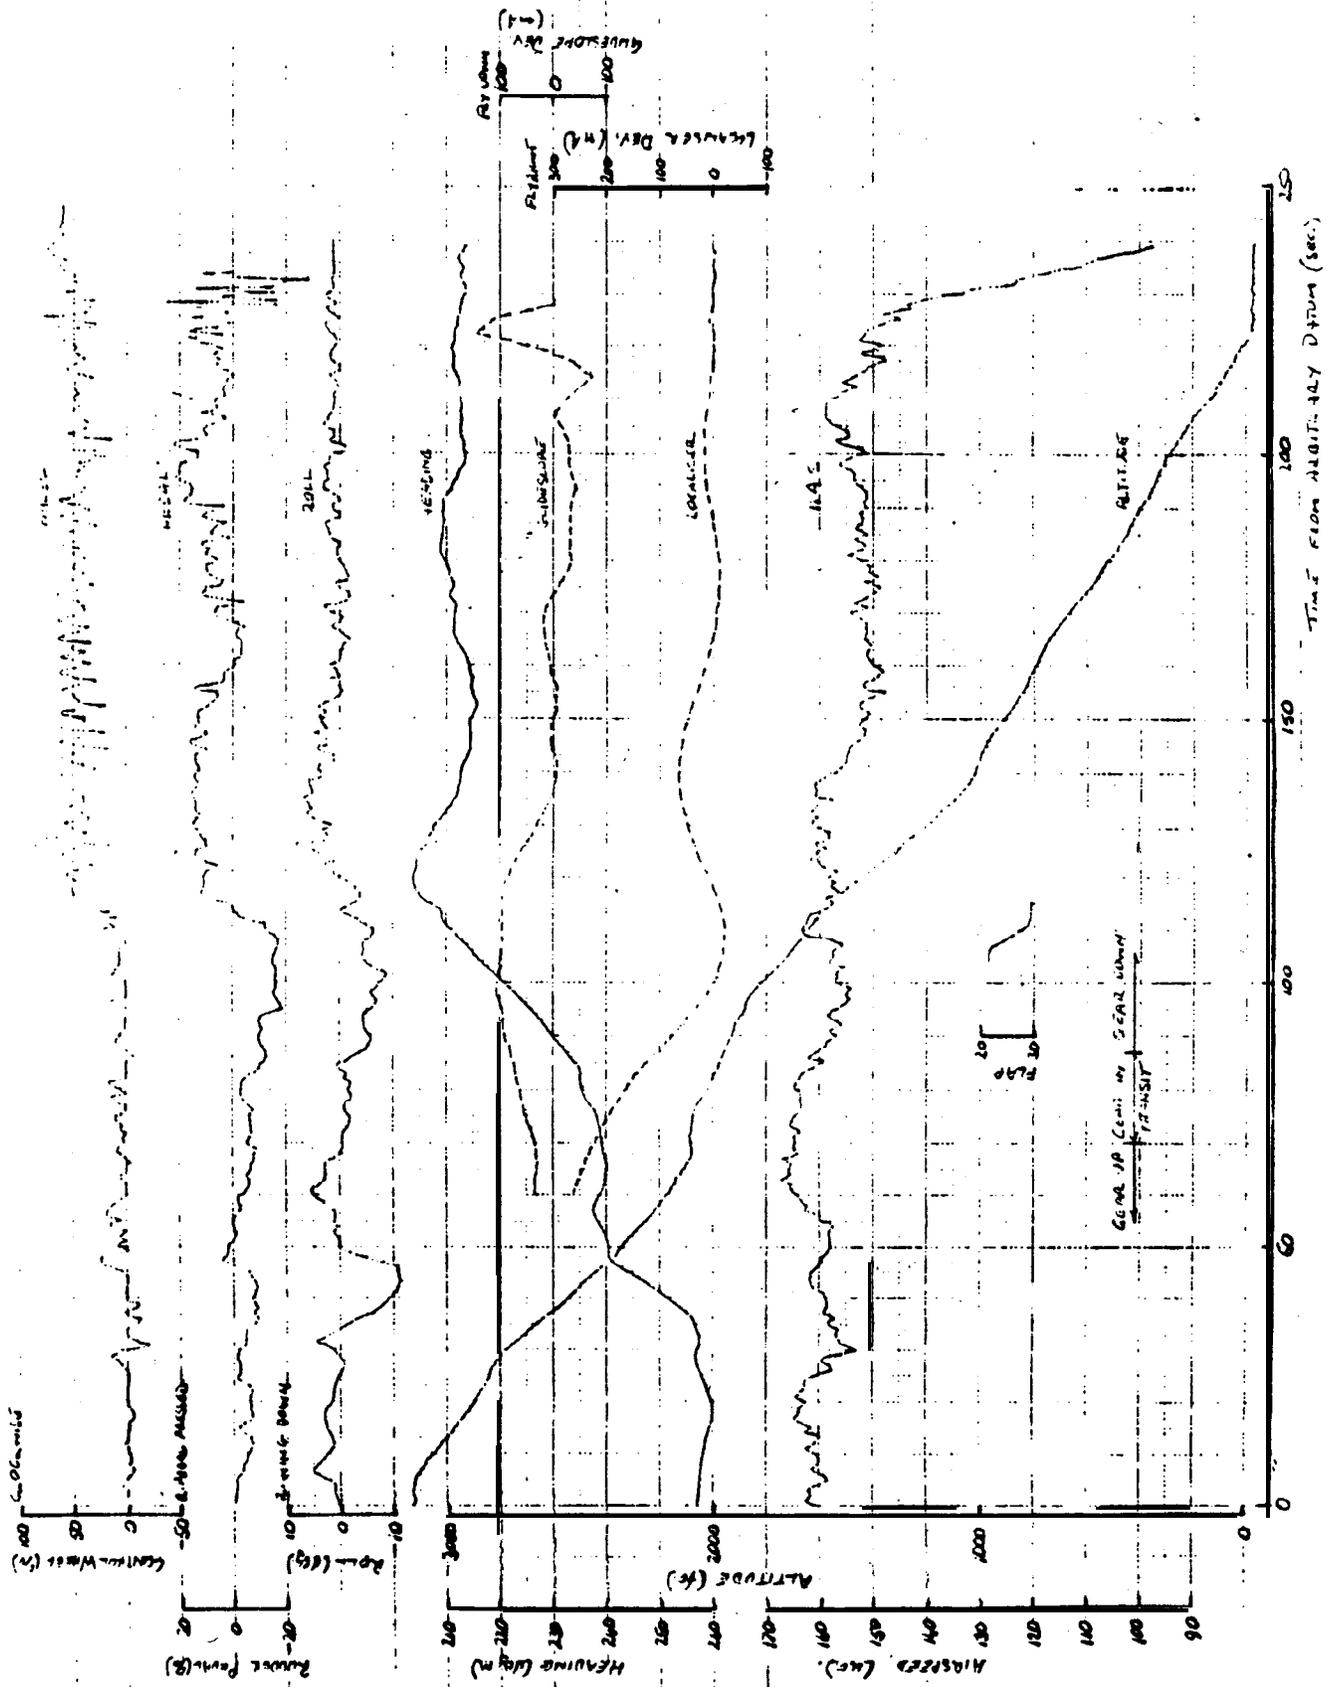
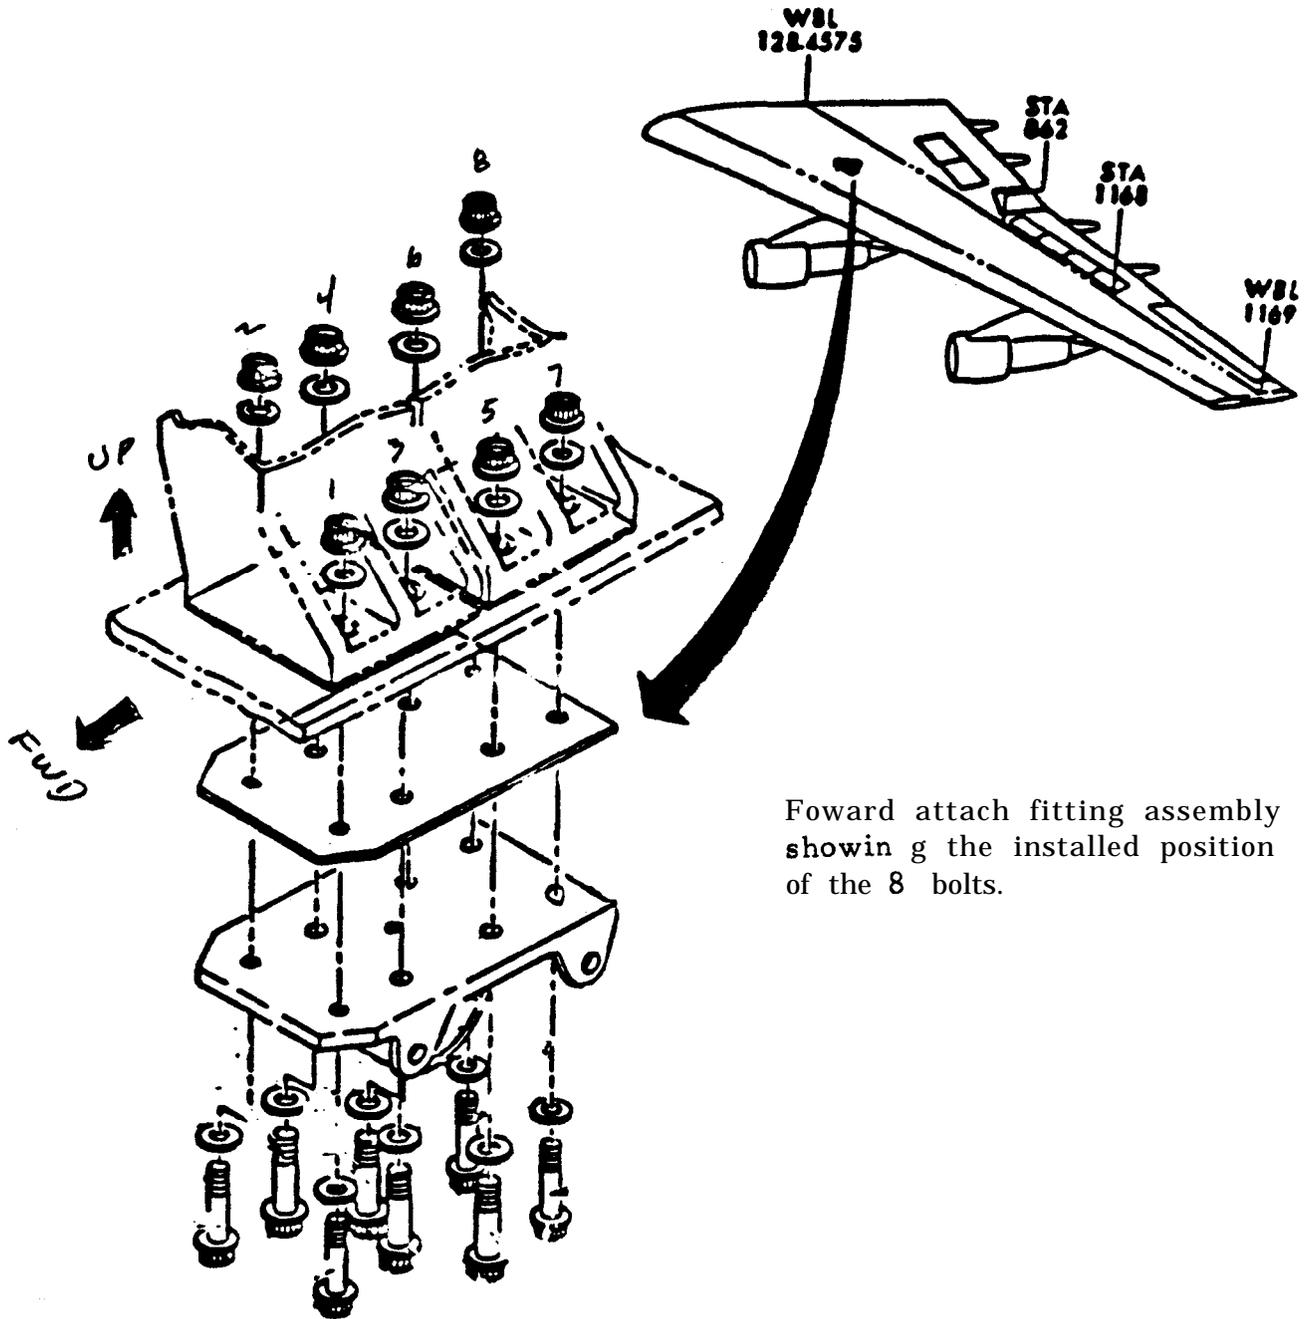
Eight bolts secure the forward attachment fitting of the No. 3 flap track to the lower wing skin and a shear tie rib in the No. 2 fuel tank. They are arranged longitudinally in two rows of four. The four bolts in the forward and aft corners are **7/16** inch in diameter, manufactured to Boeing specification **BACB30MT7T28**, while the four middle bolts in the pattern are **1/2** inch in diameter, manufactured to Boeing specification **BACB30MT8T28**. All of the bolts are made of H-11 steel alloy, which has low fracture toughness and is, therefore, susceptible to failure with small cracks. When the attachment fitting is installed on the wing, the bolts are oriented vertically with the heads down and the washers and self-locking nuts up. Inside the No. 2 fuel tank, **3/4** installation torque is 440 inch-pounds for the **7/16-inch** diameter bolts and 580 inch-pounds for the **1/2** inch diameter bolts.

Forward attach fitting assembly showing the installed position of the 8 bolts.

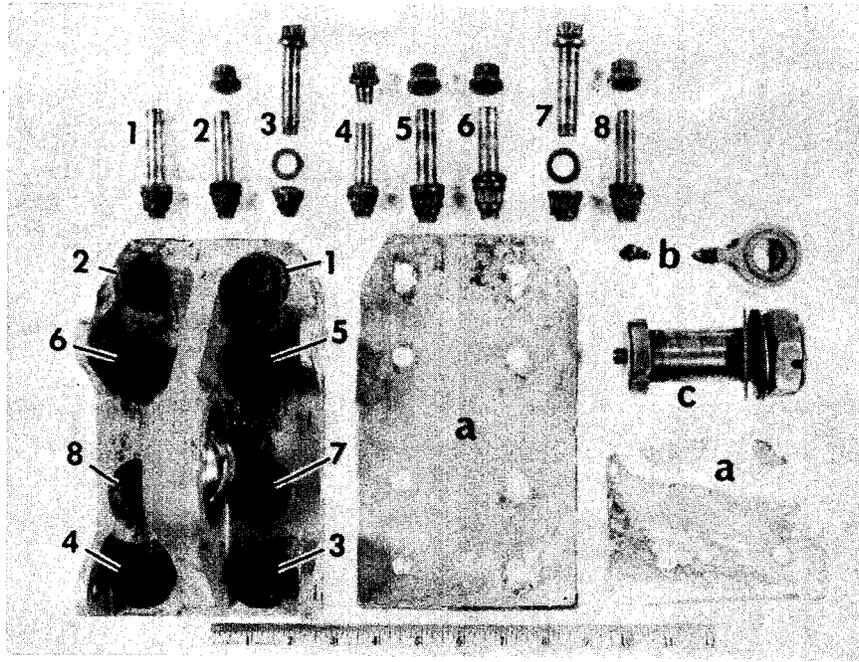
The Safety Board's metallurgical laboratory examined the No. 3 flap track forward attachment fitting and hardware, with the exception of one bolt head that was sent to the United Kingdom for examination, and the inboard nut and bolt from the aft attachment position, which were not significantly damaged. Examination of the forward fitting components revealed areas of fretting on the upper surface of the fitting. Fretting was particularly heavy on the forward portion of the fitting and between the **aftmost** bolt holes. Corresponding areas of fretting were found on the shims **that** space the fitting from the **wing's** lower surface. In addition, wear or heavy contact was found on the inboard edge of the spherical bearing.

Figure 1. Overall view of the forward attachment fitting components, including the fitting shims (a), grease fittings (b) and the spherical bearing bolt and nut (c).

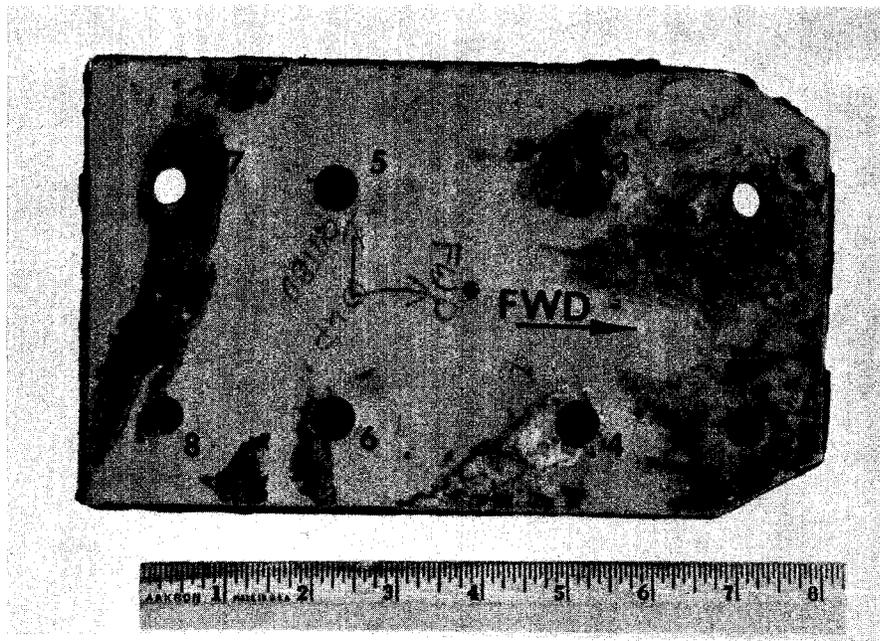
Examination of the eight fractured bolts associated with the forward fitting showed that **three** failed from gross overstress. One of these three bolts was located third aft in the outboard row, and the other two at the two **aftmost** bolt holes. No evidence of preexisting cracking was found on these three bolts.

Examination of the remaining five bolts revealed similar fracture surface features. On **all** of these bolts, the fracture features emanated from the aft side of the bolt, as installed on the airplane, between the bolt head and shank. Examination of the fractures with a scanning electron microscope revealed flat, crescent-shaped fracture regions containing features typical of fatigue cracking. The fatigue zones emanated from multiple origins and progressed a short way into the bolt before separation. This fatigue cracking and fretting on the fitting indicated that the bolts were loose or undertorqued. Fracture features beyond the fatigue zones consisted of a mixture of ductile dimples and what appeared to be intergranular features, consistent with an overstress region stemming from the fatigue zones. The examination also indicated that the bolts met the specifications for dimensions, material, finish, and strength.

Figure 2. View of the top face of the No. 3 flap track forward attachment fitting.

On February 21, 1986, Boeing issued Service Bulletin (SB) **747-57A2234**. In it, Boeing specified its final inspection requirements and corrective actions for the forward flap track attachment fittings. These included replacement of the H-11 bolts with Inconel bolts as they become available.
