Service Letter No. 328

SUBJECT: Lycoming Service Letter No. L126 dated January 29, 1960

Bulletin No. 71

SUBJECT: Replacement of Guide Collars with New Forged Collars on Certain Non-Feathering Flange Mounted Propellers.

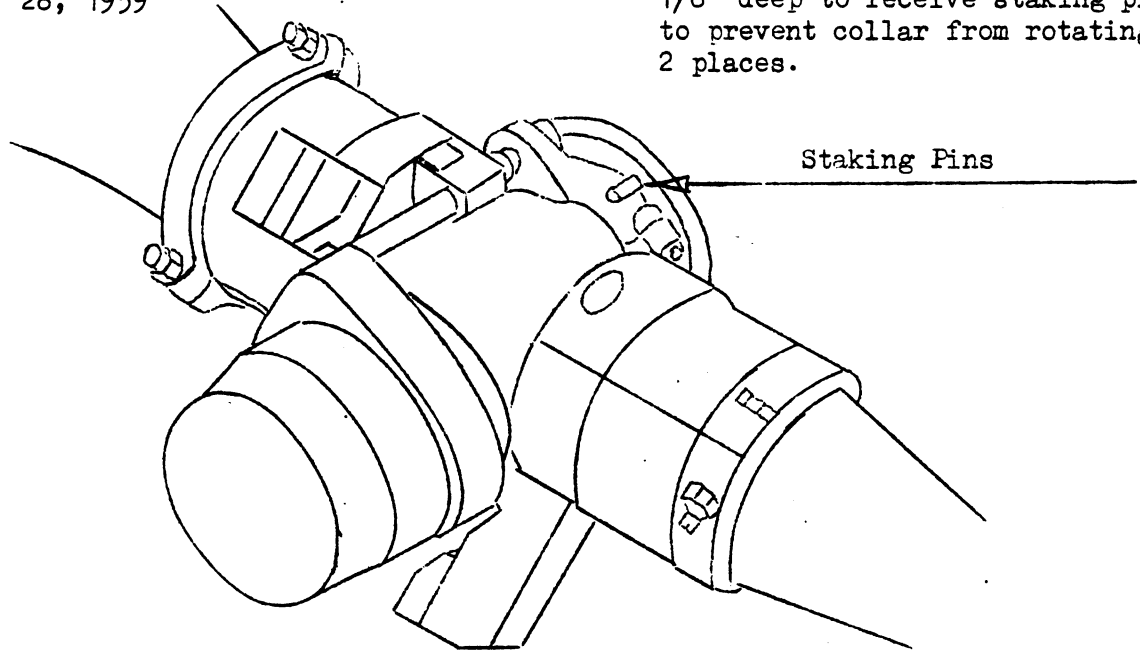
HC-82XG-1D
HC-82XG-6DL
HC-82XL-1D
HC-92ZK-8D
HC-82XK-1D
HC-92ZK-8L

After collar is properly located to receive piston guide rods, spot face edge of collar, approx. 1/8" deep to receive staking pins to prevent collar from rotating, 2 places.

When the new collar is installed, it will be necessary to spot face the edge of the new guide collar thru the two dowel pin holes and reinstall the dowel pins as shown on Page 3.

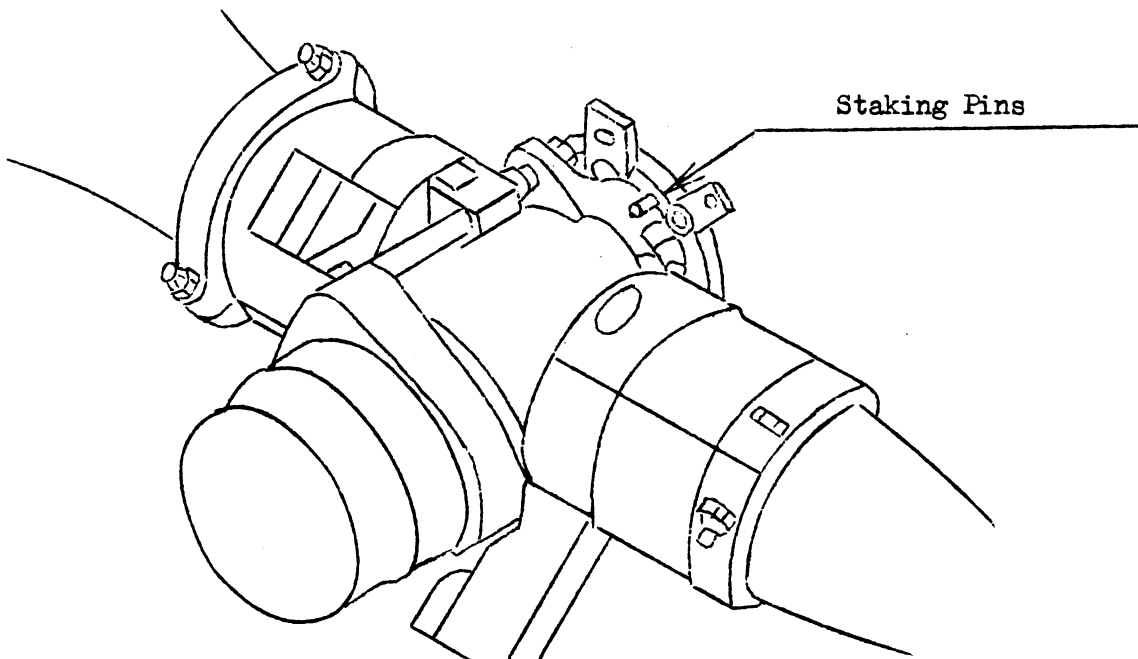
HC-82XF-1D
HC-82XF-1DB

First, install 4 spinner lugs, using new AN4E-4A bolts. After collar is properly located to receive piston guide rods, spot face edge of collar approximately 3/32" deep to receive staking pins to prevent collar from rotating, 2 places.

CAUTION!!! - For Model HC-82XF-1DB, the two steel dowel pins inserted in both the engine and propeller flanges are located 60° from the aluminum staking pins shown. BE SURE TO REPLACE THESE PINS. For the other models, the dowel pins also serve as collar staking pins.

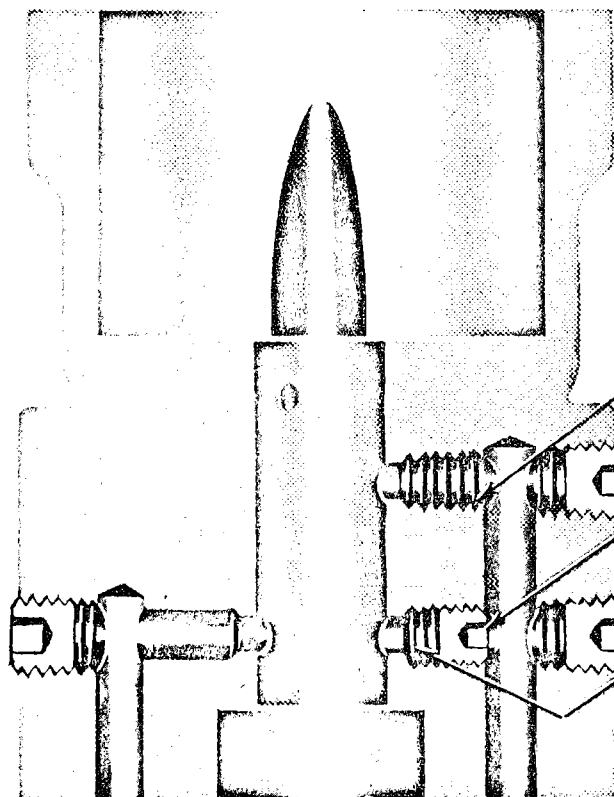
REMOVE PLUG
187824 FROM TOP
HOLE AND

INSTALL IN
BOTTOM HOLE

TAP $\frac{1}{16}$ -27 NPTF
(DRYSEAL)

BASIC GAGE LINE
TO BE .720 FROM
THIS SURFACE.
0 TO PLUS 2
TURNS FROM BASIC.

All controls that have plug in upper passage, see below, supply propeller control oil to decrease pitch. In the event a change in propellers is made and the new propeller requires control pressure to increase pitch, the governor bodies should be reworked per instructions shown below.

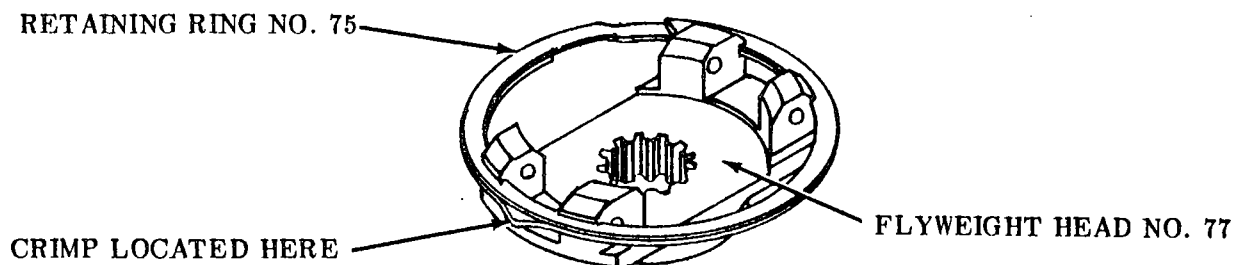
PURPOSE To describe the proper installation of the flyweight retaining ring. Torsional vibration from the engine to the governor drive tends to cause relative rotation between the flyweight head (77) and the retaining ring (75). If the crimped leaf of the retaining ring climbs the chamfer on the lug of the flyweight head, the crimp will no longer be positively retained between the flyweight head lugs, and the retaining ring may be rotated out of the retaining ring groove. Removal of the retaining ring from the flyweight head releases the flyweight pins which causes the governor to be non-controlling, in addition to causing internal damage to the flyweight cavity of the governor body. Installation of the retaining ring, with the crimp down, prevents the crimped leaf from climbing out of the groove on the flyweight head lug.

DETAILS Retaining ring (75) must be installed on the flyweight head with the crimp of the retaining ring toward the thrust bearing surface and between the flyweight lugs as shown in Figure No. 1. Be sure that the retaining ring is properly seated in the groove. ALL GOVERNORS SO MODIFIED MUST BE STAMPED WITH S22 ON THE GOVERNOR NAMEPLATE.
