Piper Aircraft Corporation

November 7, 1951

**SUBJECT:** Freezing of Nose Wheels**MODELS AFFECTED:** PA-22 airplanes with serial numbers 22-1 to 22-354 inclusive

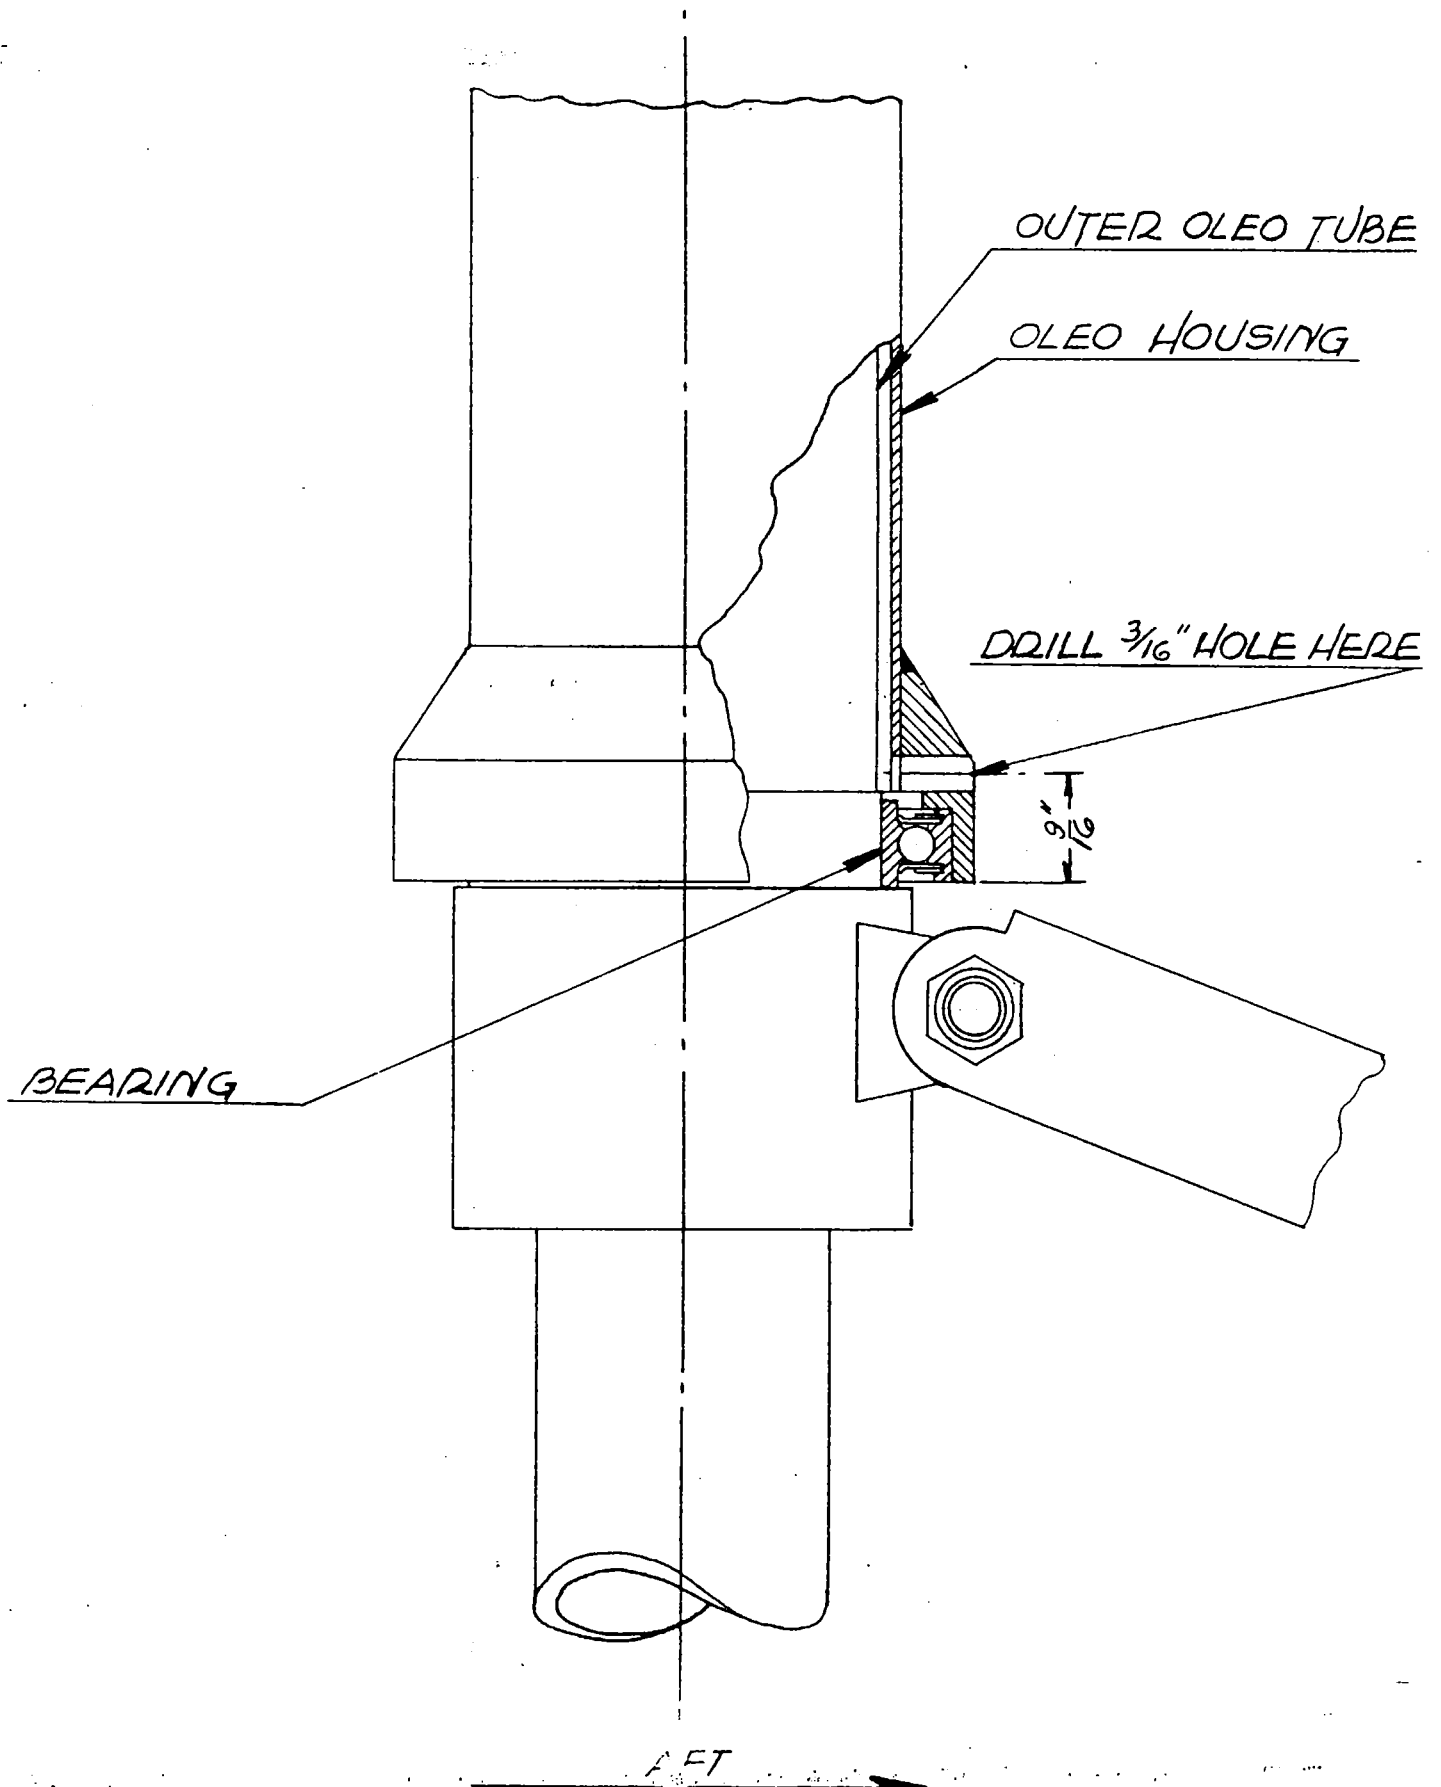
It has been found that when operating in hard driving rain or when washing the airplane water can enter the oleo housing through the upper bearing.

During freezing weather any water which may have entered the 1/16" space between the housing and the oleo will freeze causing the nose wheel to become inoperative insofar as directional steering is concerned, both on the ground and in the air.

1. Using a small punch and hammer make a mark 9/16" above the bottom edge of the lower bearing retainer ring which is located at the lower end of the nose wheel mount housing. The punch mark is to be made on the rearward side of the retainer ring (See sketch on the reverse side).

2. Using a Number 30 drill, drill a small pilot hole through the retainer ring, being very careful not to drill the oleo tube. The thickness of the material at this point is 13/32". There is only 1/16" clearance between the housing and the oleo. Do not drill into the oleo tube.

3. Using a Number 11 of 3/16" drill enlarge the size of the pilot hole which was drilled in accordance with Step 2. The purpose of the 3/16" hole is to provide a drain for any water which might have found its way into the oleo housing.

4. The airplane should be placed in a warm hangar to make sure that all traces of ice have melted and drained out of the oleo housing.
5. Apply a generous quantity of cup grease to the top of the oleo housing to prevent further seepage of water. The upper bearing and retainer nut should be completely covered.

Extreme caution must be exercised during the drilling operation as indicated in Step 2 and Step 3. The above procedure can be followed without disassembling the airplane in any way.
