SERVICE No. 924 BULLETIN

Piper Aircraft Corporation

SUBJECT: Shimmy Dampener Replacement

PA-22-125/135/150/160 Tri-Pacer
PA-22-108 Colt

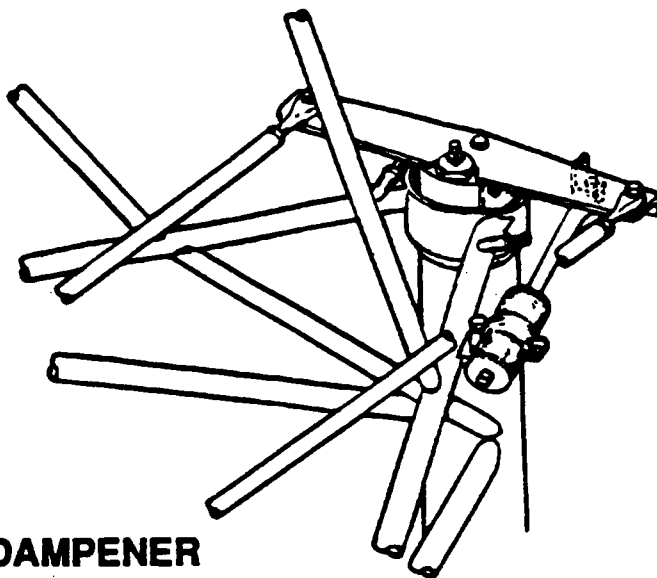
SKETCH "A"

PURPOSE: It is possible that through improper installation or by the lack of maintenance and lubrication that the shimmy dampener may bind or become unserviceable. Should this occur, especially on aircraft equipped with the early model shimmy dampeners, the possibility exists that during a maximum left turn the shimmy dampener shaft may jam or bend, causing loss of nose wheel steering. This condition could possibly lead to partial or total loss of rudder control.

**SHIMMY DAMPENER
(EARLY MODEL)
TRI-PACER - PART NO. 13086-00
(IDENTIFICATION)**

1. Remove cowling as necessary to gain access to nose wheel shimmy dampener. Refer to applicable Owners Manual or Parts Catalog.
2. Shimmy Dampeners with Piper Part Number 13086-00, as identified on Sketch A (attached), should be removed, discarded and replaced by Piper Part Number 21701-06.

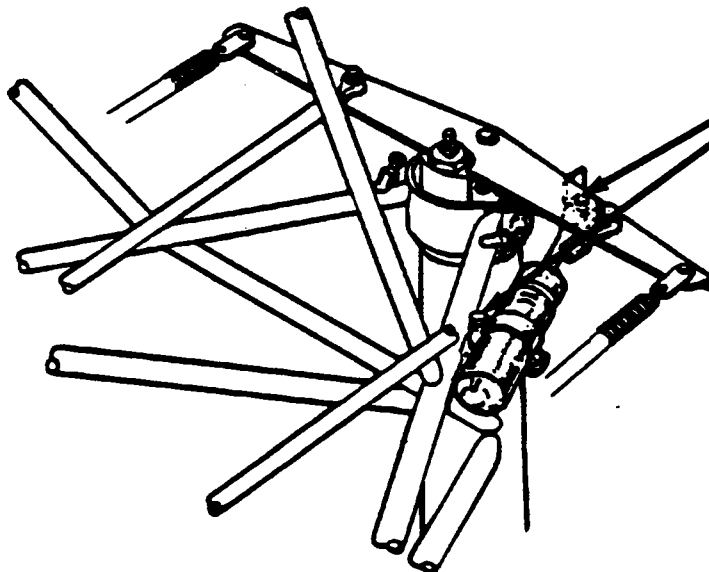
SKETCH "B"

**CHECK FOR
FREEDOM OF
ANGULAR TRAVEL**

**SHIMMY DAMPENER
(LATER MODEL)
TRI-PACER - PART NO. 21701-02
COLT - PART NO. 21701-04
(IDENTIFICATION)**

3. If the shimmy dampeners with Piper Part Numbers 21701-02 and 21701-04, Sketch B (attached), are inspected and determined to be serviceable and airworthy and the instructions below are complied with, those shimmy dampeners may be returned to service.

4. Determine that nose wheel travel is 20 degrees left and right of center.
5. Determine that the shimmy dampener rotates freely on the axis of its attachment bolt throughout its full travel, especially as it approaches the limits of nose wheel travel.

6. Determine that the attachment of the shimmy dampener rod end to the nose wheel steering arm is free to accept angular travel in either direction.
7. Should any stiffness, restrictions, or other maladies be noticed, correct by replacing parts and adjusting as necessary until proper fit and function is obtained.

8. A regular maintenance routine of inspection, cleaning, and lubrication should be performed at each one hundred (100) hours of operation or at any inspection event. Lubricate shimmy dampener rod end and pivot point using general purpose low temperature oil (MIL-L-7870 or equivalent). Wipe shimmy dampener shaft using a clean cloth saturated with MIL-H-5606 hydraulic fluid.
