SERVICE LETTER

No. 718

Subject: Bendix Magneto Bulletin No. 566 -- reference attached Avco Lycoming Service Bulletin No. 373, dated March 22, 1974.

SUBJECT: S-1200 Distributor Block and Gear Change

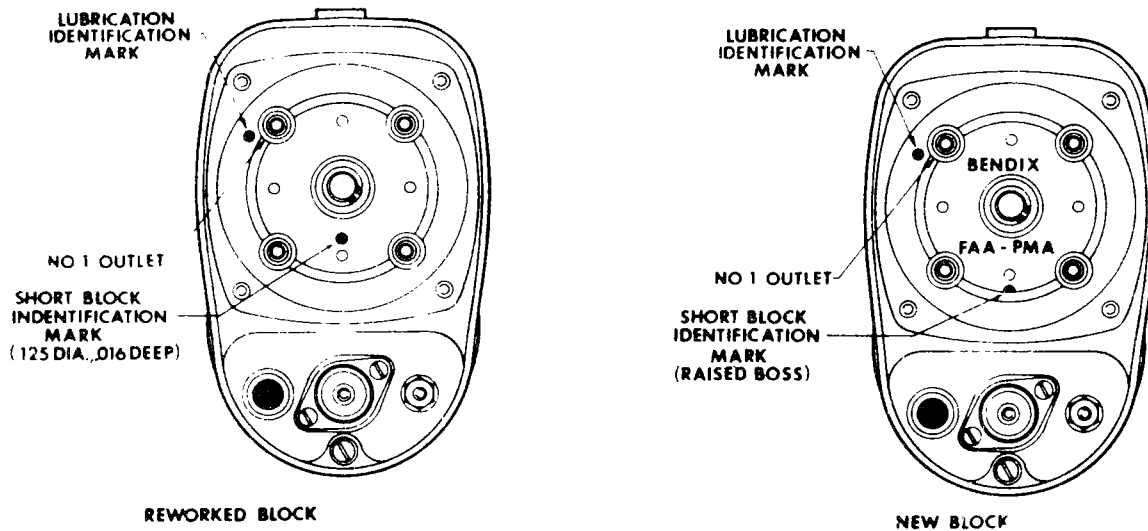
Figure 2

The addition of the washers make it necessary to shorten the gear end of the bushing and block. New production blocks incorporating the change are identified by a raised

boss between the high tension towers at the six o'clock position and molded in letters as shown in figure 2.

Reworked blocks are identified by a drill point indentation in the same location. New and reworked blocks both have different part numbers from the current (old) block. See Table 1.

7. Identify reworked blocks by drilling a flat bottomed hole .125" diameter and .016" deep in the six o'clock position as shown in figure 2.

(3) Identify distributor block by drilling flat bottomed indentation 0.125 inch diameter and 0.016 inch deep located as shown in figure 2.
