Service Letter No. 405

SUBJECT: Inspection of Upper Nose Gear Oleo Bearing

MODELS AFFECTED: PA-22 Tri-Pacer, PA-22-108 Colt, PA-22-135, PA-22-150, PA-22-160 Tri-Pacer

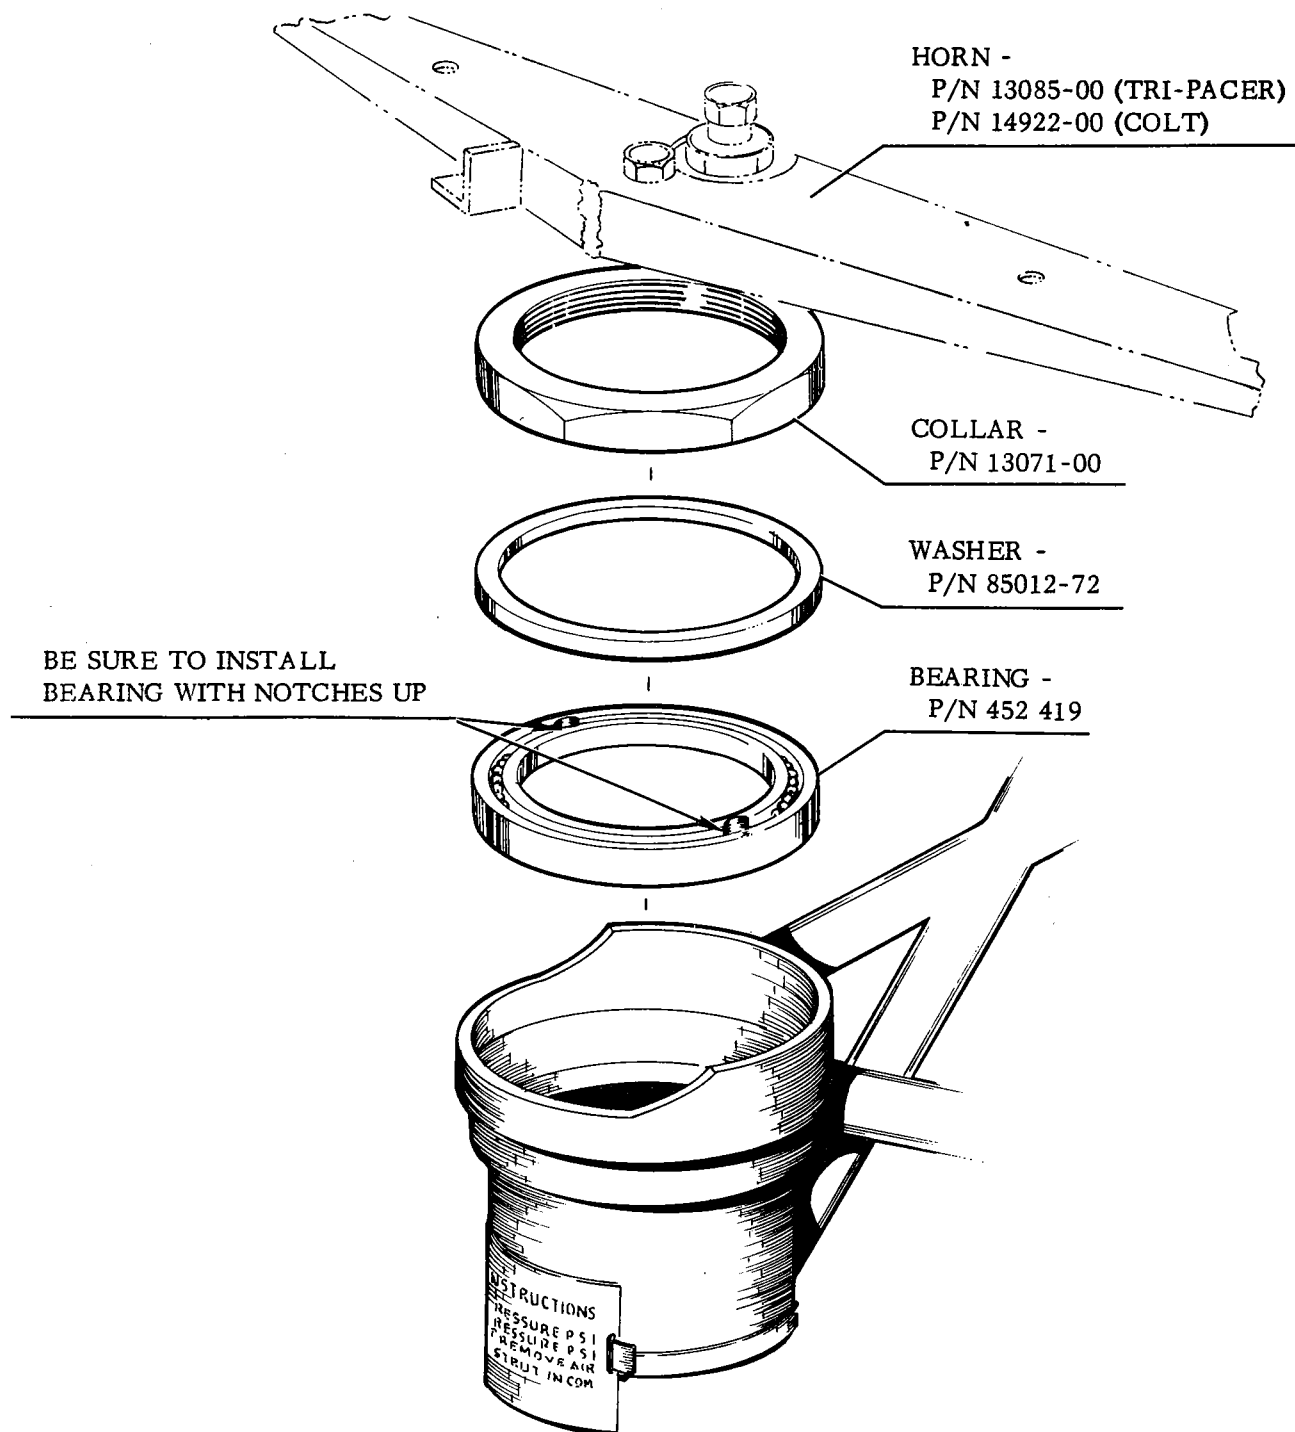
NOTE -

BEARING SHOULD BE LUBRICATED WITH MIL-G-3278 LUBRICANT.
