VSP-33  
December 18, 1981

VENDOR SERVICE PUBLICATION

To: All Piper Distributors and CORPAC's  
Subject: Bendix Service Bulletins 611, 616, 617, 619

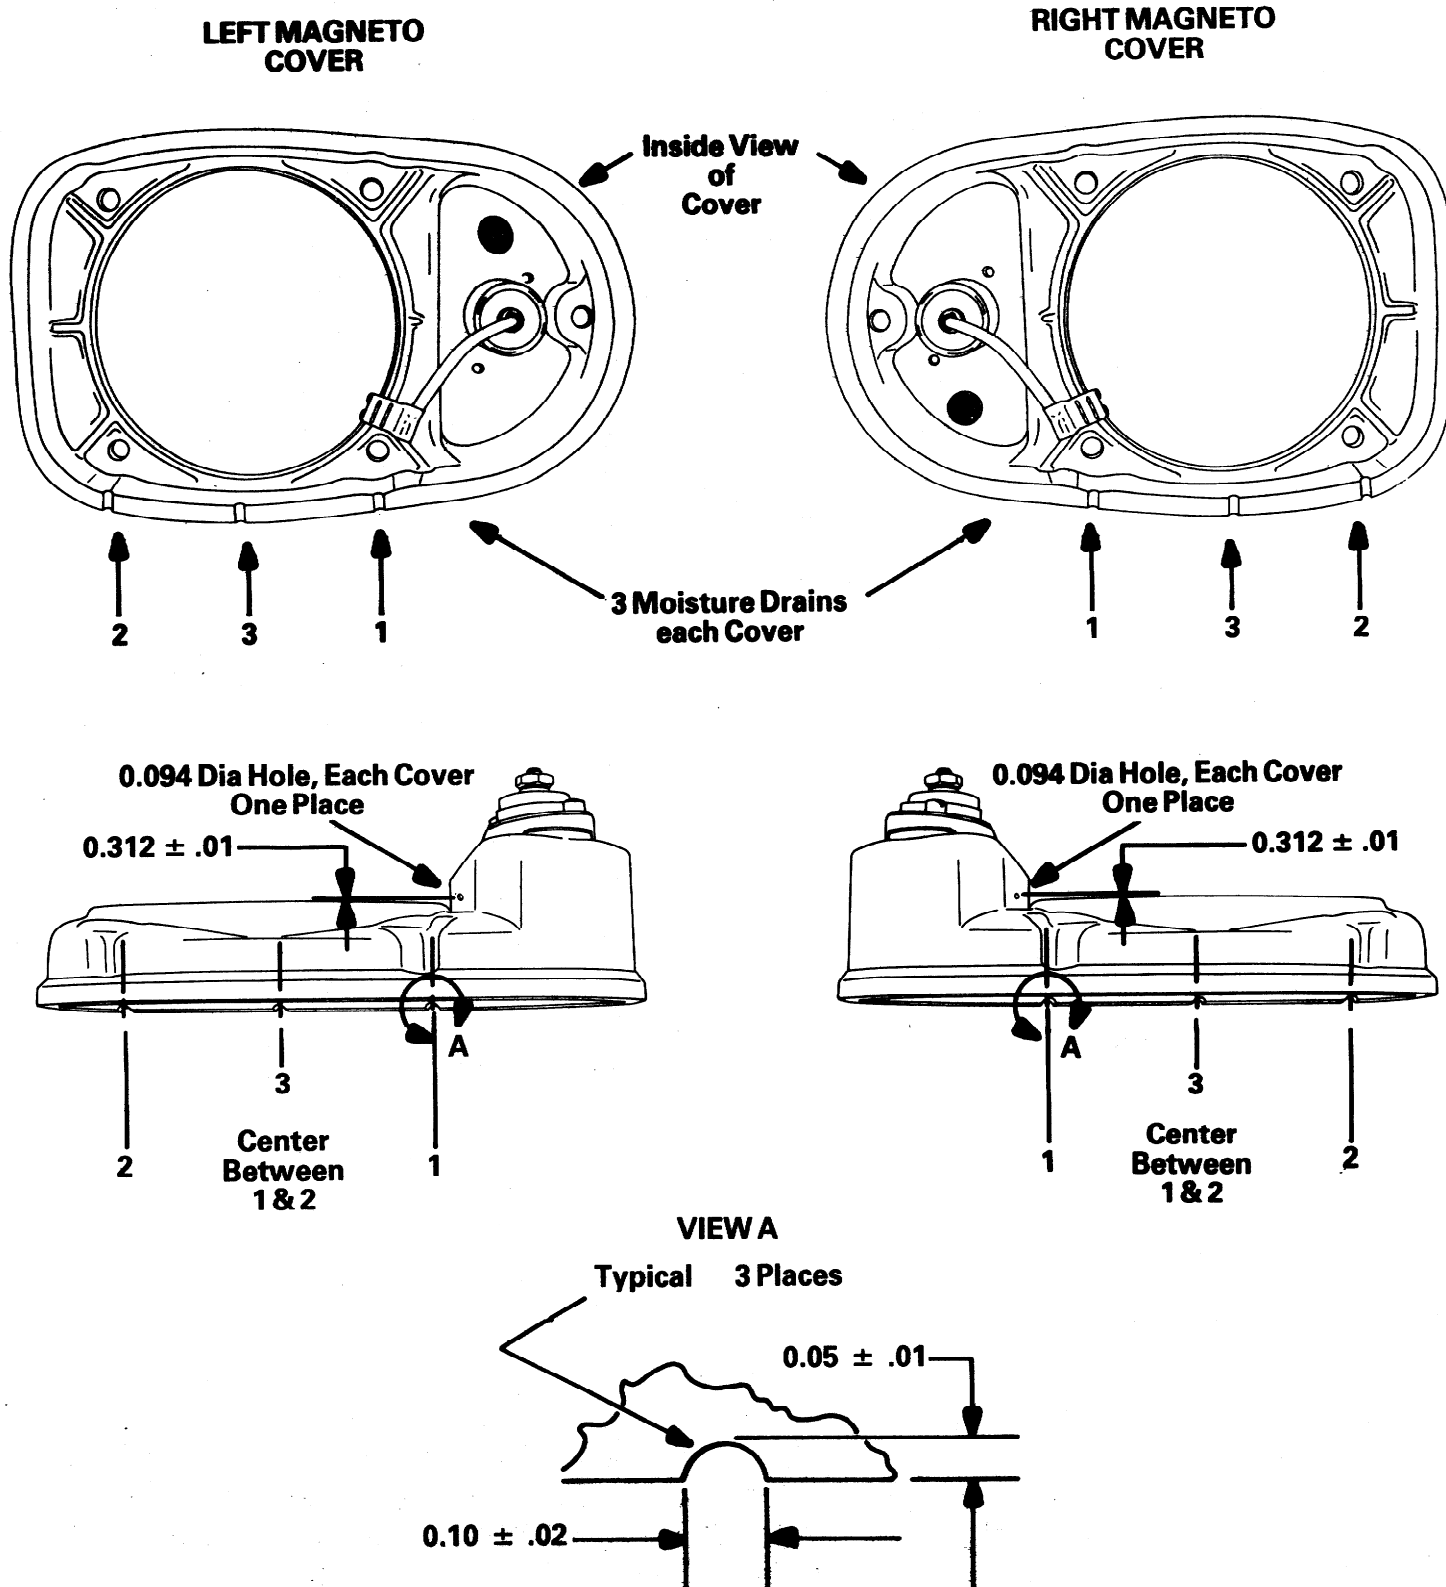
**Figure 1. Location of Drain Holes**

Field reports indicate that some operators of Teledyne Continental Engines of the 470 and 520 series are experiencing water ingestion in the S-1200

Series Magnetos. This moisture contamination may cause ignition difficulties, resulting in possible engine roughness. The addition of moisture drains and sealing of the screen vent in the magneto cover will provide a means for drainage of accumulated moisture and prevent moisture from entering the magneto through the screen vent.

1. Remove the magneto cover by removing the ignition harness adapter plate from each magneto and then removing the magneto cover securing screw. Pull the magneto cover away from the magneto and carefully pull the capacitor, and retard lead, if used, from the breaker flag terminal(s).
2. Using Figure 1 as a guide, lay out the positions for the moisture drains. Positions 1 and 2 are in line with the stud holes in the cover and position 3 is centered between 1 and 2. Using a small round file, create the three hemispherical recesses as detailed in view A, figure 1.

3. Lay out the position for drilling a 0.094 in.  $\pm$  0.005 in. hole in the center of the ledge area of the covers and drill one hole in each cover using a 3/32" or No. 42 drill, as shown in Figure 1.

4. Remove any burrs left during the filing and drilling operations on the covers and clean the covers of any metal shavings. Apply a thin coat of black enamel to the bare metal exposed during the filing of the moisture drains. Avoid getting paint on the adjacent cover-to-magneto mounting surface.

5. With a putty knife, spatula or similar tool, apply a sufficient amount of sealant to the outside of the vent screen to fill the vent screen recess flush with the adjacent cover surface. Acceptable sealants are listed below:
  - a. Dow Corning Sealant No. 3145
  - b. Permatex No. 1
  - c. Hi-Sol Epoxy Patch, Kit 1C
  - d. G.E. Silicone Sealant (Automotive type)

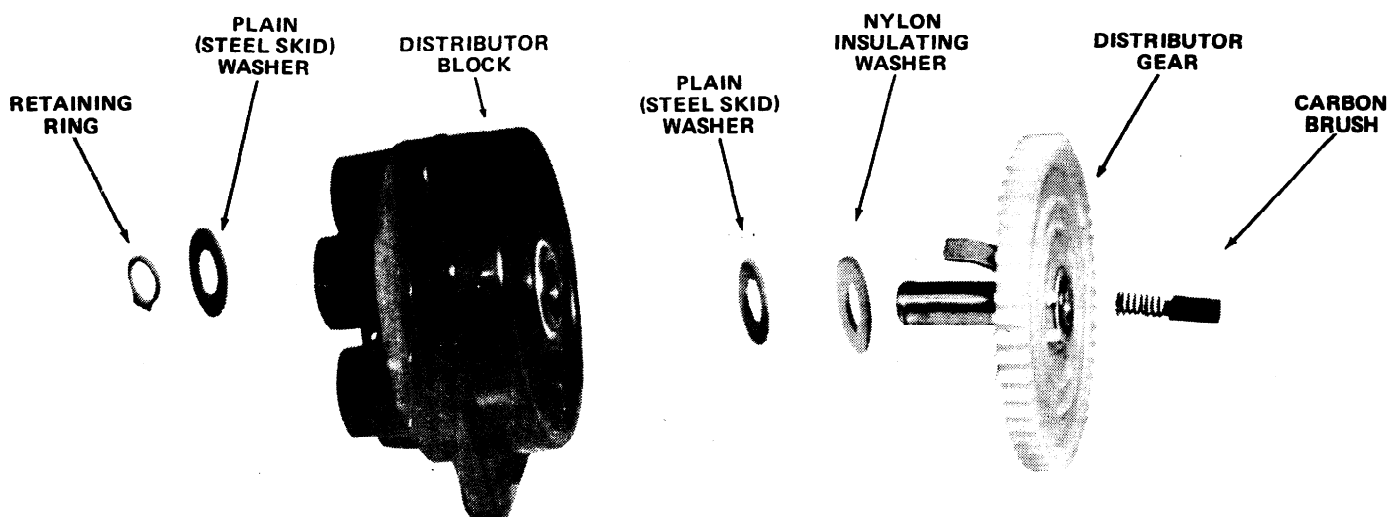
Figure 1. Exploded View

The 10-357584 and 10-357586 Insulated Distributor Gear Kits for S-20 and S-200 Series Magnetos are being provided as a standardization change for Bendix magnetos. With the introduction of these kits, all new Bendix aircraft magnetos delivered from the factory will be provided with insulated distributor gears. The insulated gear kits include all parts (except distributor block) as identified in figure 1.

Assembly sequence of the gear kit to distributor block is shown in the exploded view of figure 1.

When timing magneto on bench or when reinstalling magneto on engine no gear holding timing device should be used, as hidden gear tooth damage may result.

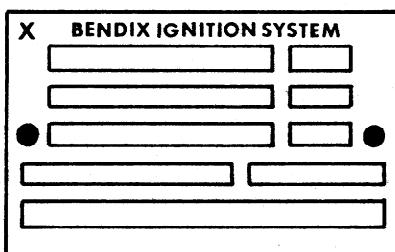
Figure 1. Location of "x" on Identification Plate

All D-2000/2200 series magnetos below serial number 35480 (red label magnetos) and below serial number 8122106 (blue label magnetos) unless identified with an "x" in the upper left corner of the identification plate before the word "Bendix" (see figure 1). The "x" on the identification plate indicates previous compliance.

6. If new serviceable gears, identified with the "z", the "x" and "o", or the "L" are installed in the magneto, identify the magneto by stamping the letter "x" in the upper left corner of the identification plate, before the word "Bendix" (see figure 1).

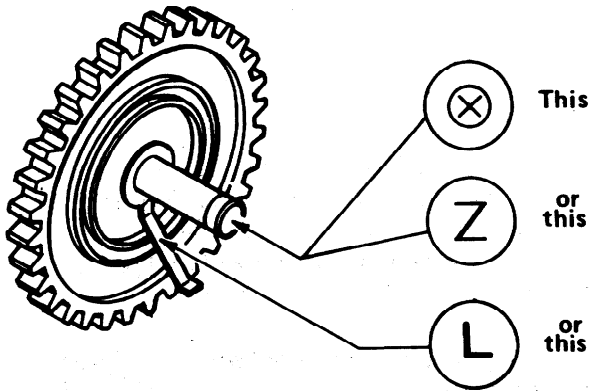
Figure 2. Location of Identification Mark(s)  
on Distributor Gear

Field reports indicate that the distributor gear electrode has been found to be loose on some D-2000/2200 series magnetos. If this condition exists, the distributor gear electrode may contact the distributor block stationary electrodes causing contamination in the distributor in the form of dusty brass particles. This contamination may cause arcing within the distributor resulting in misfiring. This could in turn cause rough engine operation or cylinder or engine damage.

hours or at the next regularly scheduled inspection, whichever occurs first, and reinspected every 100 operating hours until the magneto has 500 operating hours. If the gears fail the inspection they must be replaced immediately with new, serviceable gears; if they pass each inspection they may remain in service until magneto overhaul, at which time they must be replaced with new, serviceable gears. At owner's option, gears that pass inspection may be replaced at any time during the compliance period with new, serviceable gears as identified in this paragraph and figure 2. Serviceable gears are identified by the presence of the letter "z" or the letters "x" and "o" appearing together, laser etched on the retaining ring end of the gear axle, or the letter "L" stamped on the electrode (see figure 2).

1. Remove cover from magneto and inspect the retaining ring end of the distributor gear axles for the letter "z" or the letters "x" and "o". (The letter "x" may or may not be circled by the letter "o".) If the letter "z" or the letters "x" and "o" together are laser etched on the end of the axles, the gears are serviceable and the cover can be reinstalled. Identify the magneto per

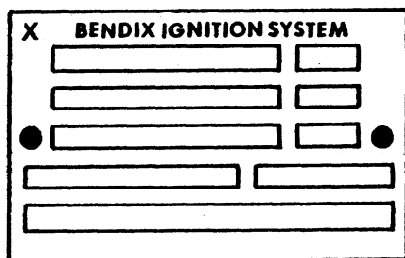
Figure 1. Location of "x" on Identification Plate

All D-3000/3200 Series (blue) Magnetos with Serial Numbers 100 through 1968 not identified by the letter "x" in the upper left corner of the identification plate (see figure 1). The "x" on the identification plate indicates previous compliance.

7. After the magneto has been reassembled with new serviceable gears, identify the magneto by stamping the letter "x" in the upper left corner of the identification plate, before the word "Bendix" (see figure 1).

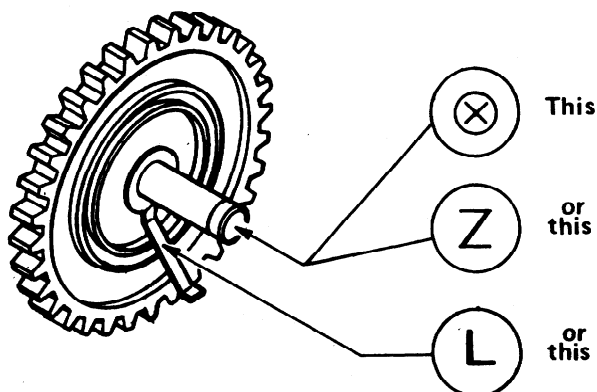
Figure 2. Location of Identification Mark(s)  
on Distributor Gear

The distributor gear electrode has come loose in service on some D-3200 Series Magnetos. If this condition exists, the distributor gear electrode may

contact the distributor block stationary electrodes causing contamination in the distributor in the form of dusty brass particles. This contamination may cause arcing within the distributor resulting in mis-firing. This could in turn cause rough engine operation or cylinder or engine damage. In order to preclude the possibility of service difficulties, the distributor gears of all affected D-3000 and D-3200 magnetos must be replaced.

5. Reassemble the distributor block with new serviceable gears. Serviceable gears are identified by the presence of the letter "z" or the letters "x" and "o" together, laser etched on the retaining ring end of the gear axle, or the letter "L" stamped on the electrode (see figure 2).
