SERVICE LETTER

No. 707

Subject: Modified Flyball Assembly to Improve RPM Control
-- reference attached Hartzell Service Letter No. 75,
dated November 16, 1973.

SERVICE LETTER NO. 75

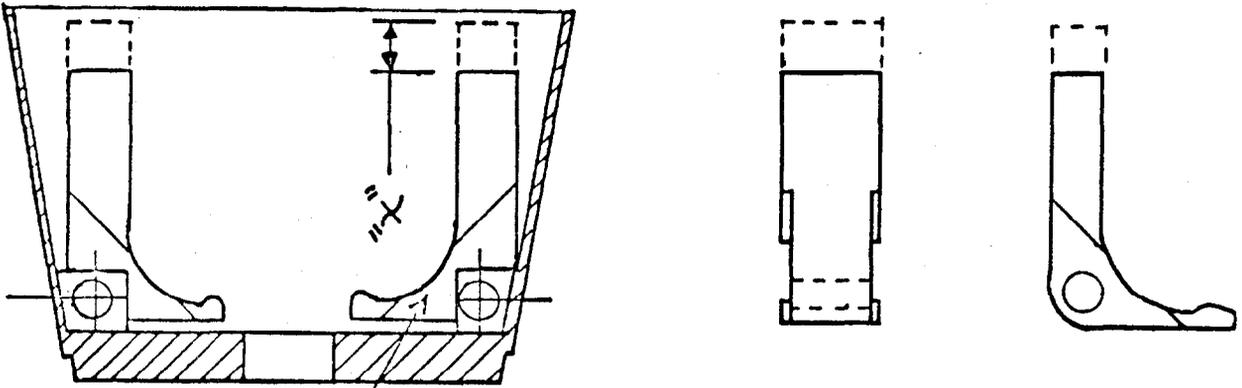
A-153(A)-(C) FLYWEIGHT (SEE CHART)
(MATERIAL GROUND FROM
SIDES ON "A" MODIFICATION)

Discussion: To effect an improved RPM control on aircraft with the Hartzell governors, a modified flyweight assembly designed to absorb the torsional motions of the drive gear are being installed in all Hartzell production governors.

A-153A-2	0	1600-2800
A-153A-1	.250	2500-3700
A-153A	.462	3200-4350
A-153-2	0	1600-2800
A-153-1	.250	2500-3700
A-153	.462	3200-4350
PART NO.	X" LENGTH REMOVED	RPM. RANGE

- 1) Determine flyweight assembly needed using parts listed in this letter.
- 2) The flyweight assembly can be changed by:
 - a) removing cover assembly
 - b) removing flyweight assembly locking ring
 - c) removing flyweight assembly
 - d) placing new flyweight assembly in place
 - e) replacing lock ring, making sure it is in place
 - f) replacing cover gasket 50672, and
 - g) installing cover assembly
