SERVICE No. 451 BULLETIN

Piper Aircraft Corporation

Subject: Inspection of Throttle Control Shaft

Models Affected: PA-23-250 (Six Place) Aztec

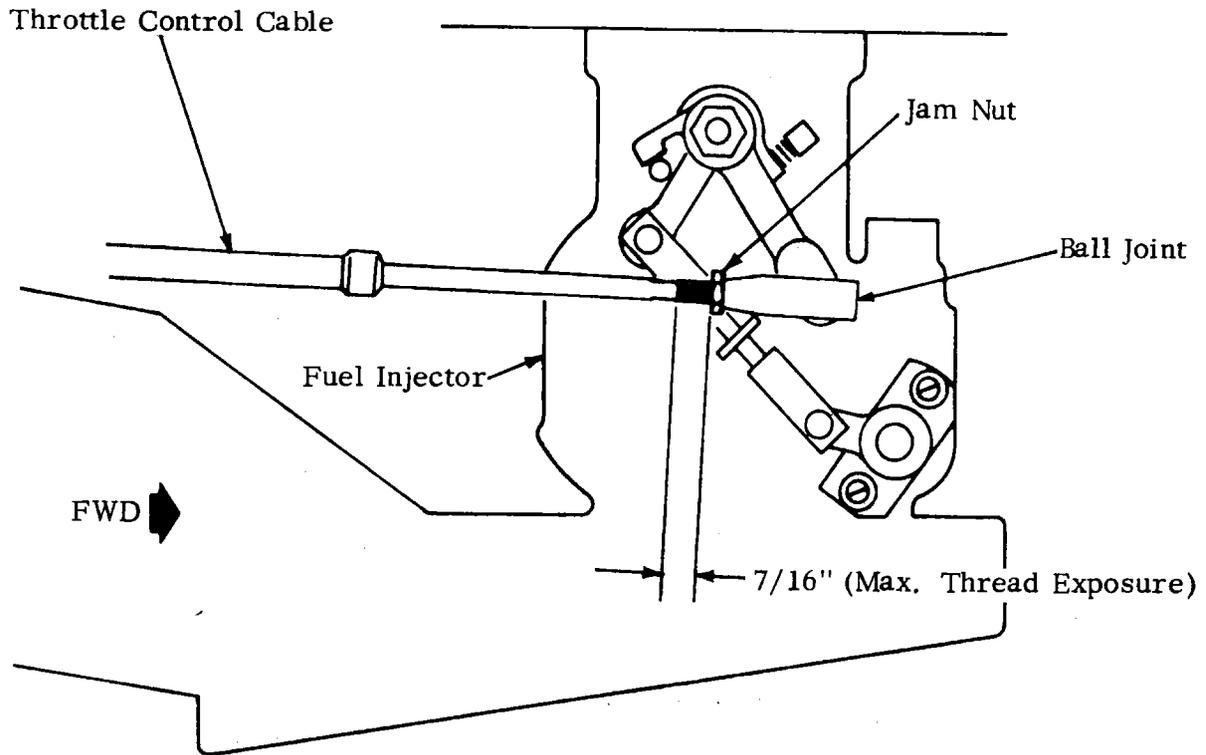
Purpose: Reports received at the factory have revealed insufficient thread engagement of the throttle control cable to the corresponding ball joint attached at the fuel injector throttle arm. This service release has been issued to provide instructions to inspect the Throttle Control Cable/Fuel Injector linkage to insure adequate thread engagement of the threaded control cable shaft into the corresponding fuel injector linkage ball joint. Insufficient thread engagement could lead to throttle control cable disengagement from the injector throttle arm, resulting in unwanted power change. (Refer to the sketch/instruction data on the reverse side of this service release for an illustrated description of this area).

- A. Remove inboard side cowl from left engine and outboard side cowl from right engine to gain access to the throttle control cable.
- B. Measure the threads exposed at the rear of the ball joint jam nut.

1. If thread exposure is 7/16 of an inch or less, no further action is required.
 2. If thread exposure is more than 7/16 of an inch, it will be necessary to proceed as follows:

- a. Remove ball joint from throttle arm. Loosen jam nut and rotate ball joint on cable until thread exposure is 7/16 of an inch or less. Tighten jam nut and reinstall ball joint on throttle arm.

- b. At the pedestal assembly, remove the engine control placard to gain access to the throttle control cable clevis and remove clevis from throttle lever. Loosen jam nut and rotate clevis the same amount as the ball joint in order to maintain the pre-set distance between ball joint and clevis. Tighten jam nut, connect clevis to throttle lever and reinstall placard.
