Service Letter No. 404

**SUBJECT:** Inspection of Altimatic and Altimatic II Pitch Servo Assembly Chain Adjustment Screw

**MODELS AFFECTED:** PA-23 Apaches, Serials 23-1502 to 23-2046 inclusive  
PA-23-250 Aztecs, Serials 27-1 to 27-504 inclusive  
PA-23-235 Apaches, Serials 27-505 to 27-572 inclusive  
PA-23-250 (6 place) Aztecs, Serials 27-2000 to 27-2388 inclusive  
PA-24 and PA-24 "250" Comanches, Serials 24-2003, 24-2203, 24-2299 to 24-3557 inclusive

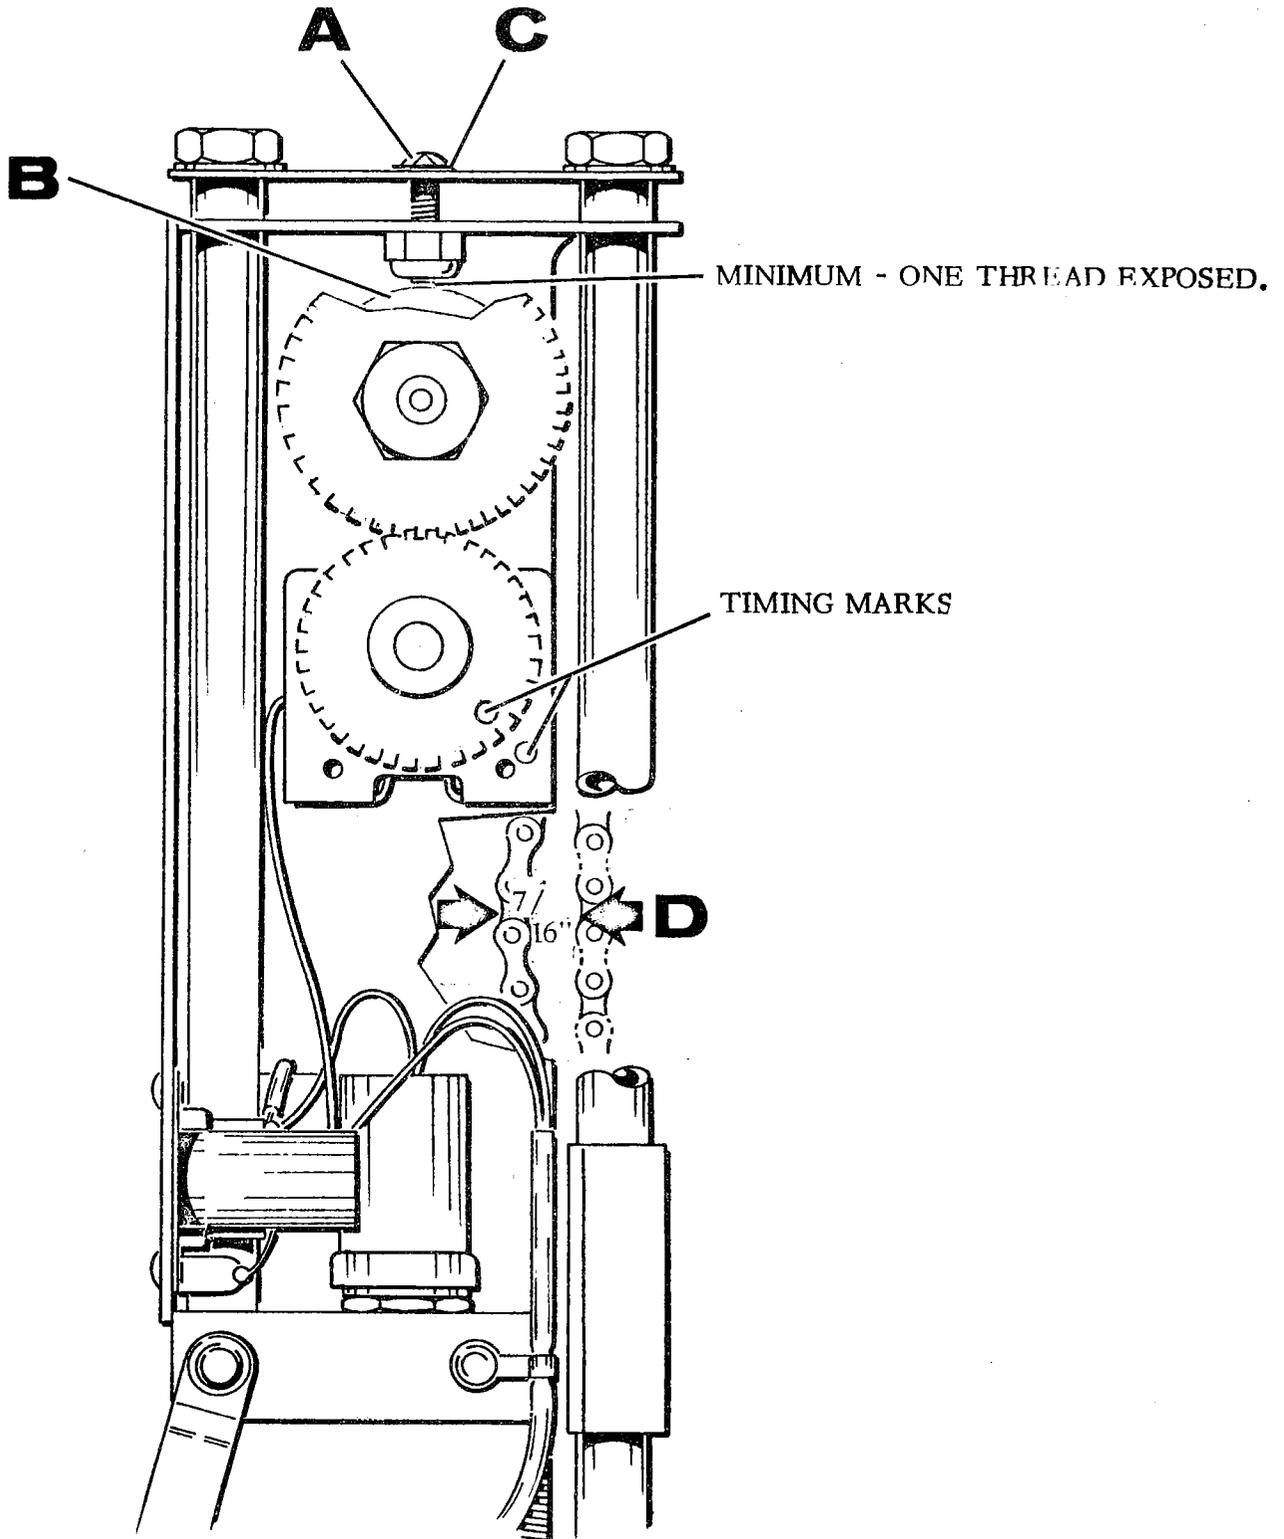
# SERVICE LETTER NO 404

In order to provide a positive lock of the screw, at least one or more threads must protrude through the nut. If this cannot be accomplished without maladjustment of the pitch servo chain tension, (See pitch servo chain adjustment procedure on the following page.) it will be necessary to remove the screw and replace it with a "long-lok" type screw (Mitchell part number 3S275). Standard AN 1/32" thickness washers may be used as required under the head of the screw to prevent driving the screw end against the adjacent sprocket mounting.

See sketch attached to this letter for screw location and chain adjustment details.

1. Completely disengage the servo.
2. Measuring on the opposite side of the slide bushing or break-away link in the center of the servo, the chain should have approximately 7/16" slack.
3. By turning the adjusting screw clockwise, the chain tension is increased and by turning counter-clockwise, the chain tension is decreased.

IF LONG-LOK SCREW (A) CONTACTS SPROCKET MOUNTING (B), REMOVE SCREW AND INSTALL PACK WASHERS (C), UNDER HEAD OF SCREW AS REQUIRED TO MAINTAIN CHAIN TENSION OF 7/16" SLACK (D).
