The New Piper Aircraft, Inc.
 2926 Piper Drive
 Vero Beach, Florida, U.S.A. 32960

SERVICE No. 1051B BULLETIN

Date: November 5, 2002 (M)

SUBJECT: FLAP TORQUE TUBE REPLACEMENT

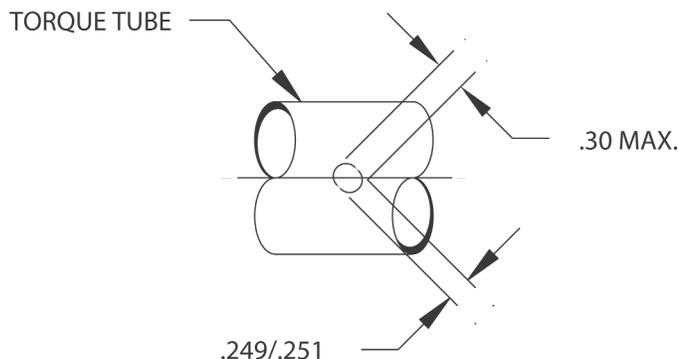
Acceptable Limits for Oblong Hole
(Angle to Center Line is not Critical)

- Examine the holes for the attachment bolts for the Flap Control Horn and the Flap Bellcrank for cracks originating out of the hole using Fluorescent Penetrant procedure per FAA AC43.13 Repair Manual, Nondestructive Testing. Also, inspect for elongation of the subject holes. Elongation up to .050 (see sketch) is acceptable provided that when the horn or bellcrank is mounted on the tube with the attachment bolts (without nuts) installed, there is no relative motion between the horn or bellcrank and the torque tube with a light load applied in a radial direction simulating a flap air load. Proceed to Instruction 5 if cracks are noted in the subject holes or elongation exceeds limits.
