SERVICE

NUMBER 151

SUBJECT: Elevator Push-Pull Tube Rollers

MODELS AFFECTED: PA-23 Apaches - Serials 23-1 to 23-903 inclusive

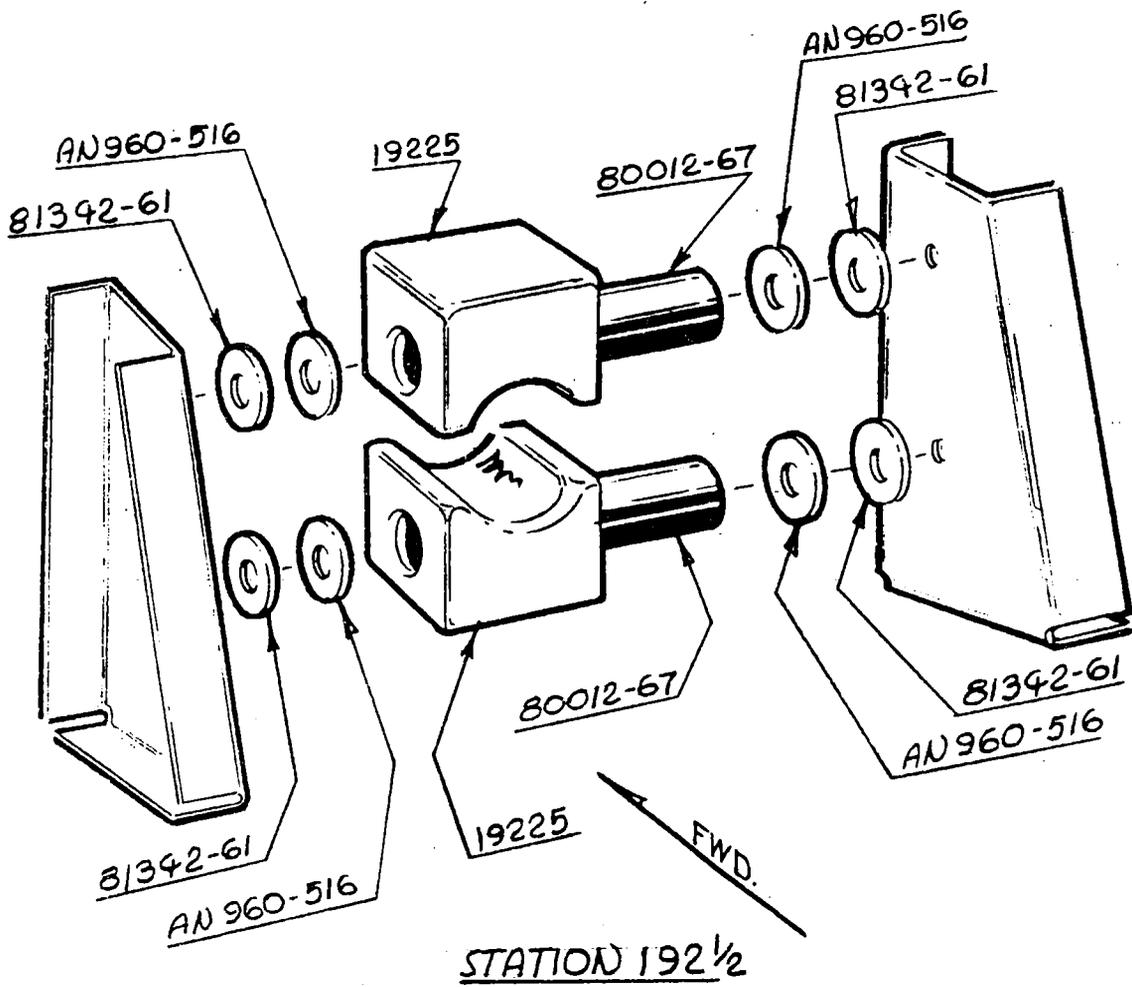
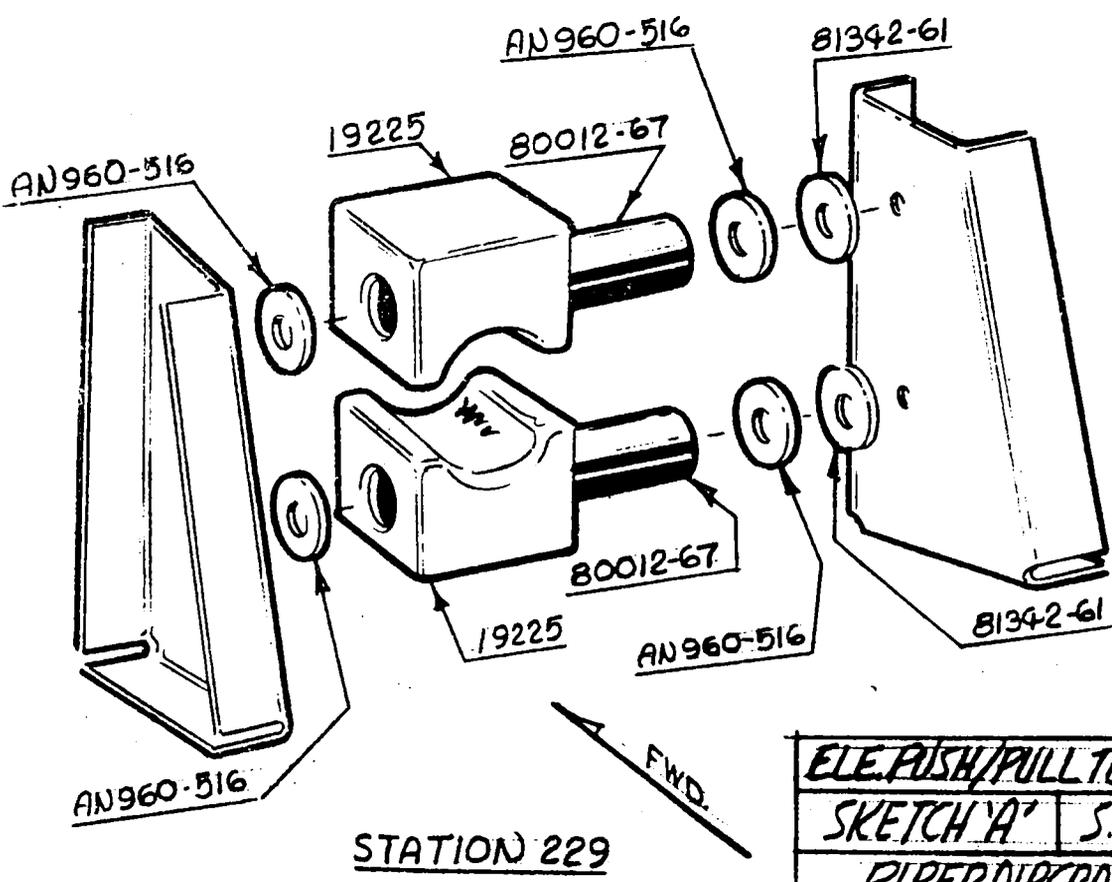
ELE. PUSH/PULL TUBE ROLLER	
SKETCH 'A'	S.B. 151
PIPER AIRCRAFT CORP.	
LOCK HAVEN, PA.

Service reports from our "Certified Service Centers" indicate that the elevator push-pull tube in the Apache is wearing at a point where it passes through the fiber rollers. This problem has been eliminated in production by the installation of nylon blocks in place of the fiber rollers.

It is requested that four (4) each of block, part number 19225-00, be obtained and installed per Sketch "A" shown on the reverse side of this Bulletin. Compliance with this Bulletin is required at the next 100 hour inspection or by May 1, 1957, whichever shall occur first. Careful examination should be made of the wear area on the elevator push-pull tube and any tube that shows wear exceeding .005 inches should be replaced. The four bearings 80012-67 and the six washers 81342-61 should be removed from the fiber roller installation and reused in the nylon block installation. The AN960-516 washers and the blocks 19225-00 are the new parts required.
