# SERVICE BULLETIN

No. 319

Piper Aircraft Corporation  
"FAA DOA EA-1 Approved"

- 
- Subject: Exhaust System Inspection and Modification
- Models Affected: PA-23-250 (Six Place) and PA-E23-250 (Six Place);  
Normally Aspirated Only.
- Serial Numbers Affected:

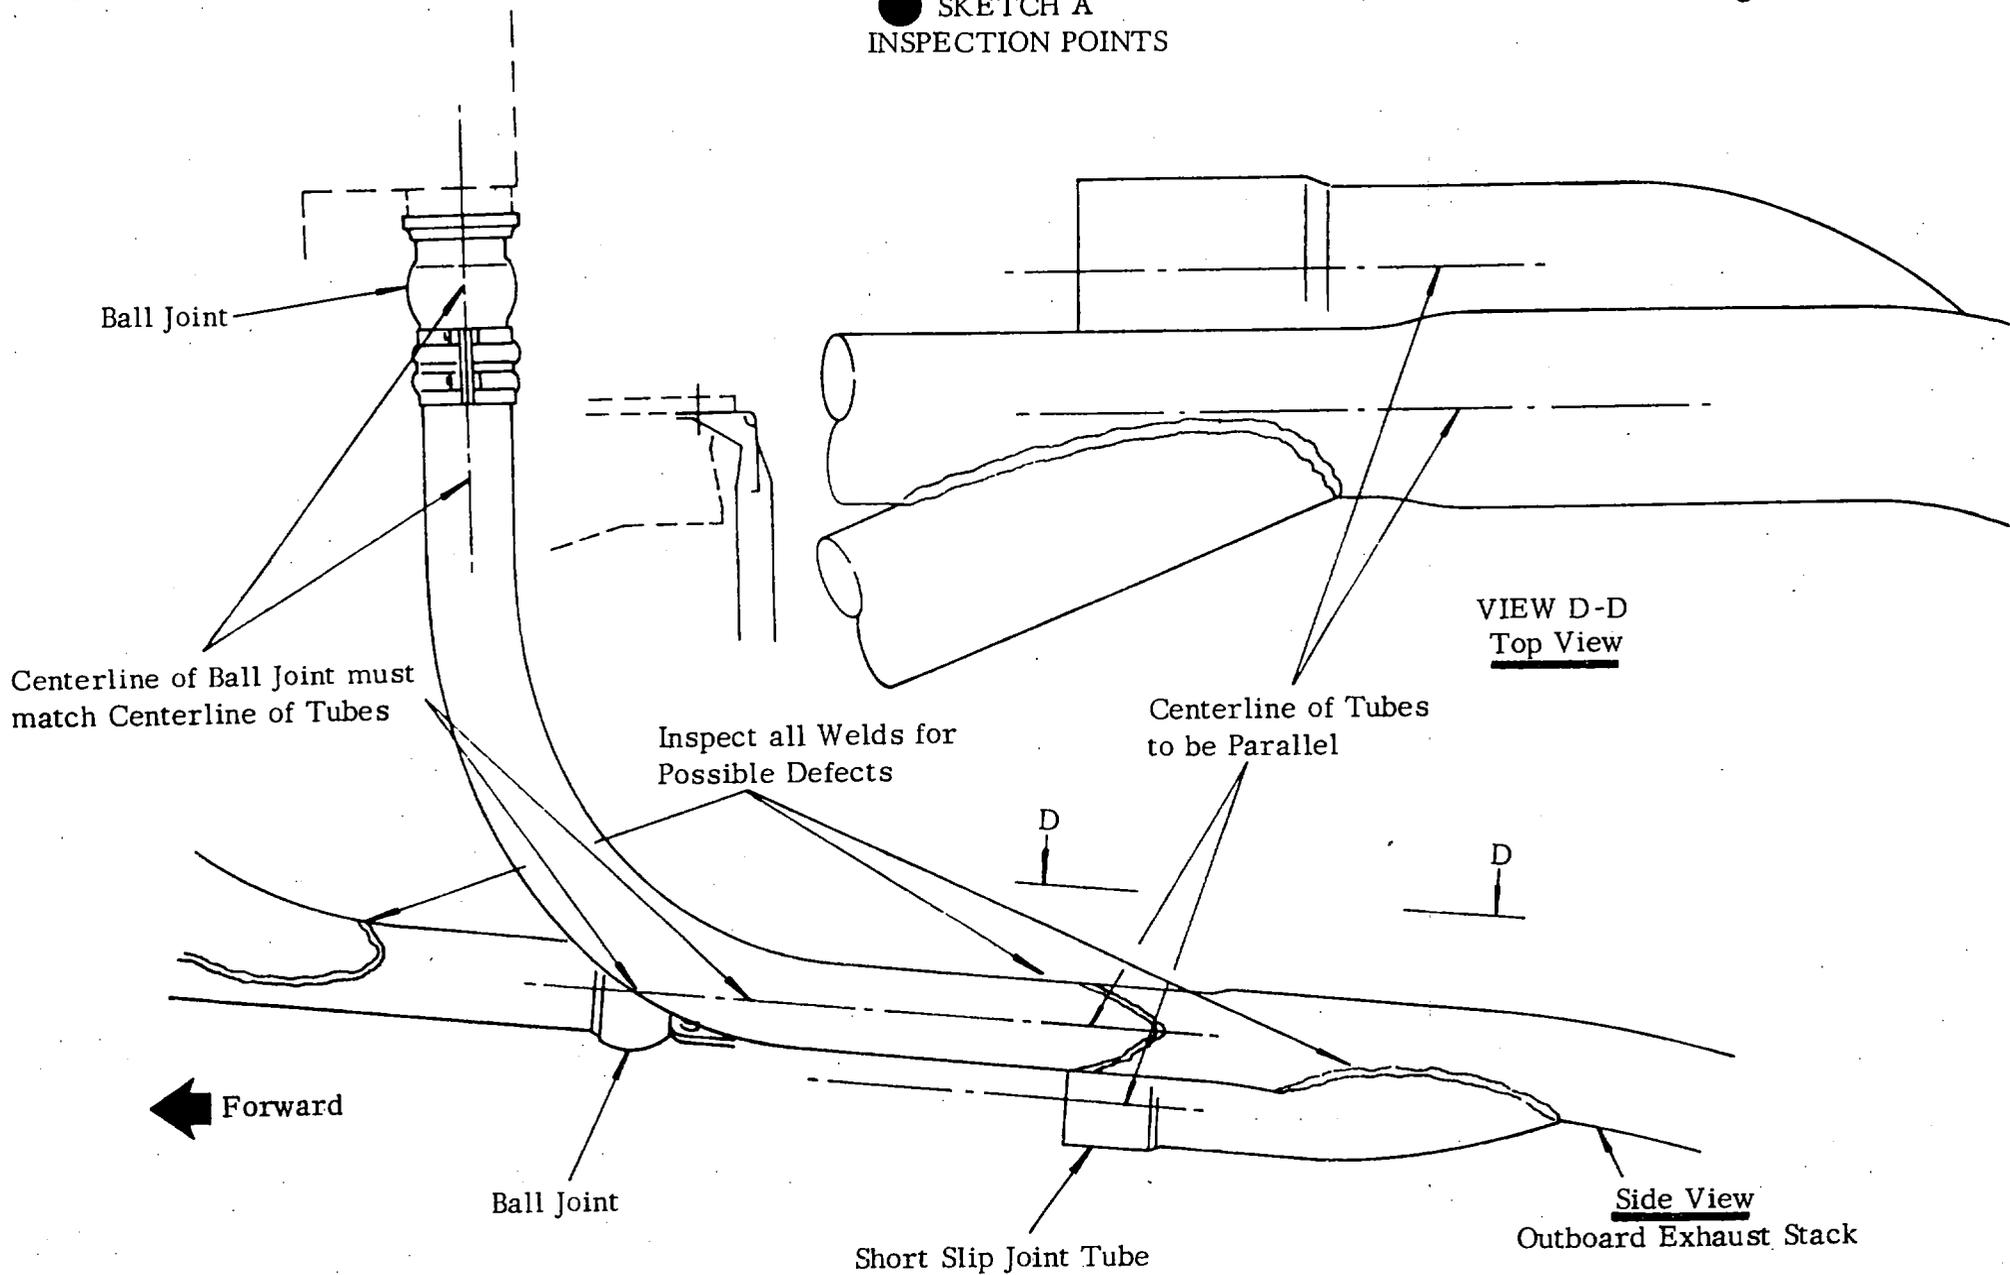
● SKETCH A  
INSPECTION POINTS

1. Remove both engine cowls. (Refer to Service Manual.)
2. Visually inspect both outboard exhaust stacks for alignment of ball joint tubes, crossover tubes, and for any cracks which may have developed in the welds as shown in Sketch A.
3. The center line of the short slip joint tube on the tailpipe must be parallel with the center line of the tailpipe tube as shown in Sketch A, top and side views. (Remove the figure eight clamp.)

4. The center line of the ball joints must match the center line of the mating tubes, as shown in Sketch A.
5. If the ball joints are not properly aligned, remove the outboard exhaust stacks and crossover tube to properly realign the stacks.

If the checks described in step 3 shows any misalignment between the two tubes or cracks at any of the welds, the tailpipe assembly should be replaced.

**NOTE**

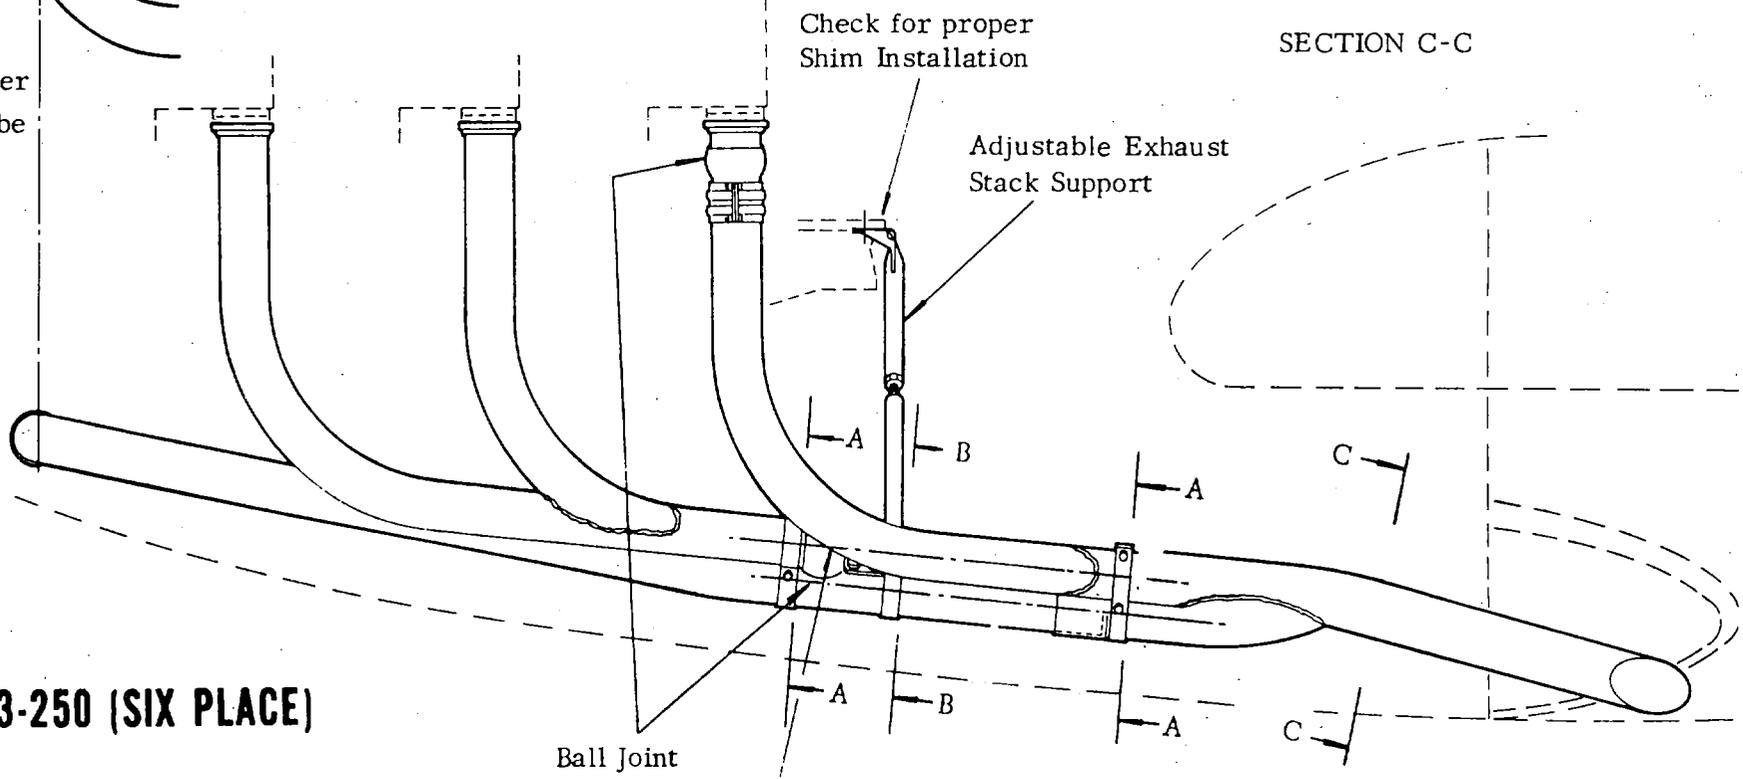
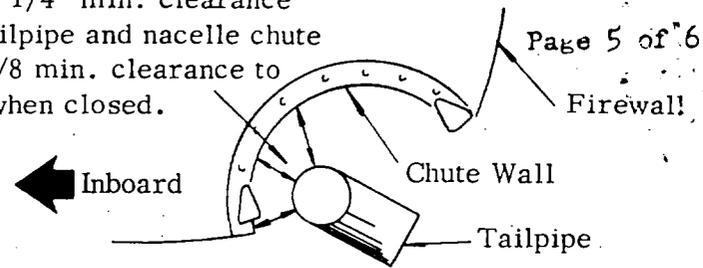
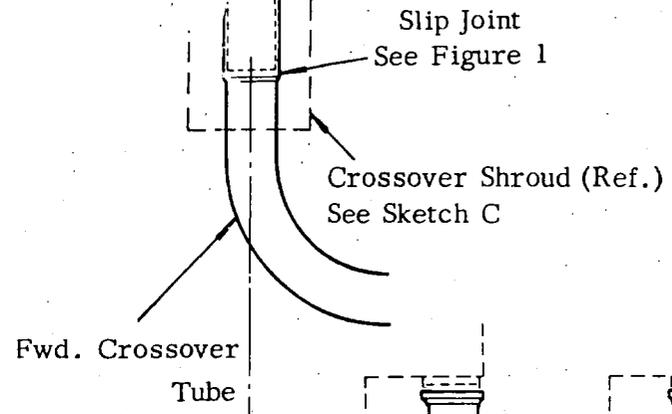
● SKETCH B  
ADJUSTMENTS

1. The crossover tube must be free to move at both slip joints prior to clamping.
2. There must be a minimum clearance of 1-1/4 inches between the tailpipe and the firewall chute, as shown in Sketch B, Section C-C. If this dimension is not obtainable, the system is not set properly and should be readjusted.

Maintain 1 1/4" min. clearance  
between tailpipe and nacelle chute  
wall and 1/8 min. clearance to  
cowl flap when closed.

7. Align the ball joint center line with the center line of the mating tube, forward and aft of the ball joint as shown in Sketch B, Figure 1. Ascertain that the crossover tube is properly positioned in the slip joints by checking the location of the previously made reference marks. Retighten the exhaust system.

9. Adjust the clamp at the end of the support bracket to securely hold the tube, refer to Sketch B, Section B-B.

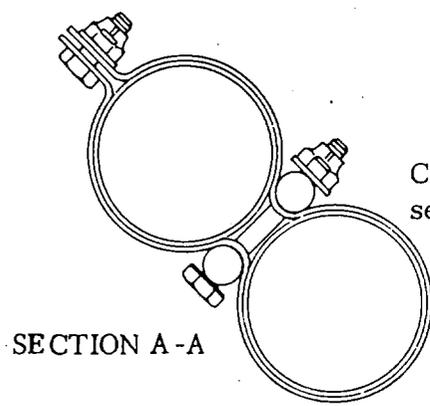
Centerline of Ball Joint  
Parallel and Straight  
with Tubes.

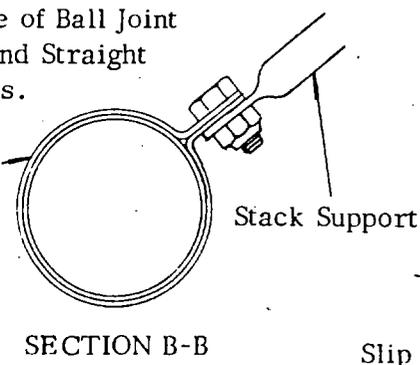
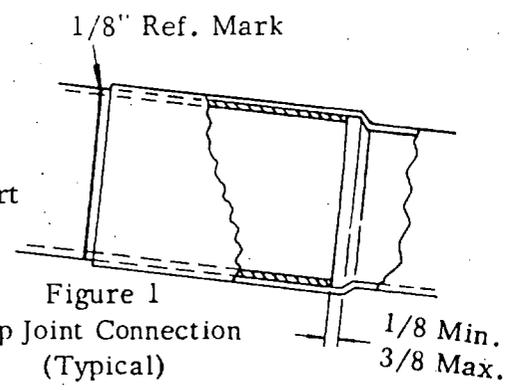
Clamp must be  
secure on tube
