SERVICE

BULLETIN

NUMBER: 149

SUBJECT: Reinforcement of Aileron Balance Weight Bracket

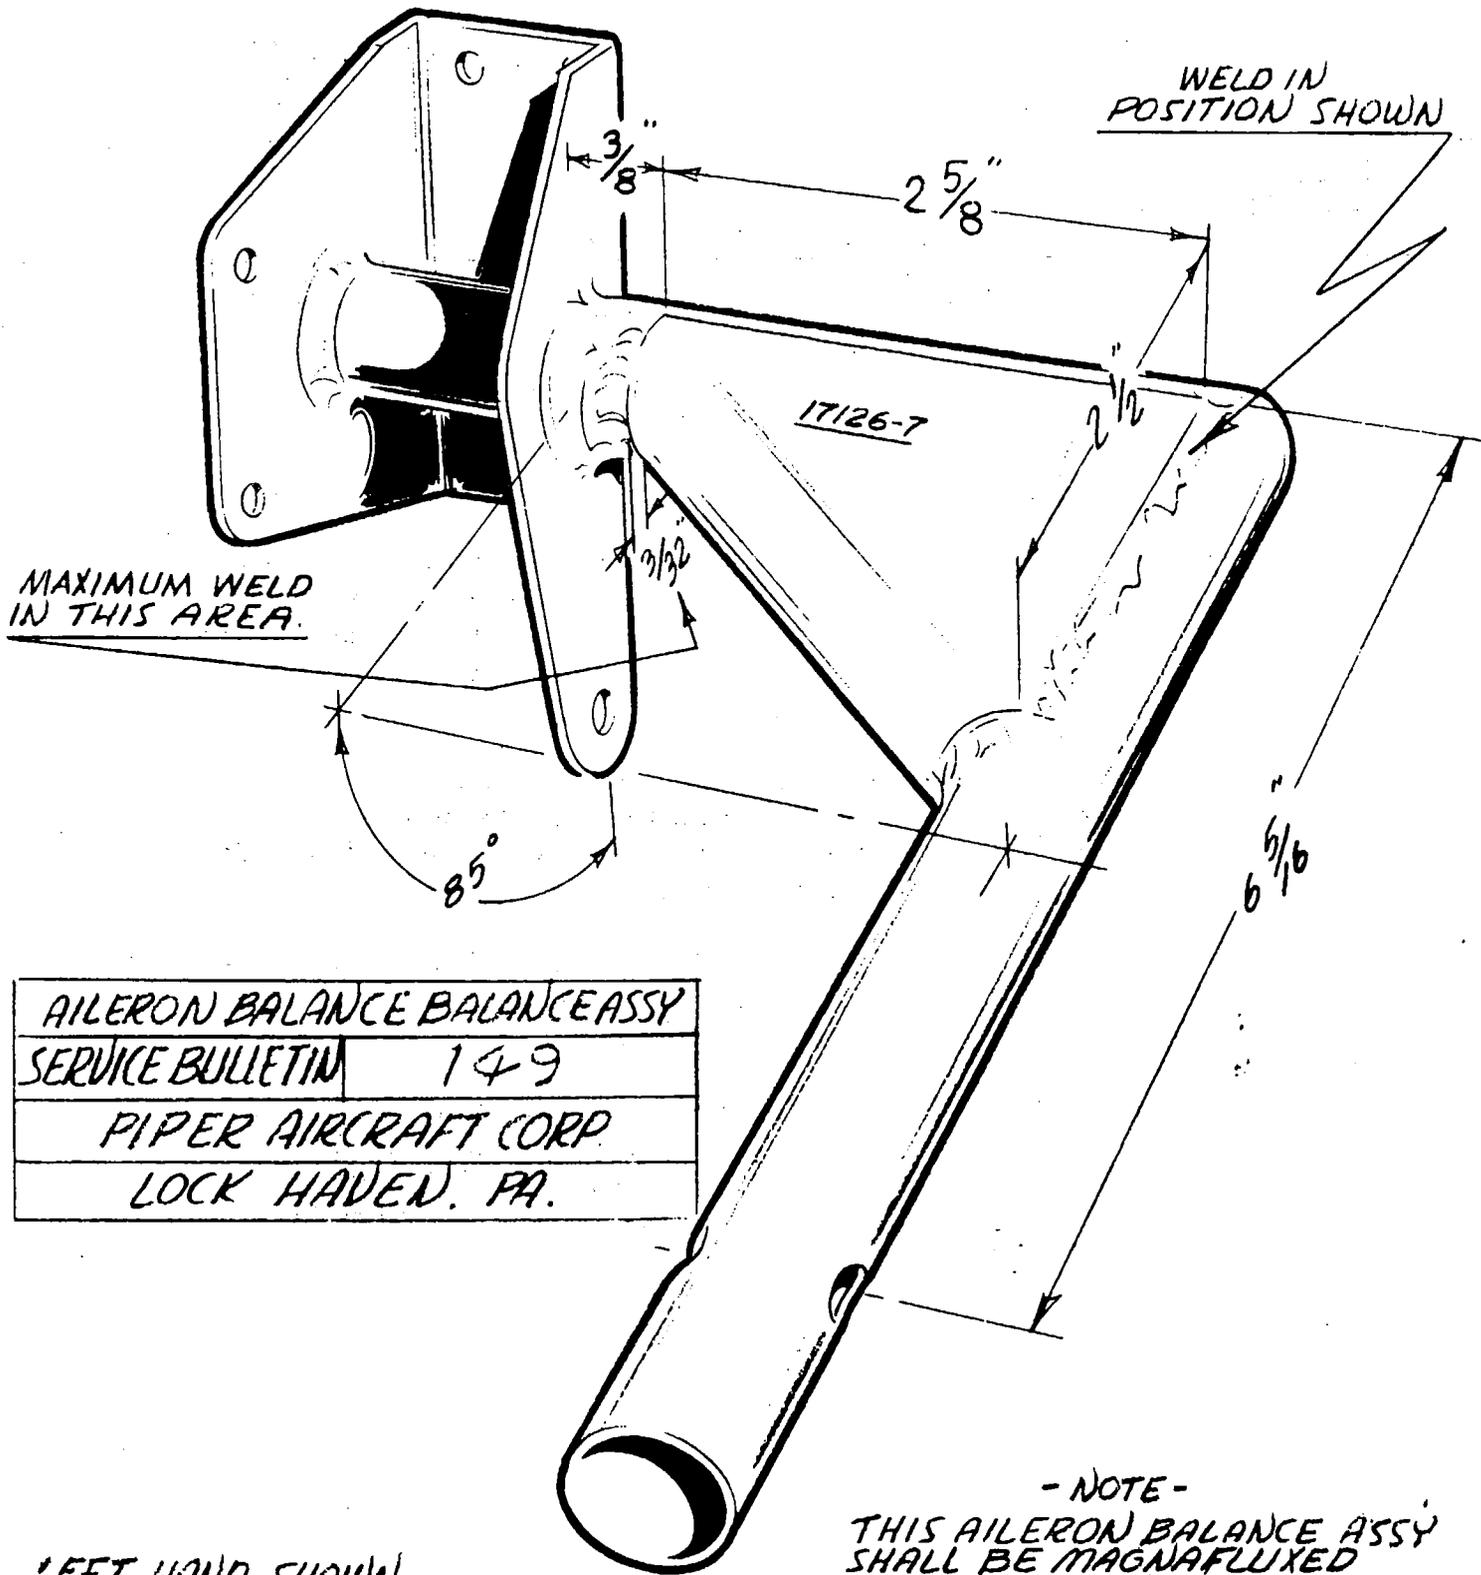
AILERON BALANCE BALANCE ASSY	
SERVICE BULLETIN	149
PIPER AIRCRAFT CORP.	
LOCK HAVEN, PA.

Several cases of fatigue cracking in the aileron balance weight bracket at a point where the bracket tubes are welded to form a 90° angle have been reported. Therefore, on the above listed aircraft it will be necessary to remove both the right and left aileron balance weight brackets and reinforce them in accordance with the Sketch shown on the reverse side of this Bulletin.

In cases where cracks are found, they are to be cleaned of paint and rewelded prior to the addition of the reinforcement. After the reinforcement gusset has been welded to the aileron balance bracket, the bracket is to be magnafluxed for welding cracks and thoroughly checked for straightness.

- NOTE -
THIS AILERON BALANCE ASSY
SHALL BE MAGNAFLUXED
AFTER WELDING.
