Service Letter No. 454

July 1, 1965

SUBJECT: Pitch Breakaway Ball Bracket (AltiMatic II)

MODELS AFFECTED: PA-23-250 (six place) with AltiMatic II

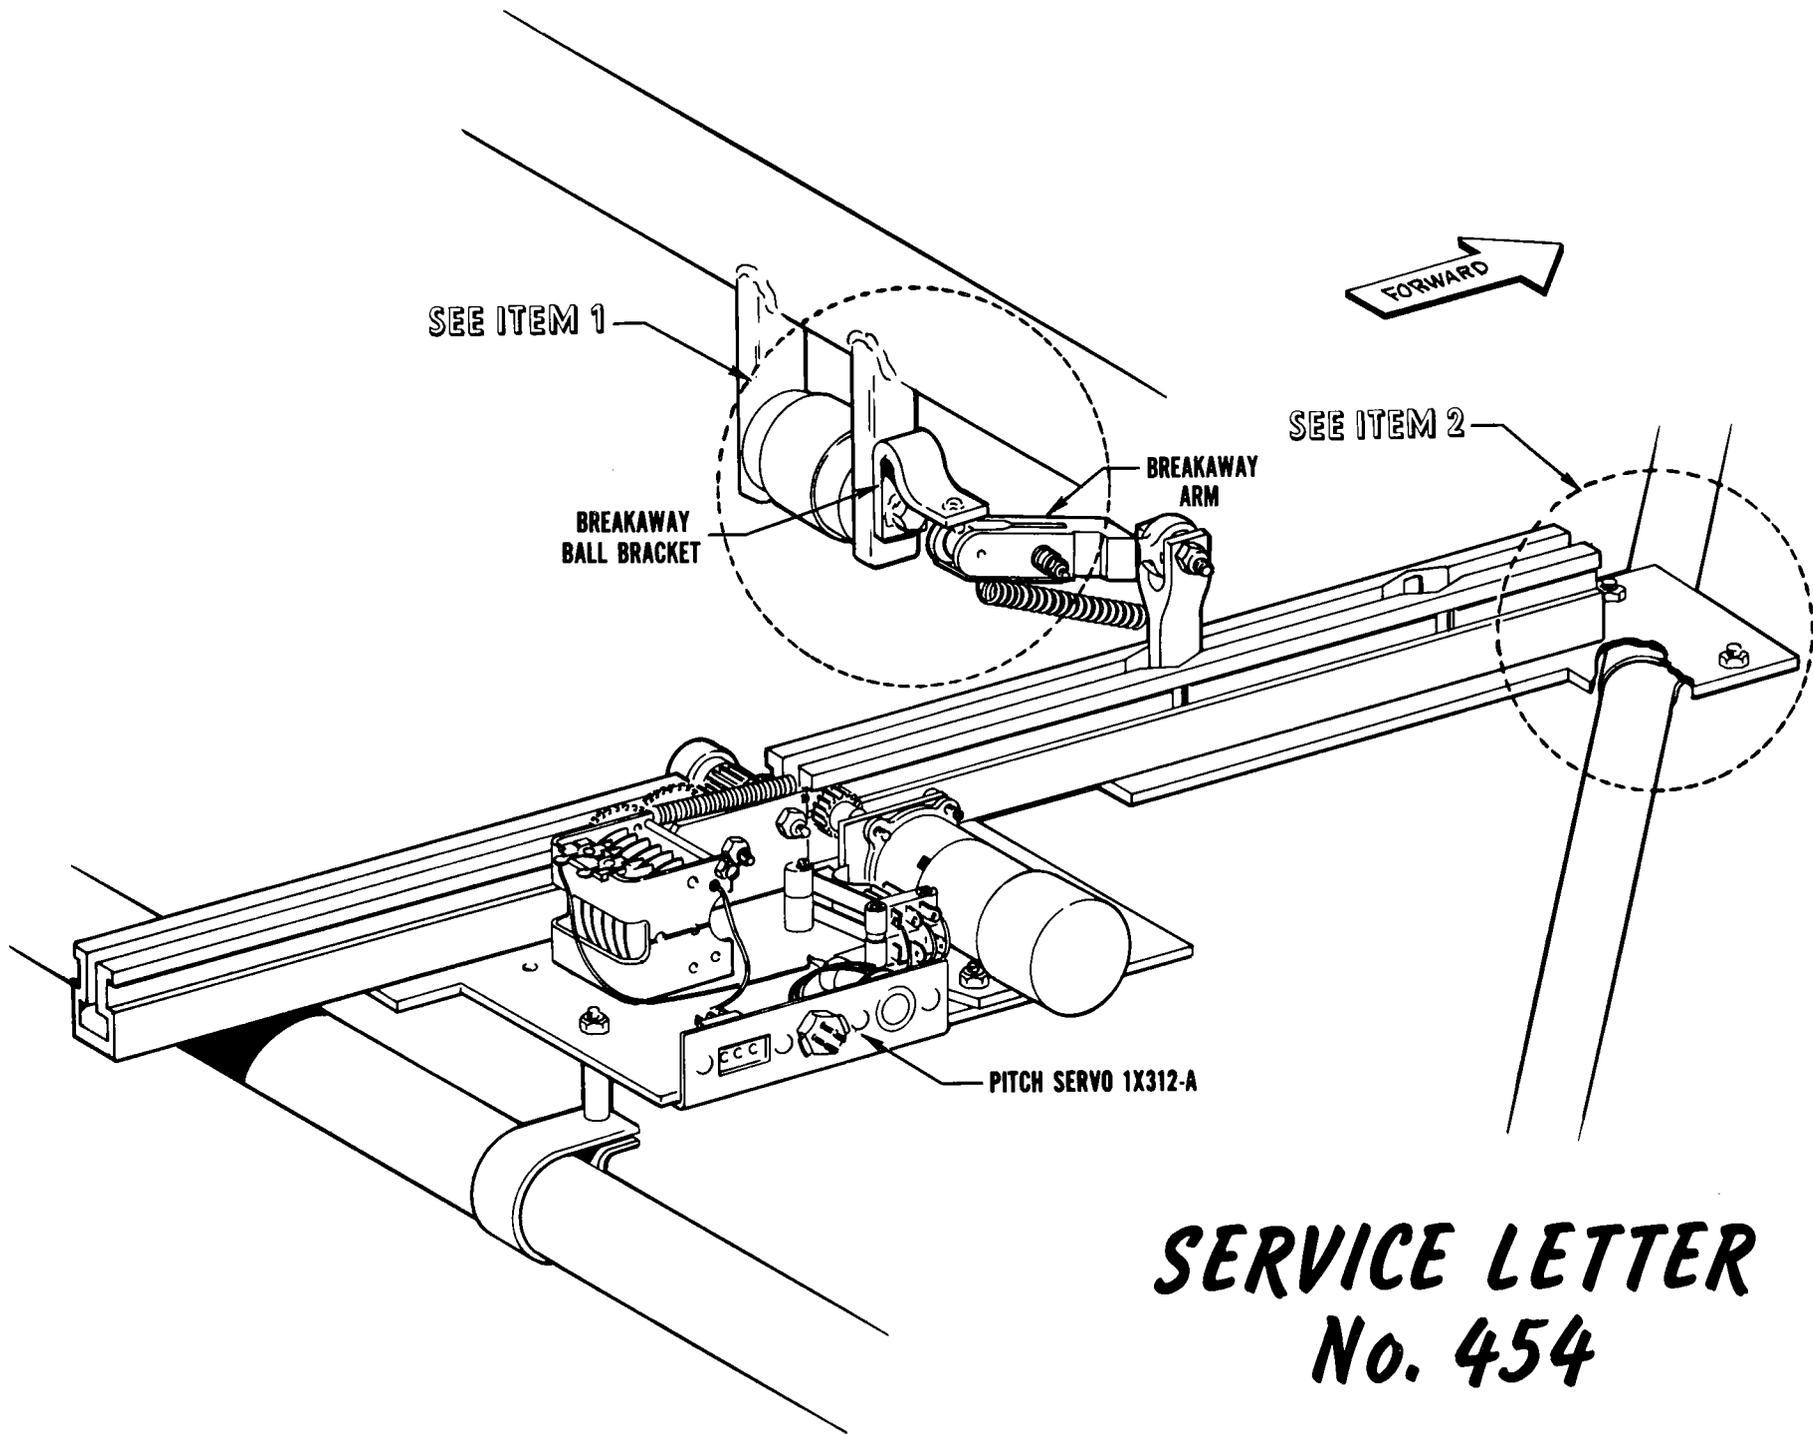
2. The forward end of the Pitch Servo (toward the bulkhead) must be mounted on the top of the fuselage tubes. All installations which have the servo mounted below the fuselage tube shall be reworked per drawing #31670, Rev. F. or per sketch on reverse side of this letter.

- 2-A. After servo has been reinstalled to comply with Item 2, if necessary, re-engage breakaway link.
- 2-B. Time pitch follow-up condenser as per EL-32A.
- 2-C. Adjust pitch leveling condenser as per ground setup outlined in EL-32A.
- 2-D. Flight check and adjust pitch leveling condenser as per in-flight adjustments outlined in EL-32A.
