# SERVICE No ~~334~~ BULLETIN

Piper Aircraft Corporation

Subject: Alternate Air Hose Replacement

Models Affected: PA-23-250 (Six Place) Turbocharged Aztec

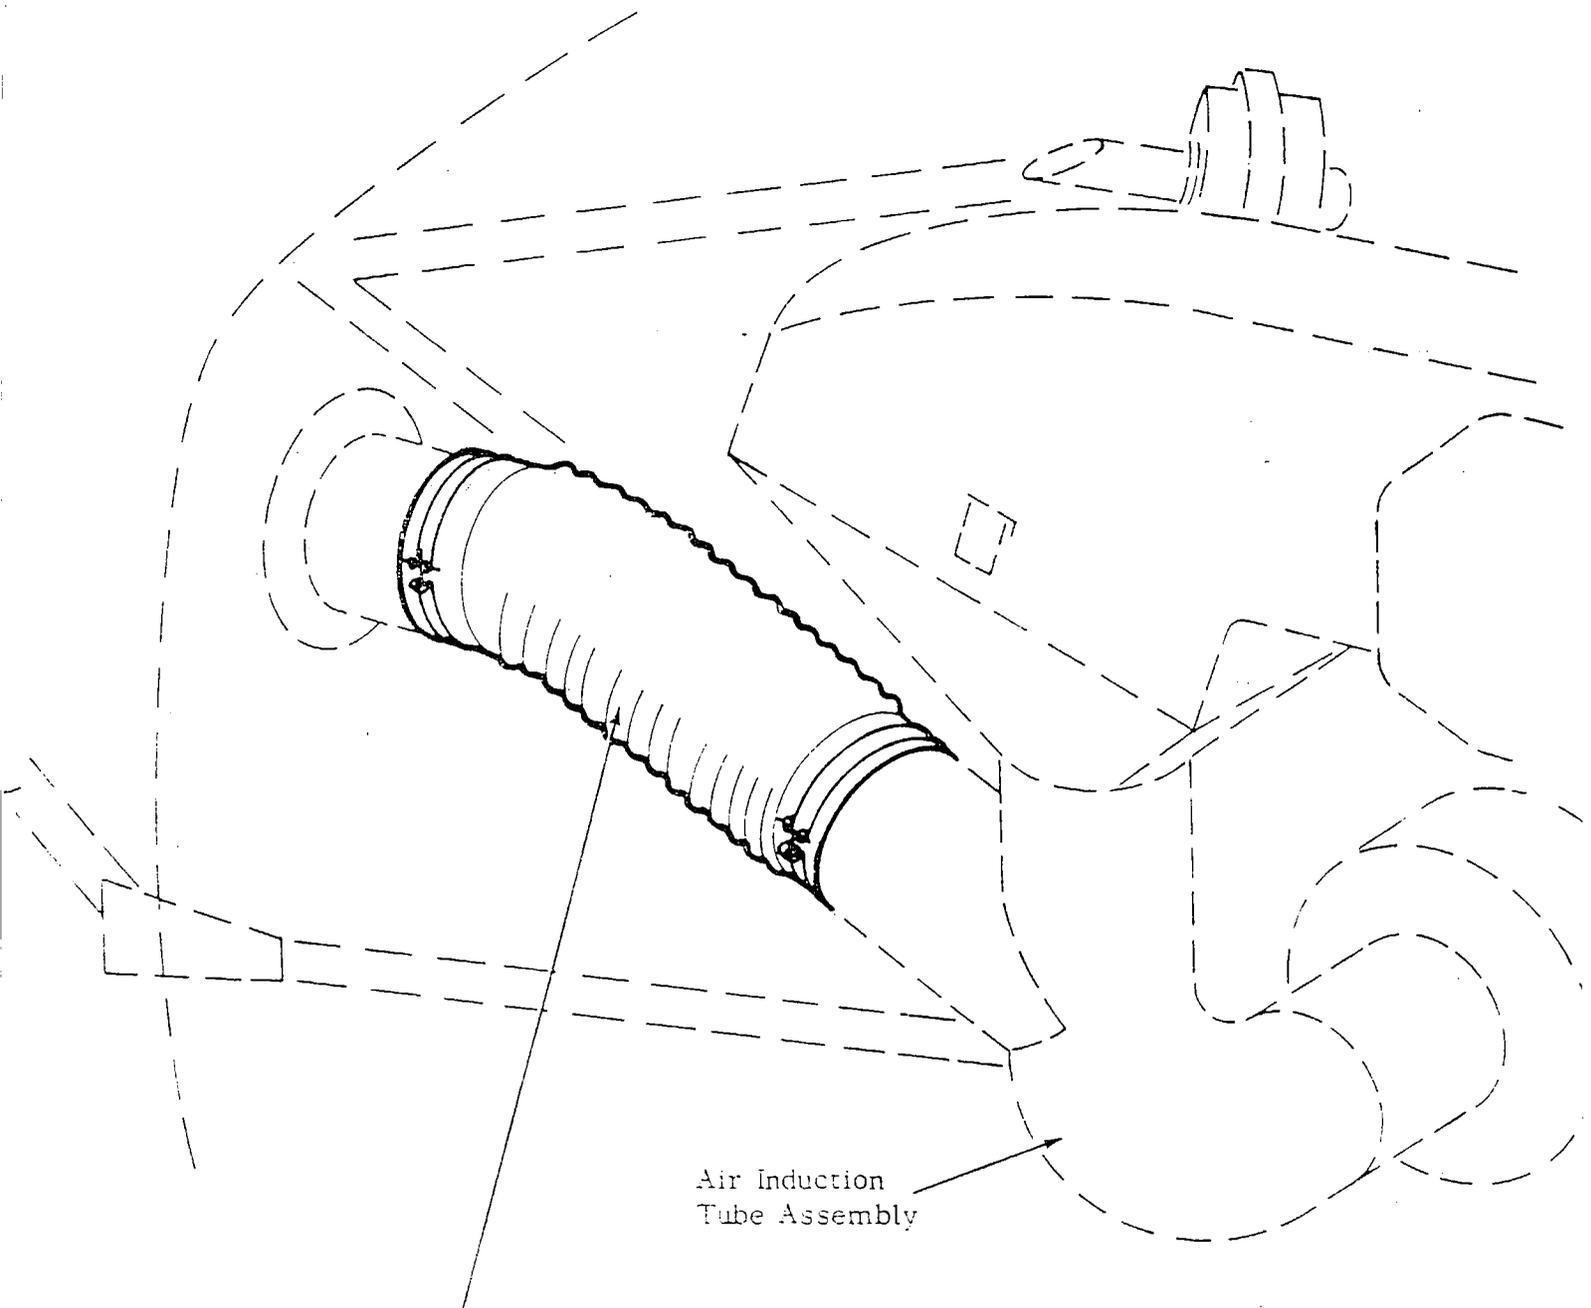
Purpose: To replace the existing Alternate Air Hoses on the above referenced aircraft with new improved Alternate Air Hoses.

Remove the existing Alternate Air Hose and install new hose, Part No. 48076-02, using existing clamps.
