SERVICE *No. 401A* BULLETIN

Date: May 16, 2000 (M)

INSPECTION OF HEATER FUEL VALVE

PA-23, PA-23-160 Apache
 PA-23-235, PA-23-250 and
 PA-23-250 (Six Place) Aztec

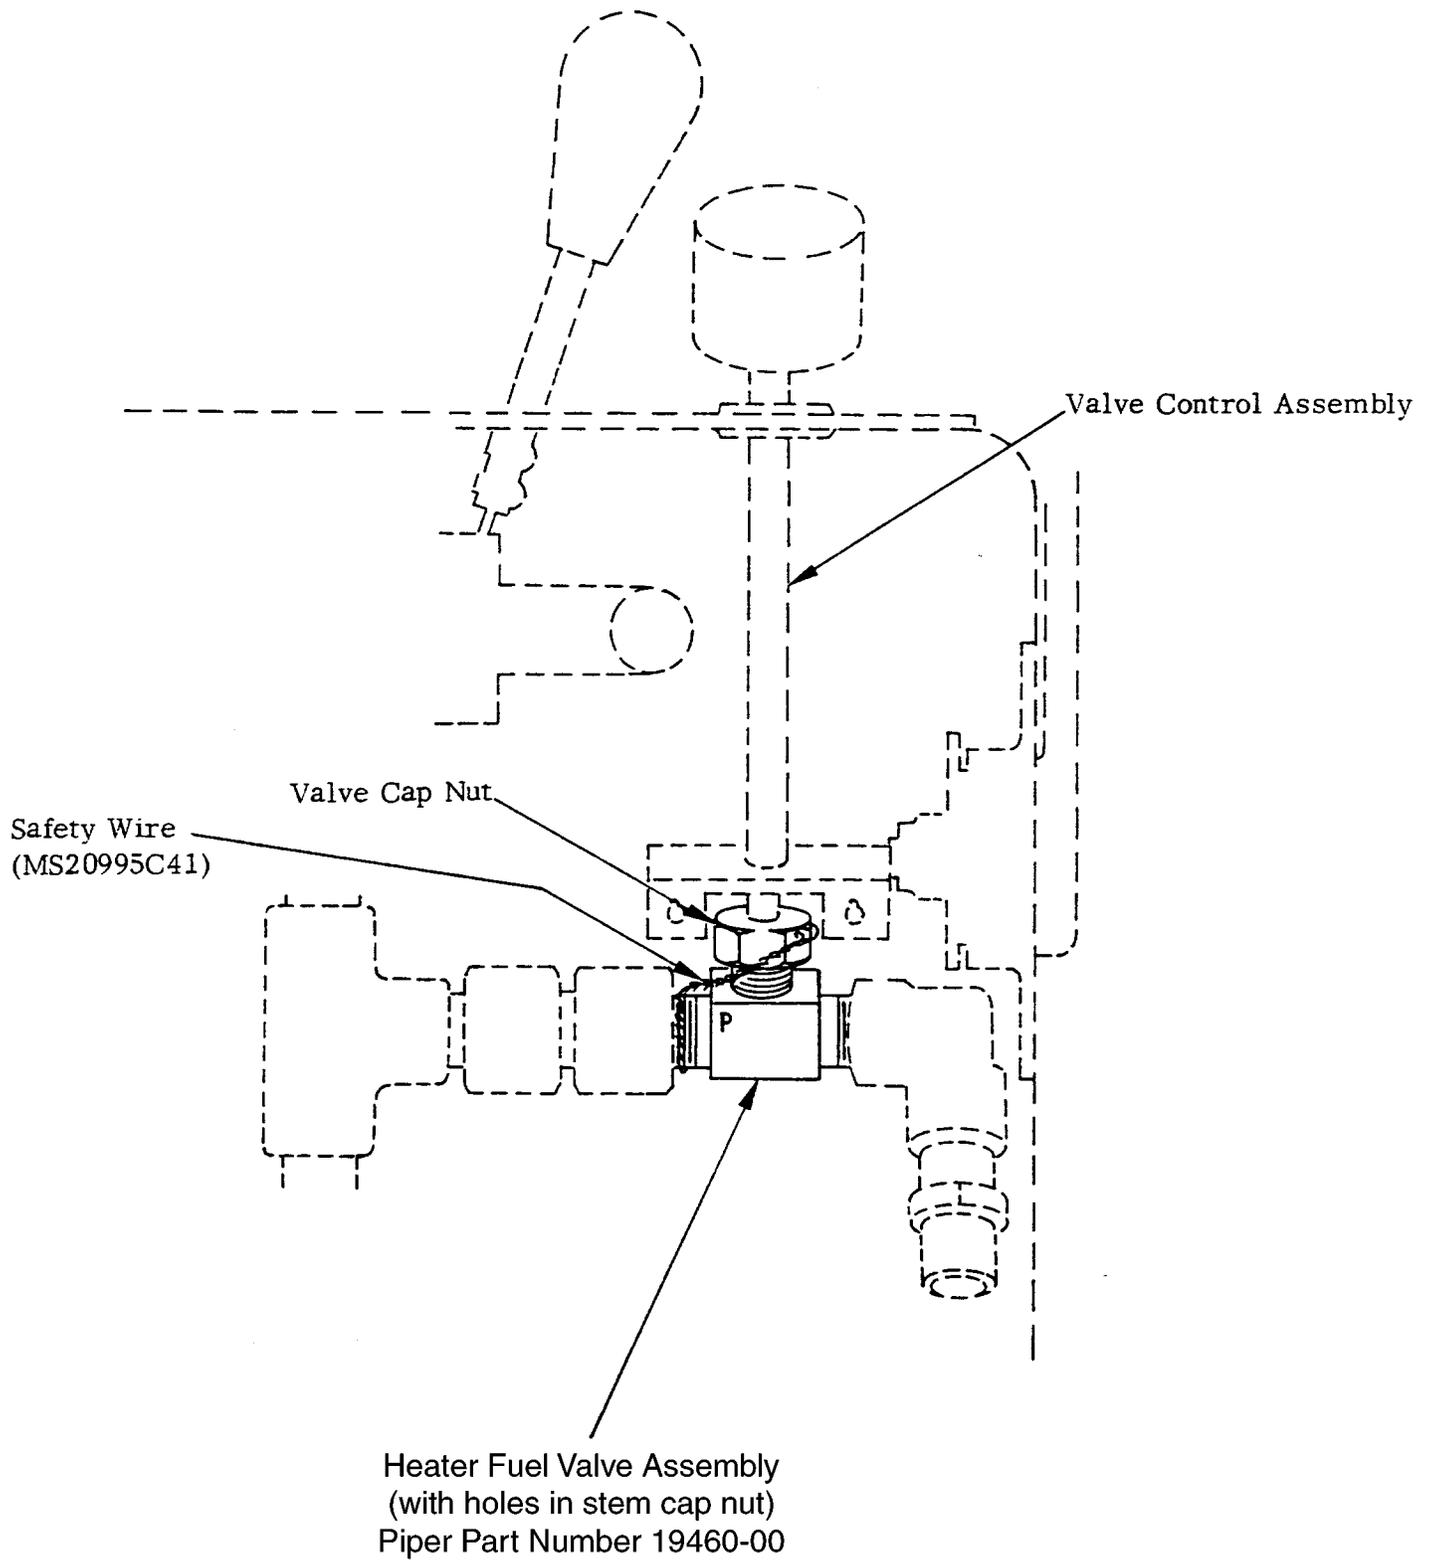
A situation has occurred where the heater fuel valve core “backed out” of the fuel valve, allowing leakage of fuel into the belly of the aircraft adjacent to the fuel system control box assembly. Adequate safetying of the fuel valve cap nut normally prevents the valve core from “backing out”; the current Apache and Aztec Service Manuals, Section XIII, Inspection and Repair of Heater Fuel Valves, illustrate and describe proper safetying of the fuel valve stem cap nut and also states that “if any part of the stem assembly is not drilled for safetying purposes, replace the assembly.” Refer to Figure 1 of this Service Bulletin for an illustration of proper safety wire installation on heater fuel valves with holes in the stem cap nut.

Since there were several previous methods of safetying the fuel valve stem cap nut (not safety wire), and since it is apparent that not all affected aircraft have checked and replaced stem assemblies in accordance with the instructions in the service manual, Part I of this Service Bulletin requests that the heater fuel valve stem assembly cap nut be inspected to insure that it is safetyed properly, and to replace the stem assembly if the proper method of safetying was not employed. Refer to Apache and Aztec Service Manuals, Section XIII, Inspection and Repair of Heater Fuel Valves.

1. Gain access to the heater fuel valve in accordance with the Apache and Aztec Service Manuals, Section XIII, Removal of Heater Fuel Valve.
2. Inspect the stem and cap nut for proper safetying in accordance with Figures 1 or 2 (whichever applies) of this Service Bulletin.
3. If any part of the stem assembly is damaged or is not able to be safety wired properly, or if leakage is evident, replace the assembly.
4. Install the heater fuel valve in accordance with the Apache and Aztec Service Manuals, Section XIII, Installation of Heater Fuel Valve.
5. If proper safetying is evident in accordance with Figures 1 or 2 (whichever applies) of this Service Bulletin, and no leakage is evident, the aircraft may be returned to service.
6. Make appropriate log book entry.

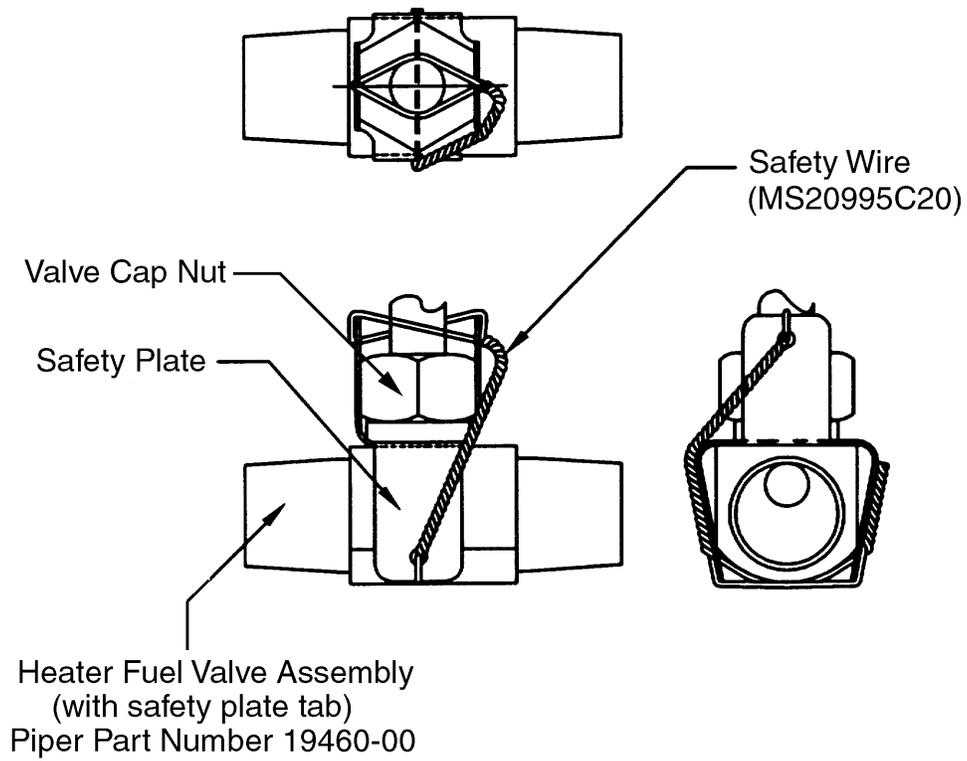
Since heater fuel valves with safety wire holes in the stem cap nut are no longer available, Piper has designed a new heater fuel valve assembly which incorporates a different safety wire installation. The new heater fuel valve is a complete assembly that incorporates a safety plate tab and safety wire, which has been pressure tested to 40 psi. (The Piper Part Number, 19460-00, remains the same.) Refer to Figure 2 of this Service Bulletin for an illustration of proper safety wire installation on heater fuel valves with the safety plate tab.

Part II of this Service Bulletin requests that the heater fuel valve stem assembly cap nut be inspected to insure that it is safetied properly, and to replace the valve assembly if the proper method of safetying was not employed.
