SERVICE

NUMBER 137

April 26, 1955

SUBJECT: PA-23 Landing Gear CO₂ Extension System

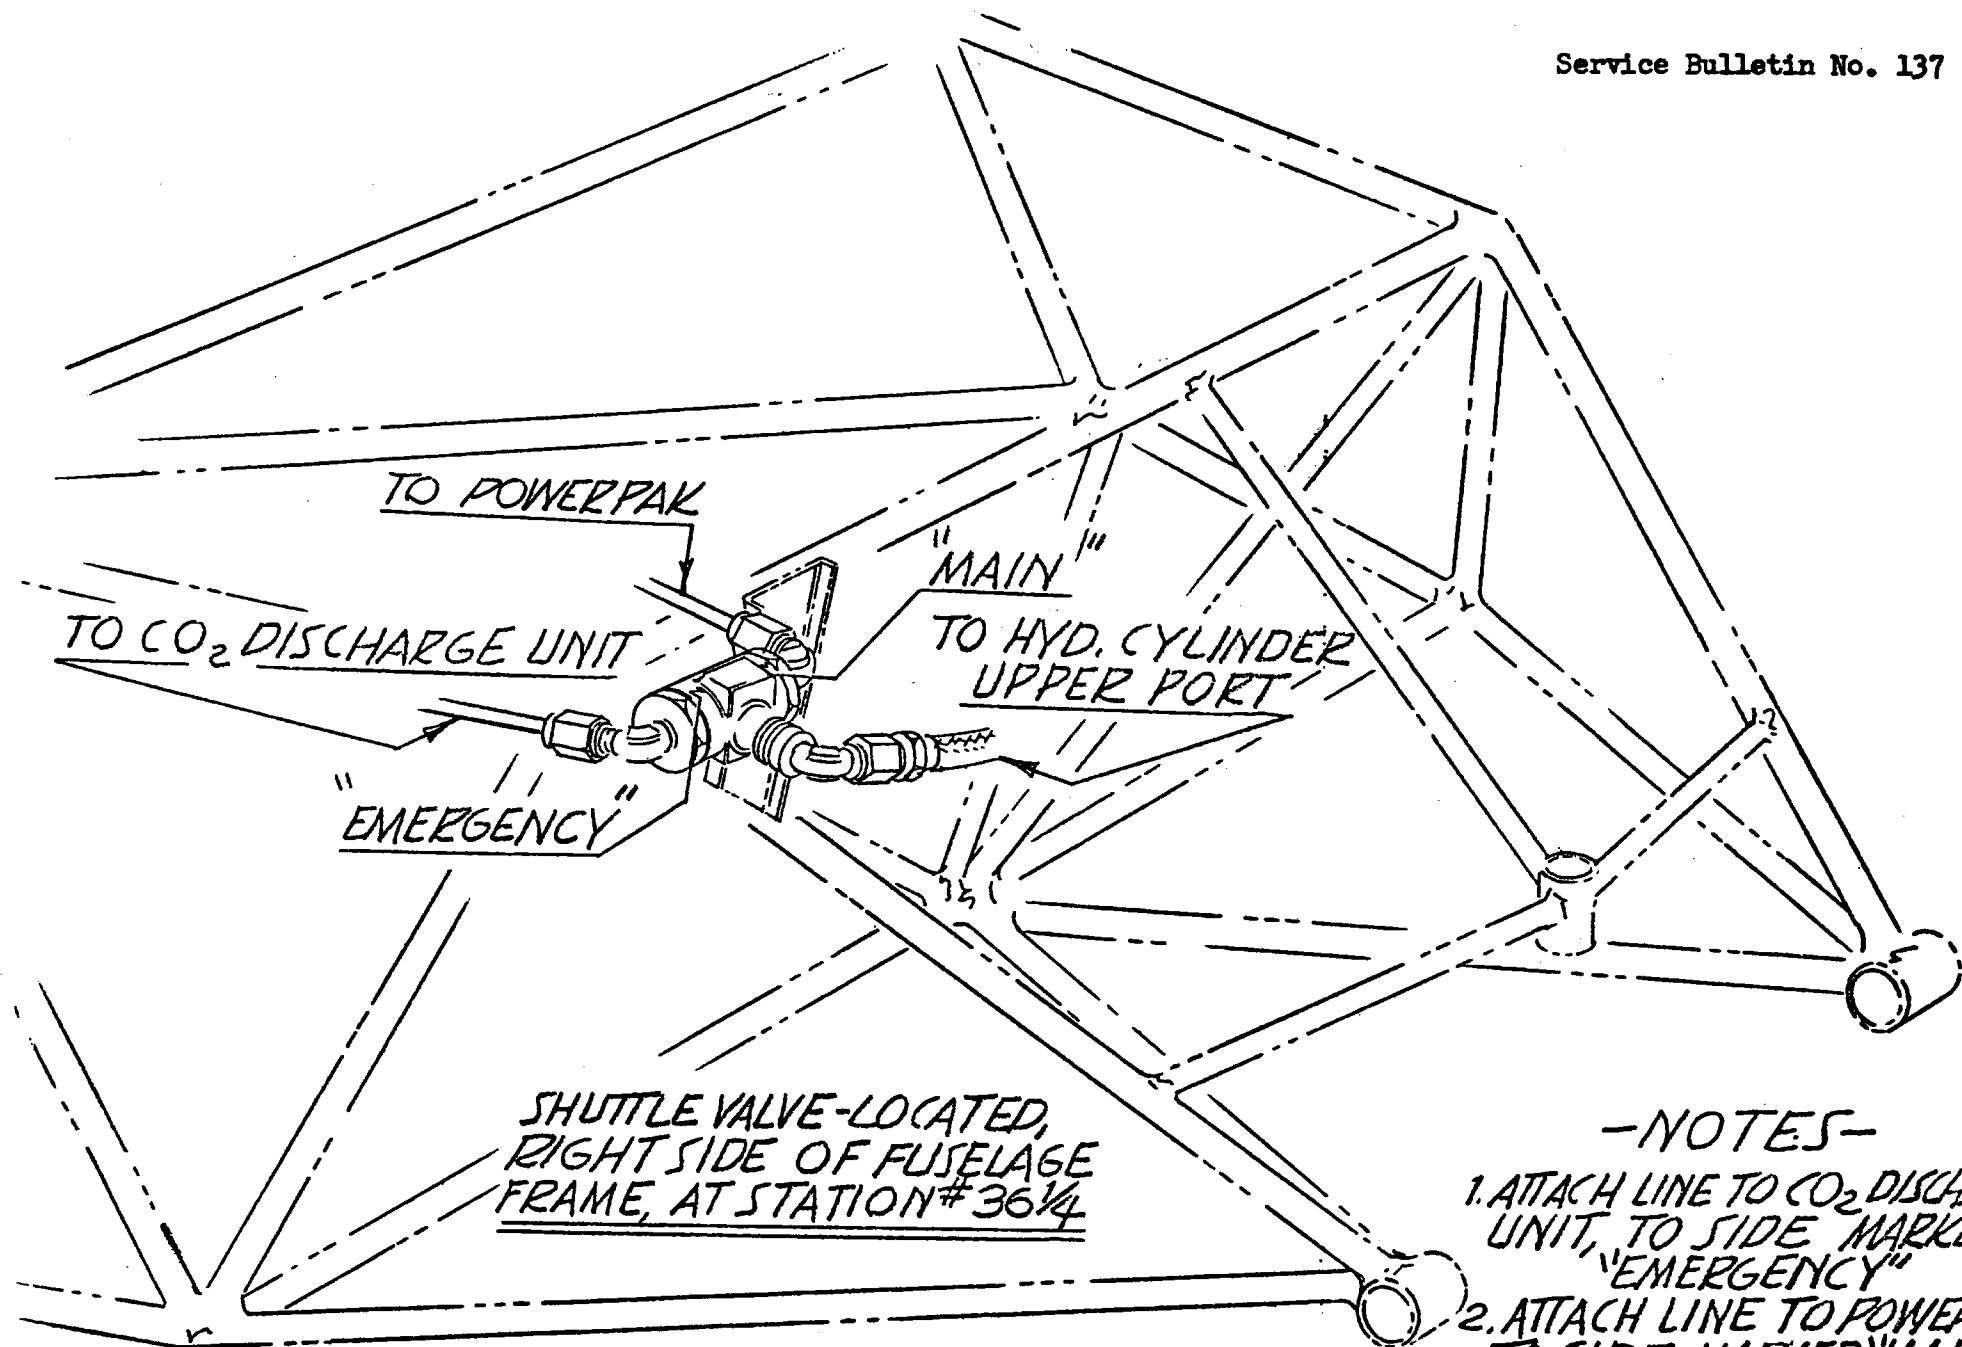
From operational experience in the subject airplanes it has been found that the nose wheel shuttle valve can become unseated, thereby permitting the CO₂ system lines to be filled with hydraulic fluid locking the landing gear in the down position.

The only means of retracting the gear is to bleed the CO₂ system lines. Therefore, in order to eliminate this condition it is necessary to immediately install one spring loaded shuttle valve at the nose wheel actuating cylinder in accordance with the sketch shown on the reverse side of this bulletin.

NOTE: Care should be taken in installing the new nose wheel valve to see that the airplane is put on jacks and that the main hydraulic line is attached to the end of the shuttle valve marked MAIN, and the CO₂ line is attached to the end of the shuttle valve marked EMERGENCY.
