SERVICE BULLETIN

No. 629

Piper Aircraft Corporation

Subject: Landing Gear Hose Assembly Inspection and Replacement.

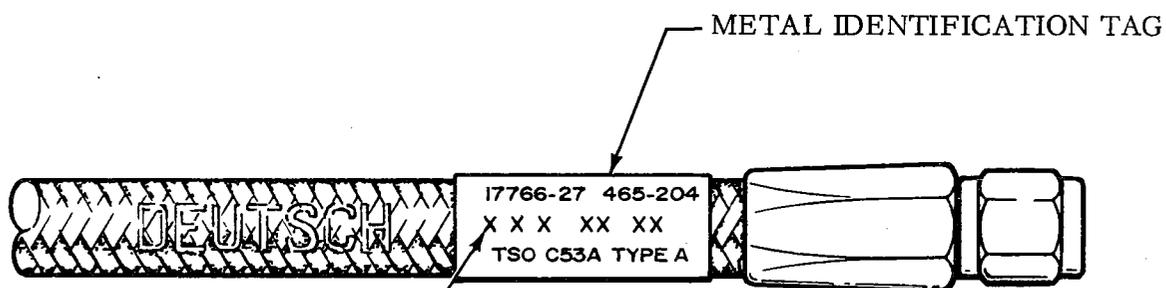
2. Inspect the metal identification tag on the Hose Assemblies for an assembly date of 4Q77 or 1Q78 (See attached sketch).
3. If a Hose Assembly has an assembly date other than 4Q77 or 1Q78, no further action is required. Make an appropriate log book entry of compliance with this Service Bulletin.

INSPECT ASSEMBLY DATE. HOSE ASSEMBLY WITH ASSEMBLY DATE OF 4Q77 or 1Q78 MUST BE REPLACED.

5. Remove Hose Assembly(ies) which have assembly dates of 4Q77 or 1Q78. Visually inspect the Hose Assembly for blockage, deterioration or signs of leakage which would indicate delamination.

6. If no evidence of delamination is present, replace the Hose Assembly(ies) with new part(s) having an acceptable assembly date and proceed to steps 6.a. and 6.b.
