SERVICE BULLETIN

No. 408B

Piper Aircraft Corporation

Flap Outboard Hinge Replacement.

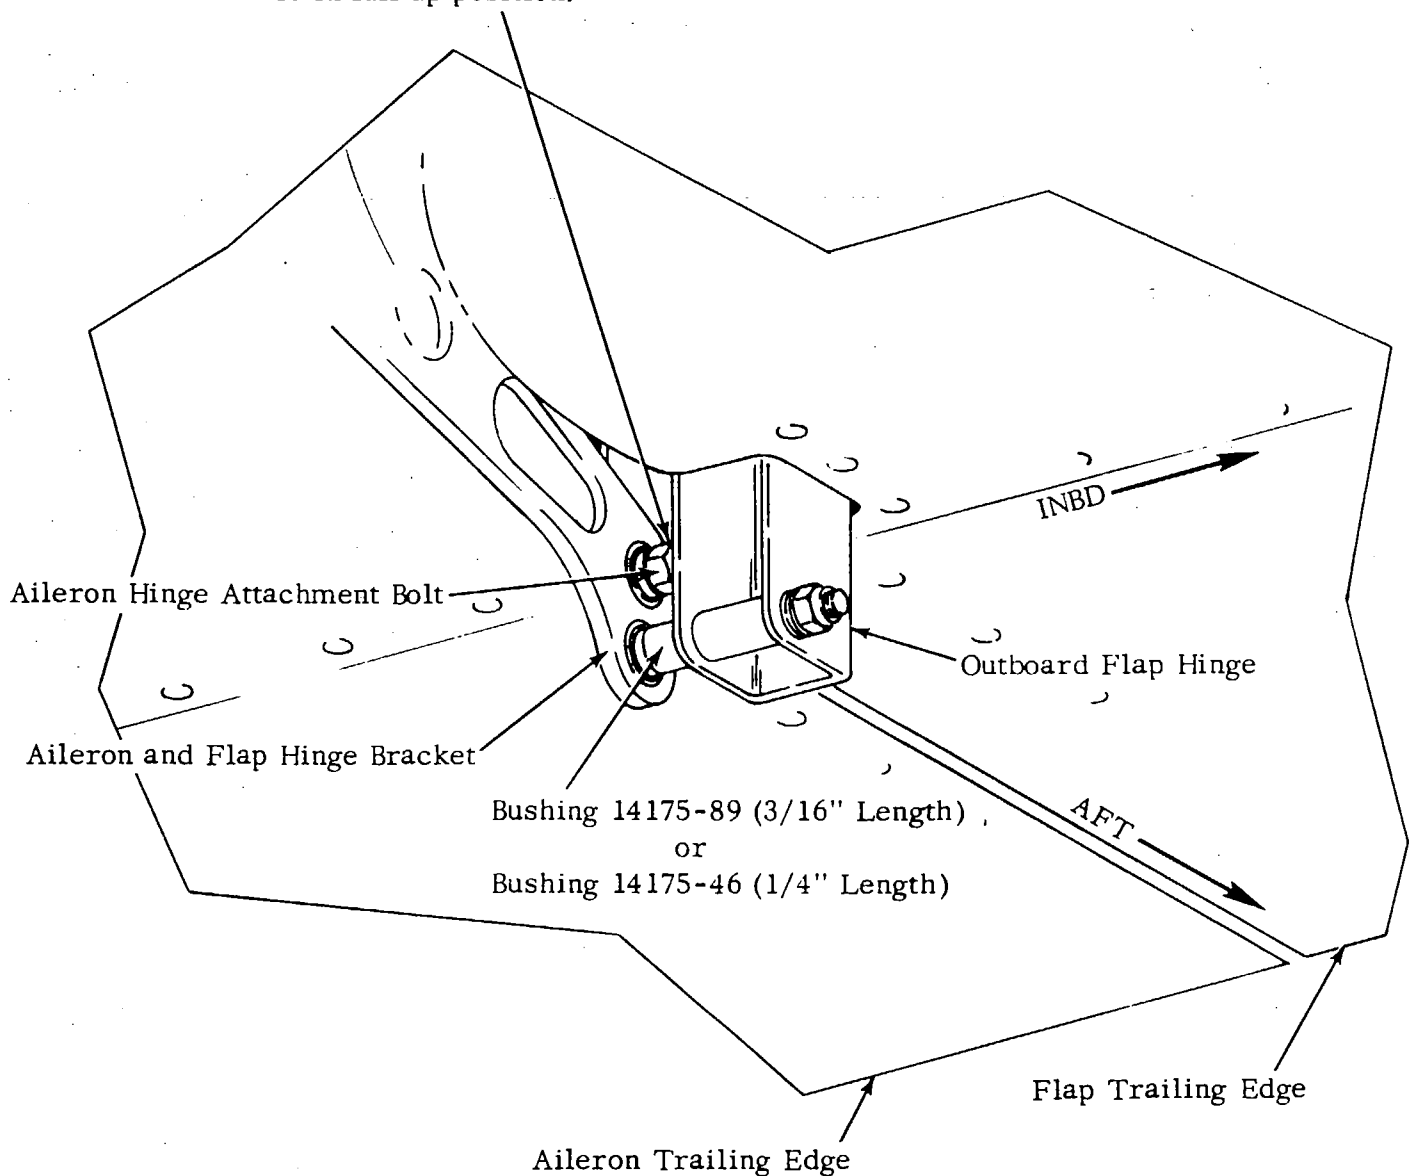
- Inspect area between flap hinge and aileron hinge attachment bolt head to insure that positive clearance exists when flap is in full up position.

BOTTOM VIEW OF RIGHT WING SHOWN - LEFT WING OPPOSITE

- B. If proper clearance exists, no further action is required; make appropriate log book entry.
 - C. If proper clearance does not exist and hinge has been damaged, remove existing bushing and replace with bushing Piper part number 14175-46; replace outboard flap hinge Piper part number 33608-03 (right) and Part Number 33608-02 (left).
