SERVICE LETTER

No. 519

Piper Aircraft Corporation

Subject: Replacement and Relocation of Alternator Ground Wire

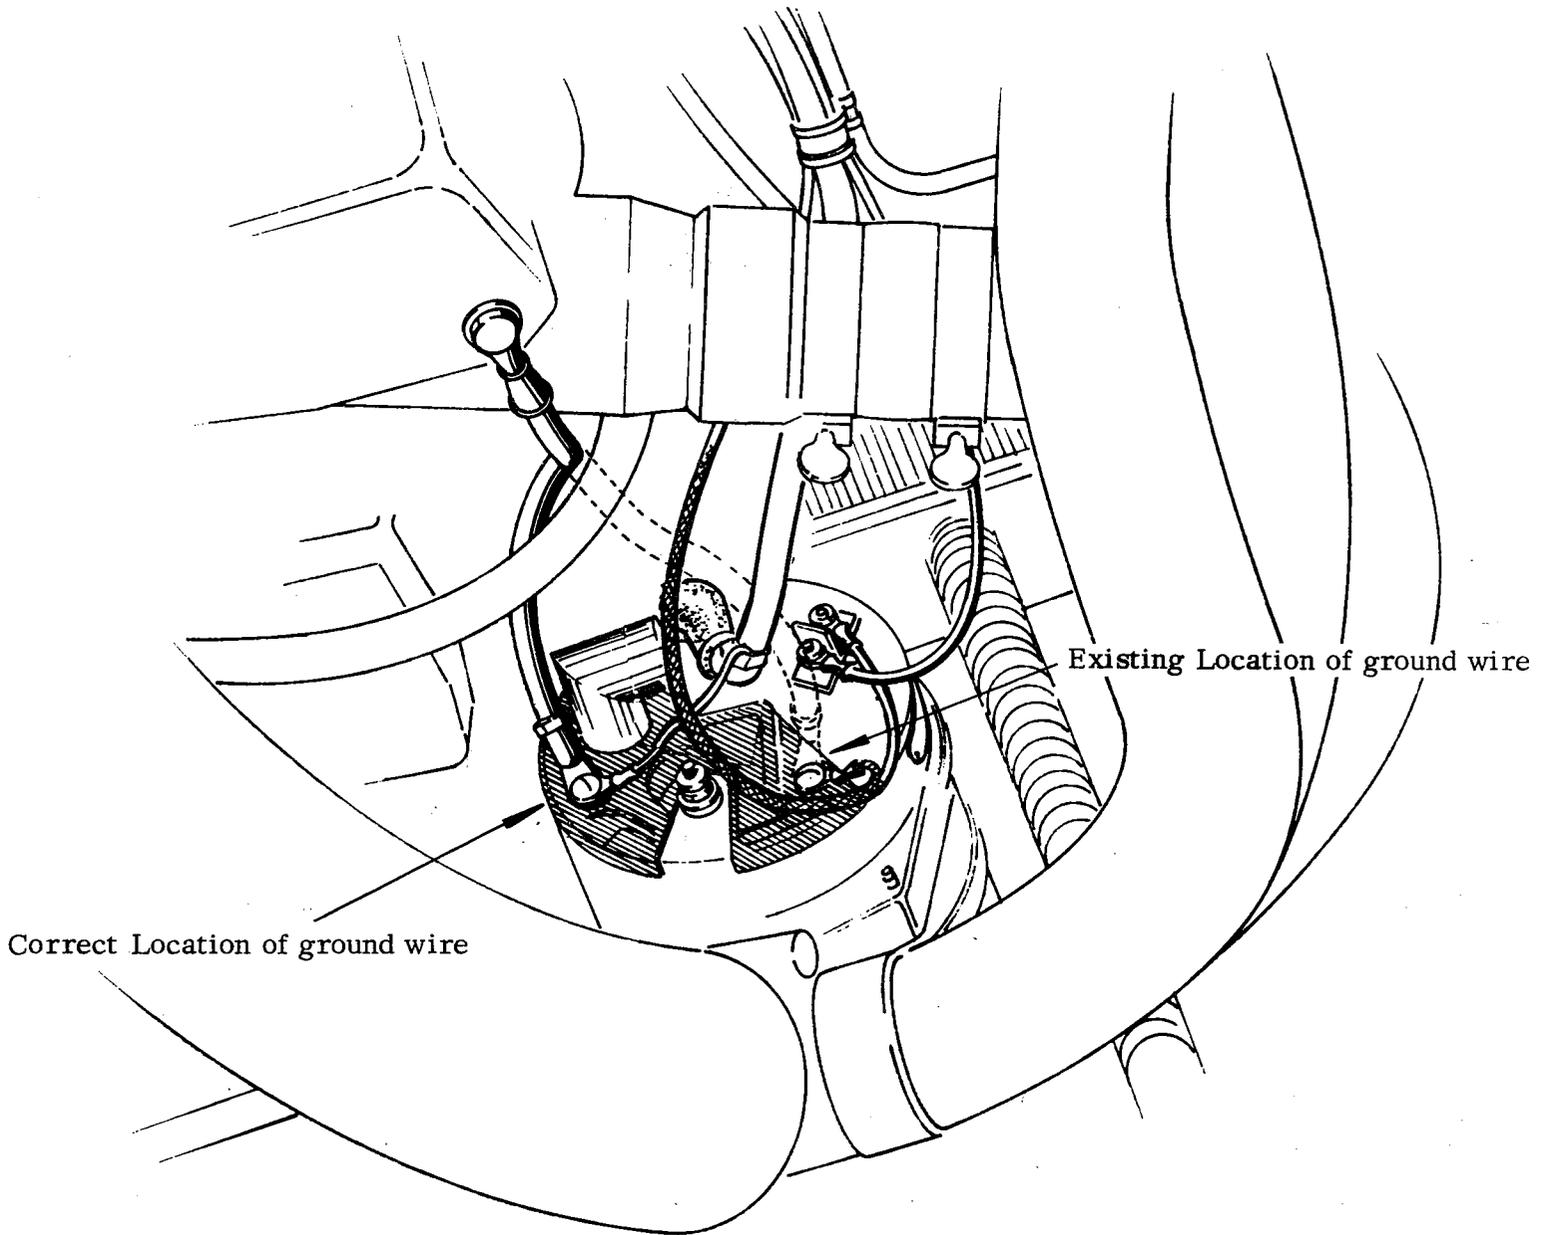
SERVICE LETTER NO. 519

Purpose: To replace the existing alternator ground wire and relocate the ground wire attachment point on the alternator blast tube cover to insure a more positive alternator ground. (See sketch on reverse side of this letter for additional information.)

Instructions: Contained in Kit No. 760 282, Alternator Ground Wire Replacement
