SERVICE LETTER

No. 627

Piper Aircraft Corporation

Propeller Installation

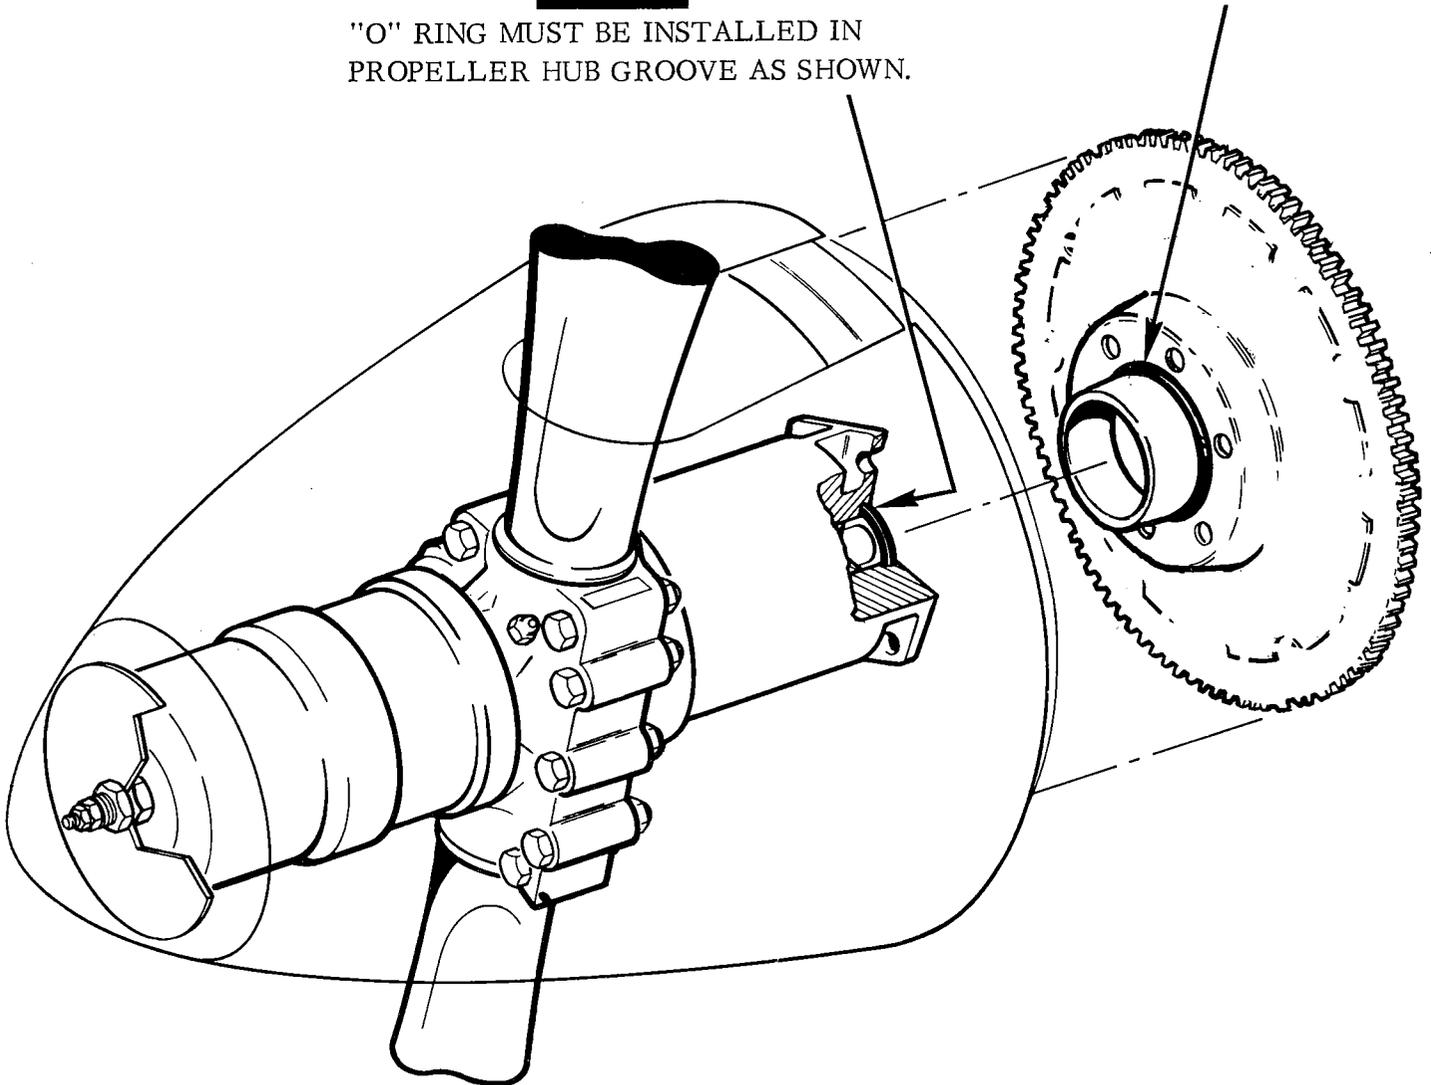
A recent report was received concerning the loss of a propeller on one of the above referenced aircraft during aircraft operation. A subsequent investigation revealed that the affected propeller had been recently removed and was apparently incorrectly installed -- with indications of (1) inadequate propeller mounting bolt torque and (2) incorrect installation of an extra "o" ring between the prop flange and the engine crankshaft flange.

CORRECT

"O" RING MUST BE INSTALLED IN PROPELLER HUB GROOVE AS SHOWN.

INCORRECT

DO NOT INSTALL "O" RING OVER CRANKSHAFT FLANGE.

A. If an "o" ring exists in this location, the "o" ring must be discarded and the propeller should be removed from the aircraft and inspected to insure that the proper "o" ring is correctly installed in the propeller hub groove -- as shown in attached sketch.

3. Reinstall propeller, insuring that prop mounting bolts are properly torqued.
4. Make appropriate log book entry.
