SERVICE BULLETIN

No. 590

Piper Aircraft Corporation

Subject: Inspection of Stabilator Tab Horn/Stabilator Trim Control Rod Attachment

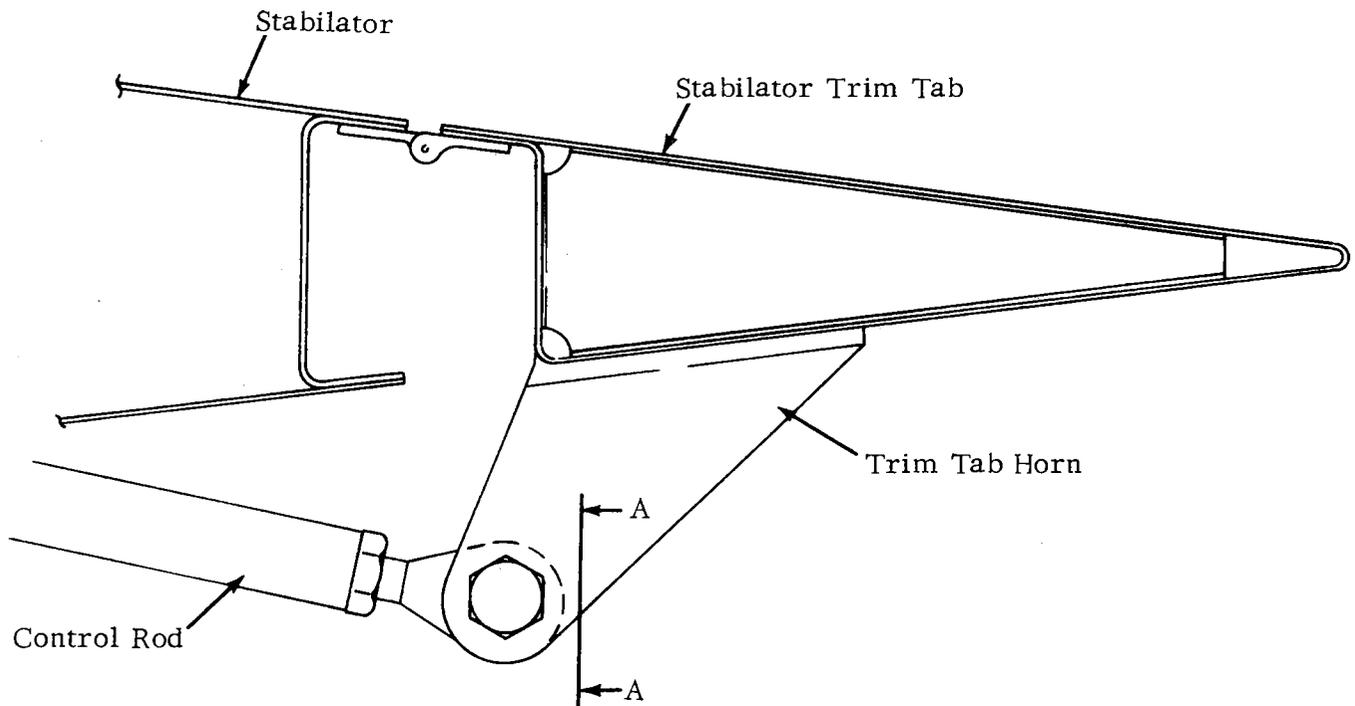
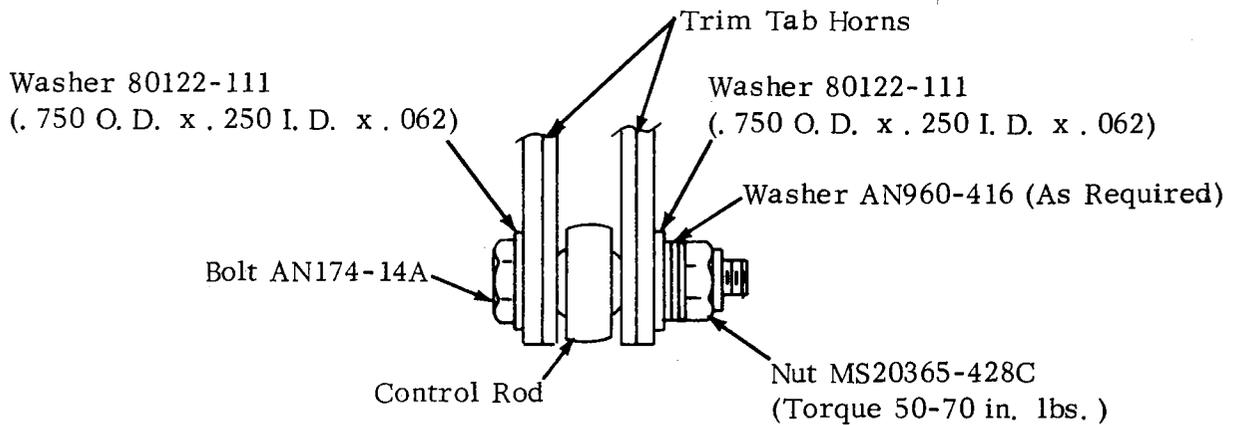
SECTION A-A

Purpose: It has been brought to our attention that the stabilator tab horn to stabilator trim control rod attachment hardware on the above referenced aircraft may have been improperly assembled and/or torqued. If not corrected, excessive control rod end play and bolt wear and eventual stabilator trim tab vibration may result.

1. Remove AN174-14A bolt from trim tab horn and control rod.
2. Inspect for evidence of nut having cut additional threads on bolt.
3. If evidence of additional threads is apparent, discard bolt and replace with new bolt.
4. Install hardware as shown above.
 NOTE: With 50-70 in. lbs. Torque, the trim tab horns must be tight against the ball of the rod end bearing, the bolt should not turn readily, the nut must not "bottom" on bolt threads and there may be no "end play" in the attachment bolt.
5. Make appropriate Logbook entry of Service Bulletin compliance.
