SERVICE BULLETIN

No. 146B

Piper Aircraft Corporation

SUBJECT: Elevator Butt Rib and Torque Tube Attachment Casting Cracks

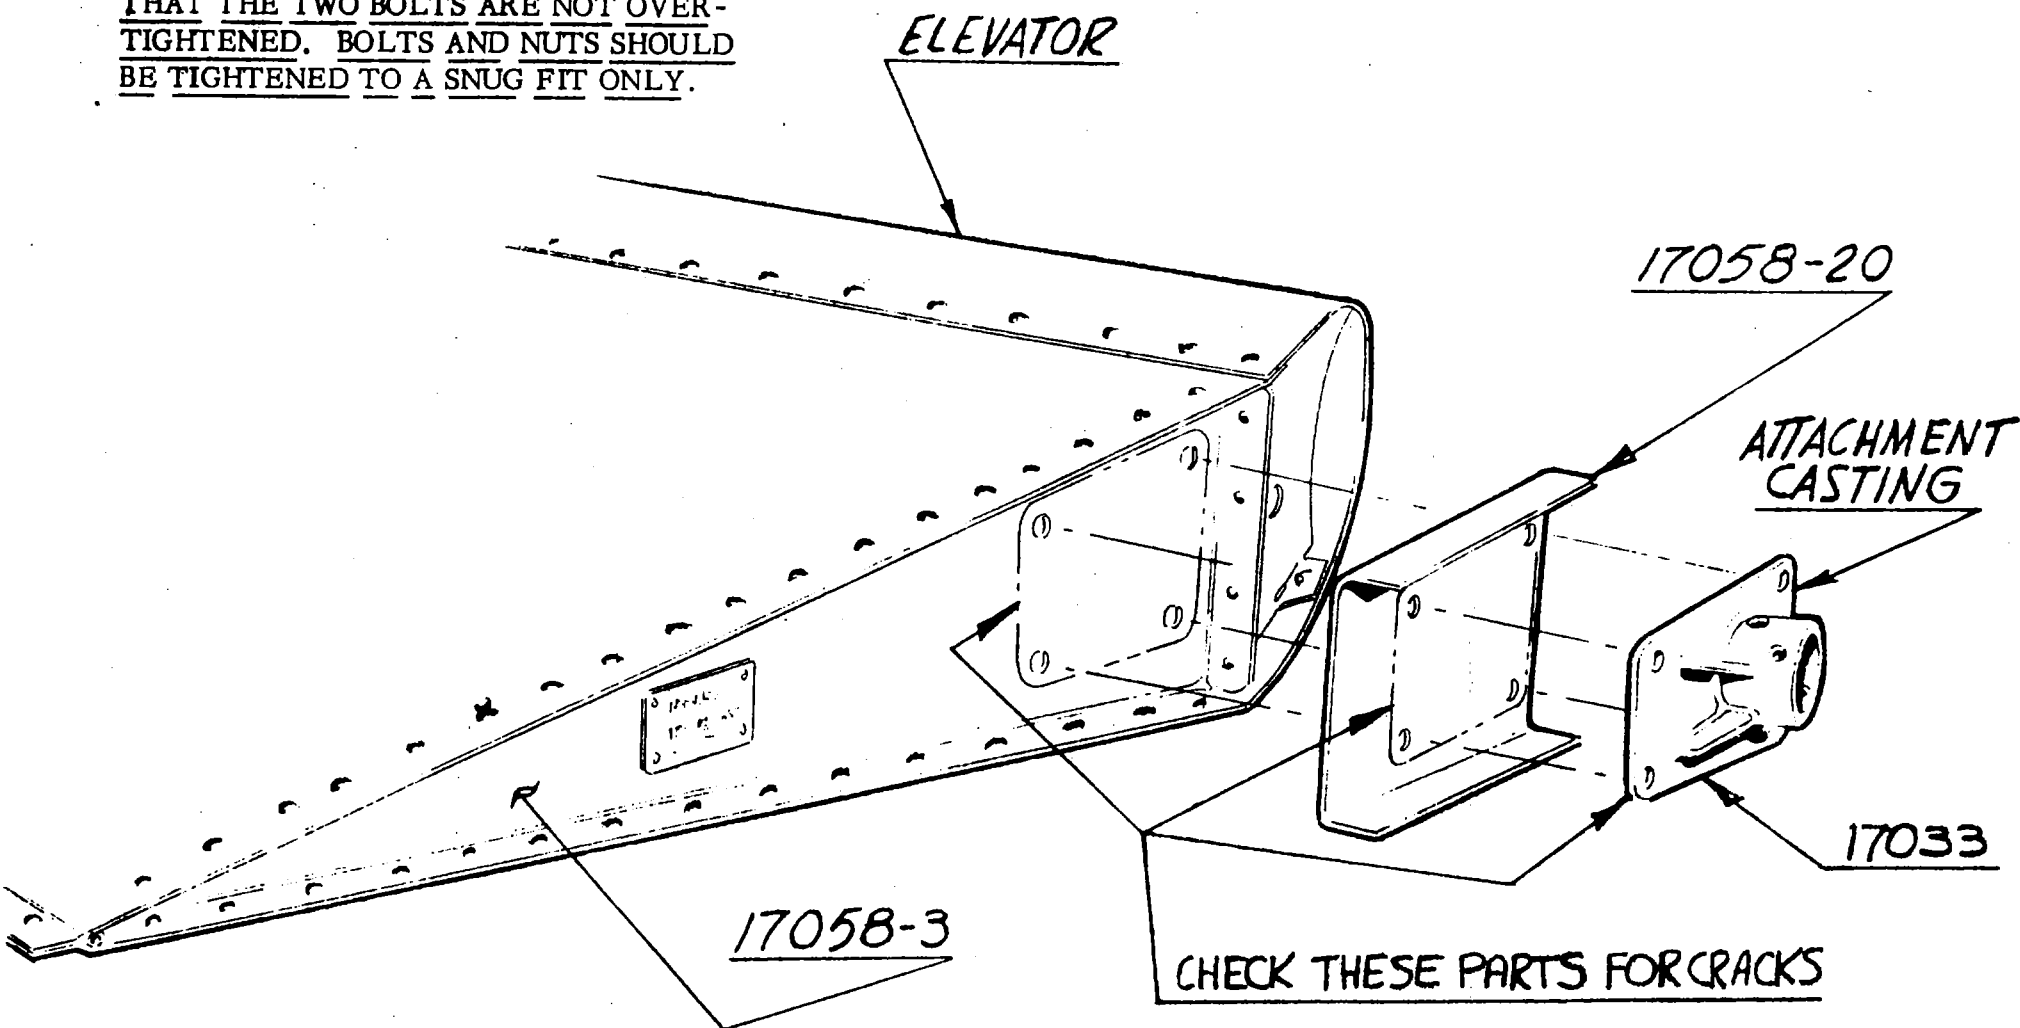
ELE. BUTT RIB & ATTACHMENT CASTING	
SERVICE BULLETIN	146B
PIPER AIRCRAFT CORPORATION	
LOCK HAVEN, PENNSYLVANIA

Investigation of field reports reveal that cracks have occurred in the butt rib and doubler plate of the PA-23 elevators. These cracks were caused by a slight misalignment between the elevator torque tube and the elevator assemblies. Also cracks have been found in the torque tube attachment casting, part number 17033-00, which were caused by over-tightening of the attachment bolts.

This general condition may also cause cracks to appear in the elevator and stabilizer skin. Inspection of the tail surface skins should also be accomplished after each 100 hours of flight. If skin cracks appear they should be repaired in accordance with C.A.M. 18. Surface skin cracks sometimes precede butt rib cracks and we would like to suggest that elevator alignment be accomplished if it becomes necessary to effect tail surface skin repairs.

It is requested that the affected parts indicated on the accompanying sketch be inspected immediately and every 100 hours thereafter and if the rib, doubler plate or casting is cracked, it should be replaced with a new part. It will be necessary to remove the complete elevator torque tube assembly in order that the casting, part number 17033-00, can be taken off and inspected. After repairs have been made, it is important that the alignment of both elevator assemblies be accomplished in the following manner:

1. Assemble the elevator torque tube and both elevators into a single unit.
2. Hold complete assembly in attachment position and check alignment of the five hinge holes. All hinge pins should be a slip fit.
3. If the pins are not a slip fit, add shims under the torque tube attachment casting (shown on accompanying sketch) to obtain proper fit and alignment.
4. Install complete assembly to aircraft and safety.

NOTE
WHEN REINSTALLING ATTACHMENT
CASTING MAKE ABSOLUTELY CERTAIN
THAT THE TWO BOLTS ARE NOT OVER-
TIGHTENED. BOLTS AND NUTS SHOULD
BE TIGHTENED TO A SNUG FIT ONLY.
