SERVICE BULLETIN

No. 498

Piper Aircraft Corporation

Inspection of Inboard Fuel Cell Vent Line Assemblies.

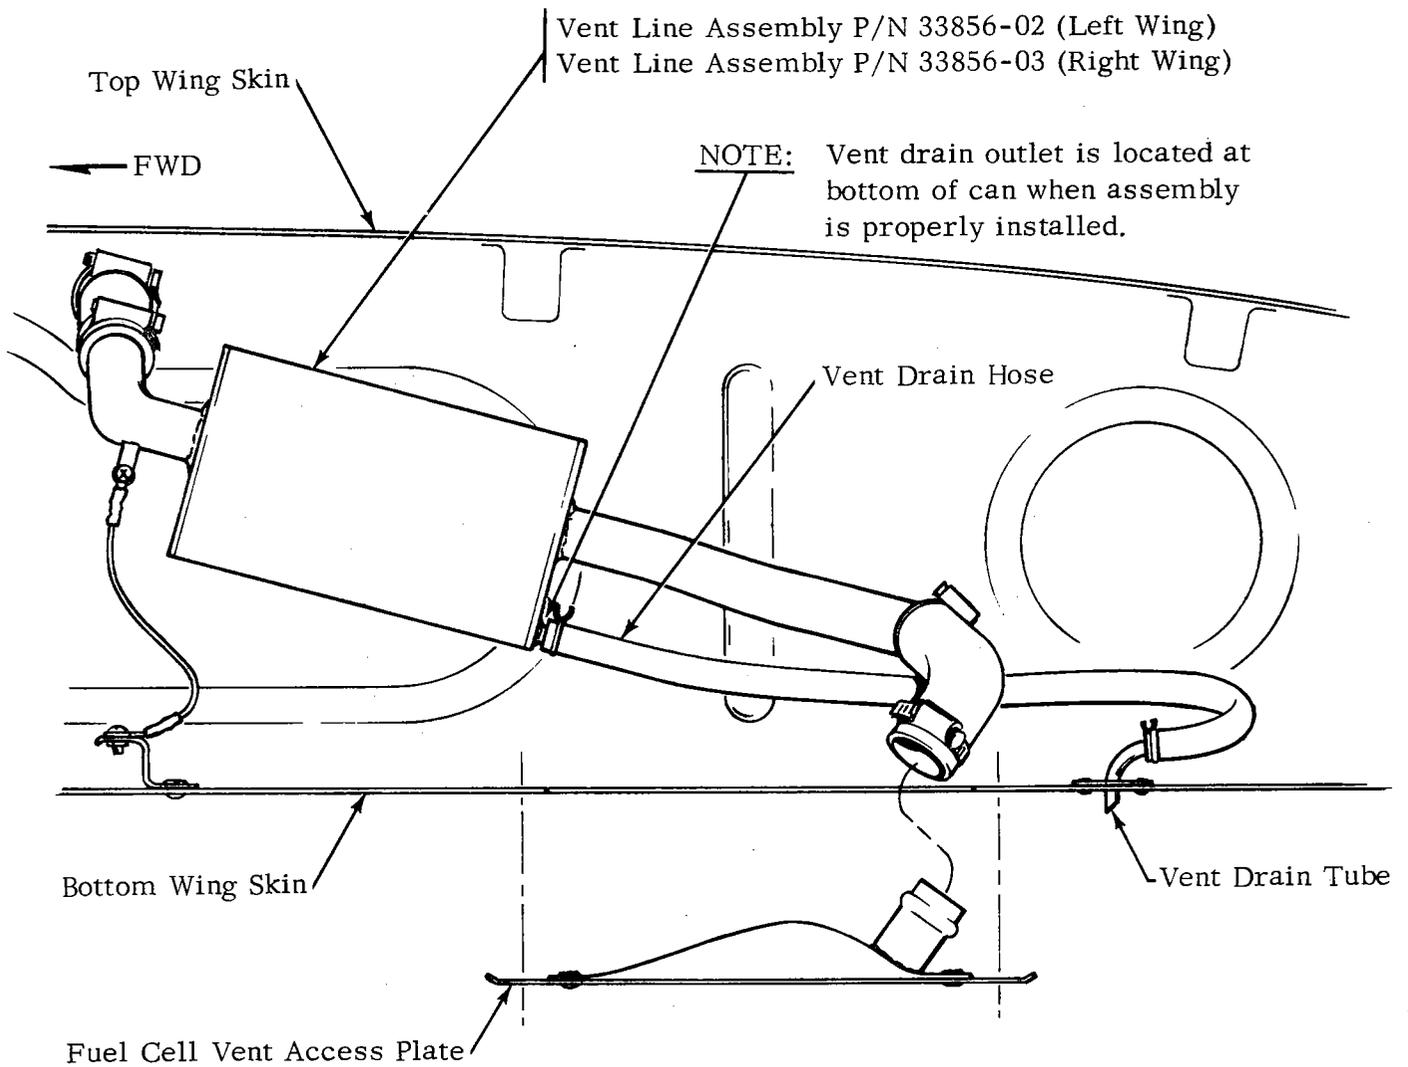
View Looking At Inboard Fuel Cell Vent Line Assembly (Left Shown - Right Opposite)

1. Remove fuel cell vent access plate from bottom of left and right wing skins to gain access to inboard fuel cell vent line assemblies.
2. Inspect vent line assemblies to determine if vent drain outlet is properly located at bottom of can as shown.
 - a. If inspection reveals that vent line assemblies are not properly installed, switch assemblies from one wing to the other. (The vent drain outlet must be located at bottom of can on both wings.)
3. Reinstall fuel cell vent access plates and make proper logbook entry of inspection.
