## VENDOR SERVICE PUBLICATION

SUBJECT: Bendix Service Bulletin No. 629

Inspection and replacement of certain Bendix Aircraft Magneto Brown Distributor Blocks as used on turbocharged six (6) cylinder engines.

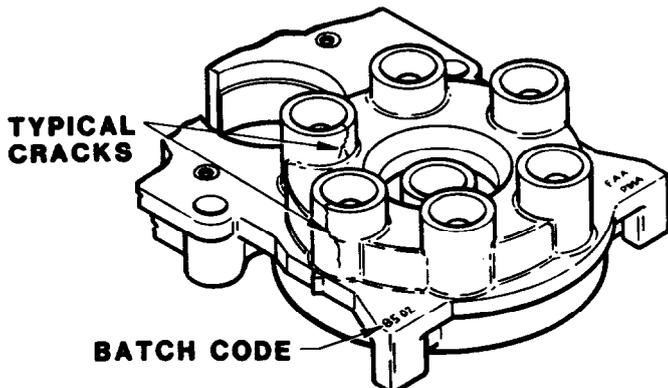
To remove from service distributor blocks that may contain outlet tower cracks. See Figures 1 through 3.

Figure 1  
D-2000/D-3000 Series  
Batch Codes 0000 through 8552

Field reports indicate some brown distributor block towers may crack (ref. Figures 1 through 3). Should the tower or towers crack the indications could be loss of ignition to the associated spark plug(s) or possible misfiring and/or cross firing of the engine.

1. Following published procedures, remove the harness cover or adapter plate from the Magneto. Using a high intensity light, inspect each distributor block tower for open cracks as shown in Figures 1 through 3.

CAUTION: BEFORE FURTHER FLIGHT, BLOCKS FOUND WITH CRACKS MUST BE REPLACED BY BLOCKS WITH BATCH CODES NOT LISTED AS AFFECTED UNDER THE "EQUIPMENT AFFECTED" SECTION OF THIS BULLETIN. FOLLOW PUBLISHED PROCEDURES.

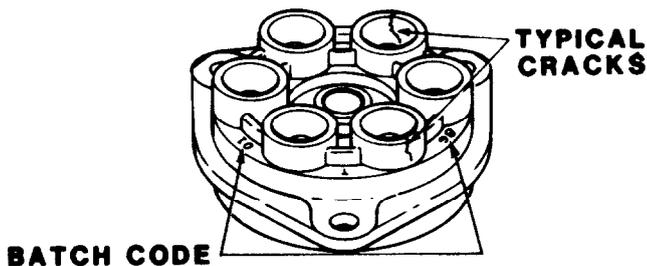
Figure 2  
S-20/S-200 Series  
Batch Codes 0000 through 8601

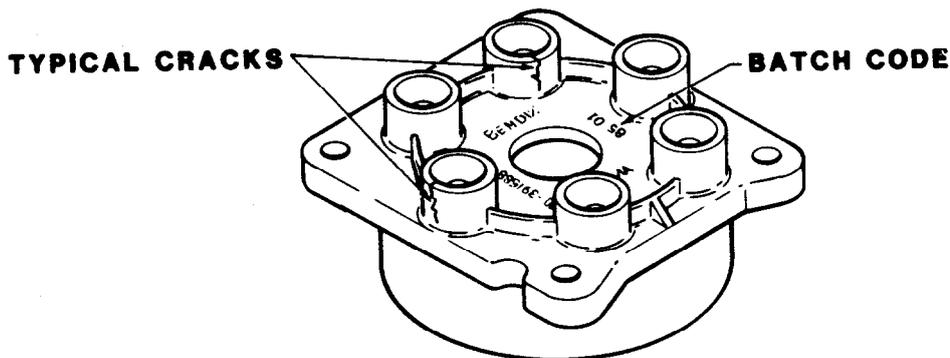
Figure 3  
S-1200 Series  
Batch Codes 0000 through 8601
