SERVICE BULLETIN

No. 441

Piper Aircraft Corporation

Subject: Clamping of Manifold Pressure Hose

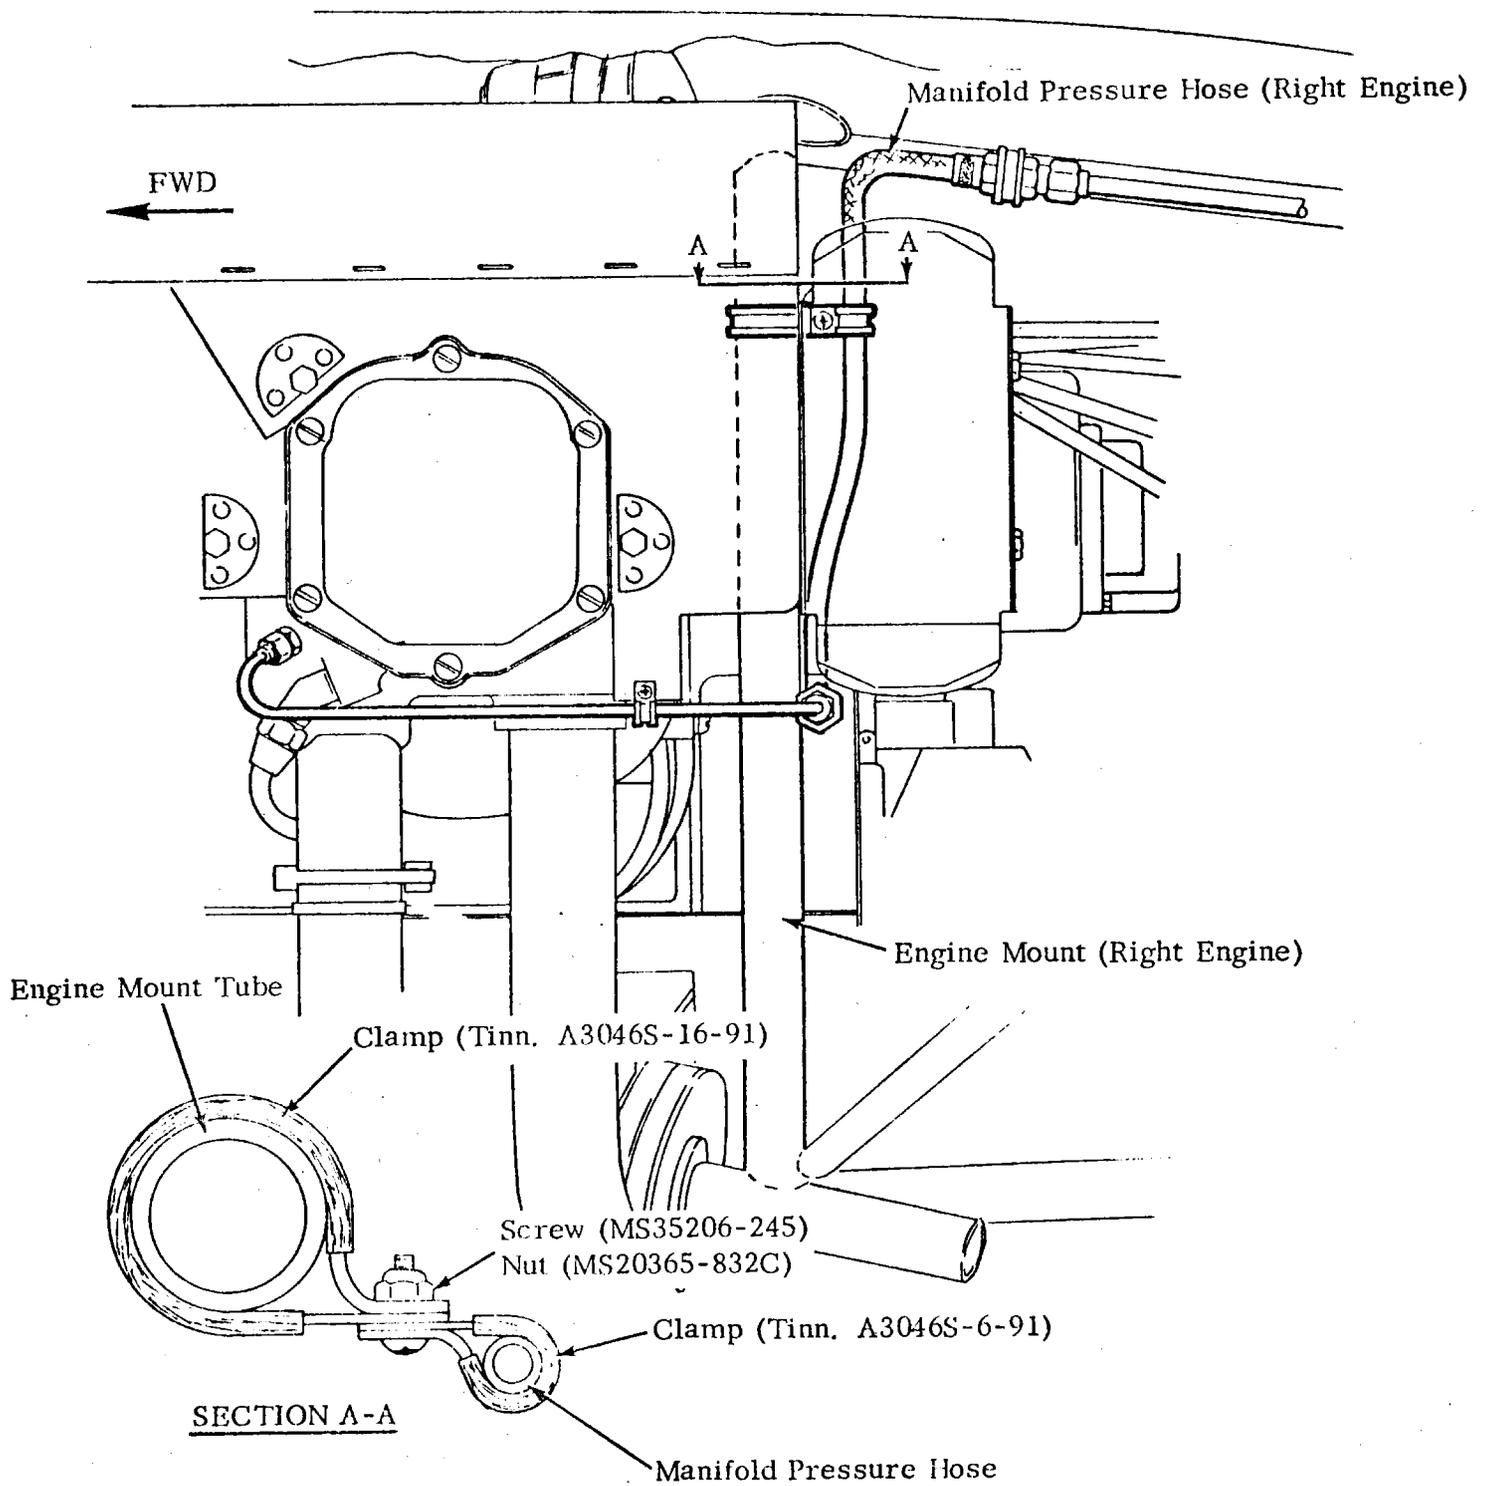
INSTRUCTIONS

Purpose: The right engine manifold pressure hose assembly, Piper part number 17766-77, has, in recent production configurations of the above referenced aircraft, been changed from a rubber composition shielded (i.e., external covering) to a braided metal outer shielding. It has been found that the metal shielded manifold pressure hose assembly - in the right engine compartment only - may contact a section of the adjacent engine mount tubing. Left unattended, this condition may cause wear of the engine mount tubing resulting from prolonged chafing of the tubing by the metal (stainless steel) covered manifold pressure hose.

1. Locate manifold pressure hose (right engine), Piper part number 17766-77, and determine the type of outer covering.
 - a. If the hose is covered with a rubber composition shielding, no further action is required.
 - b. If the hose outer shielding is metallic braid, proceed to Step 2, below.
2. Visually inspect adjacent engine mount tube for indications of excessive chafing and/or wear.
 - a. If no indication of chafing and/or wear is evident, proceed to Step 3, below.
 - b. Engine mount tube wear up to 10% of wall thickness (.007 inch) may be tolerated; any wear in excess of this amount will require either a welded patch or an outside sleeve repair per FAR43.13 - 1.
3. Locate and install clamps and related hardware as shown on the attached sketch / instruction sheet.
4. Make appropriate log book entry.

Locate and install clamps to right engine manifold pressure hose and engine mount tube as shown above. Locate clamps to insure sufficient clearance between the manifold pressure hose and engine mount tube and between the hose and magneto.
