Service Letter No. 438

SUBJECT: Clamping Priority Valve Actuating Cable

MODELS AFFECTED: PA-23-250 (six place) Aztecs, Serial Numbers 27-2505 to 27-2658 incl.

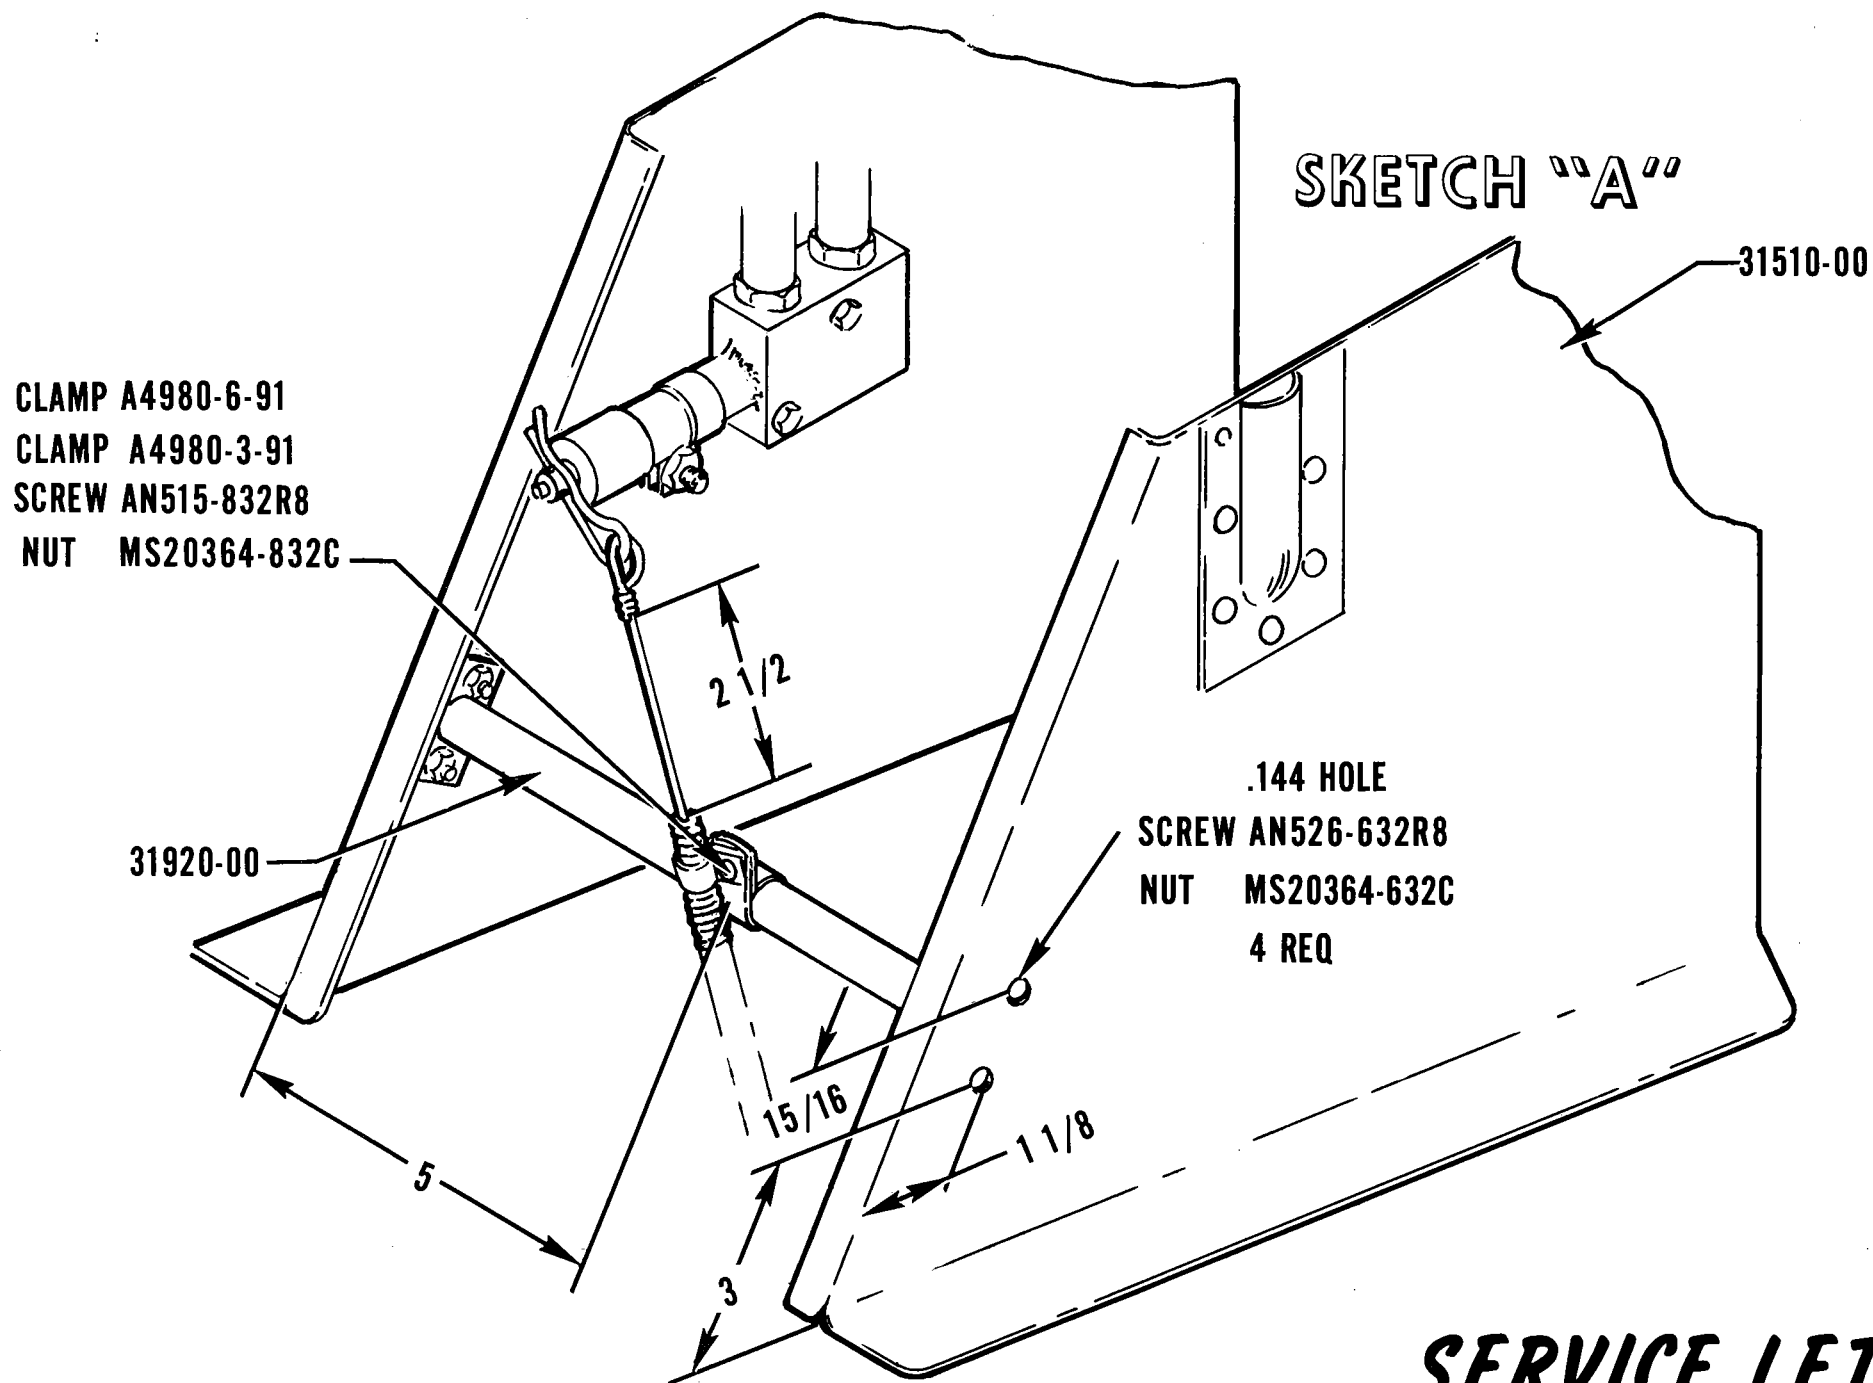
1. Remove CO₂ bottle from discharge unit.
2. Install tube and clamp in KIT 756 878 as shown in Sketch "A".
3. Check the 2 1/2 inch dimension on the end of the cable that is fastened to the pin in the priority valve, as shown in Sketch "A" and tighten clamp. If necessary, cut end of flexible housing, as a dimension of 2 1/2 inches must be maintained.

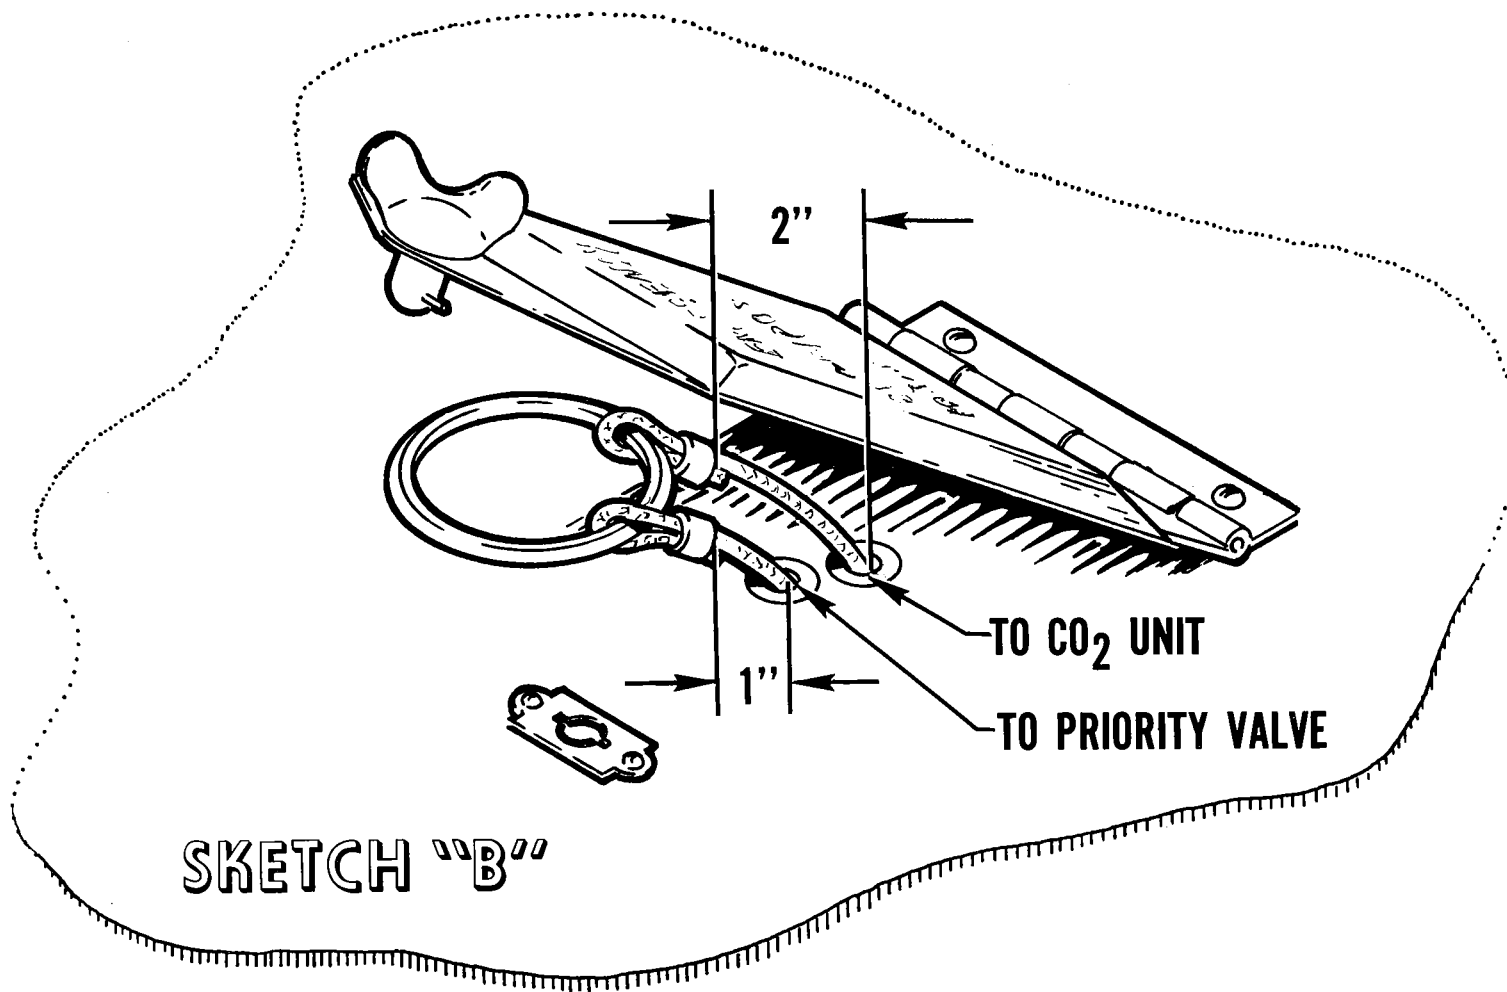
5. Gently take up the slack in the cable to the CO₂ discharge unit so that it will slide up the ring as shown in Sketch "B". The CO₂ cable should be 1 inch longer than the priority valve cable at this point.
