# SERVICE LETTER

No. 710

Piper Aircraft Corporation

Subject: Inspection of Stabilator Control Cable and Rudder Control Cable Attachments

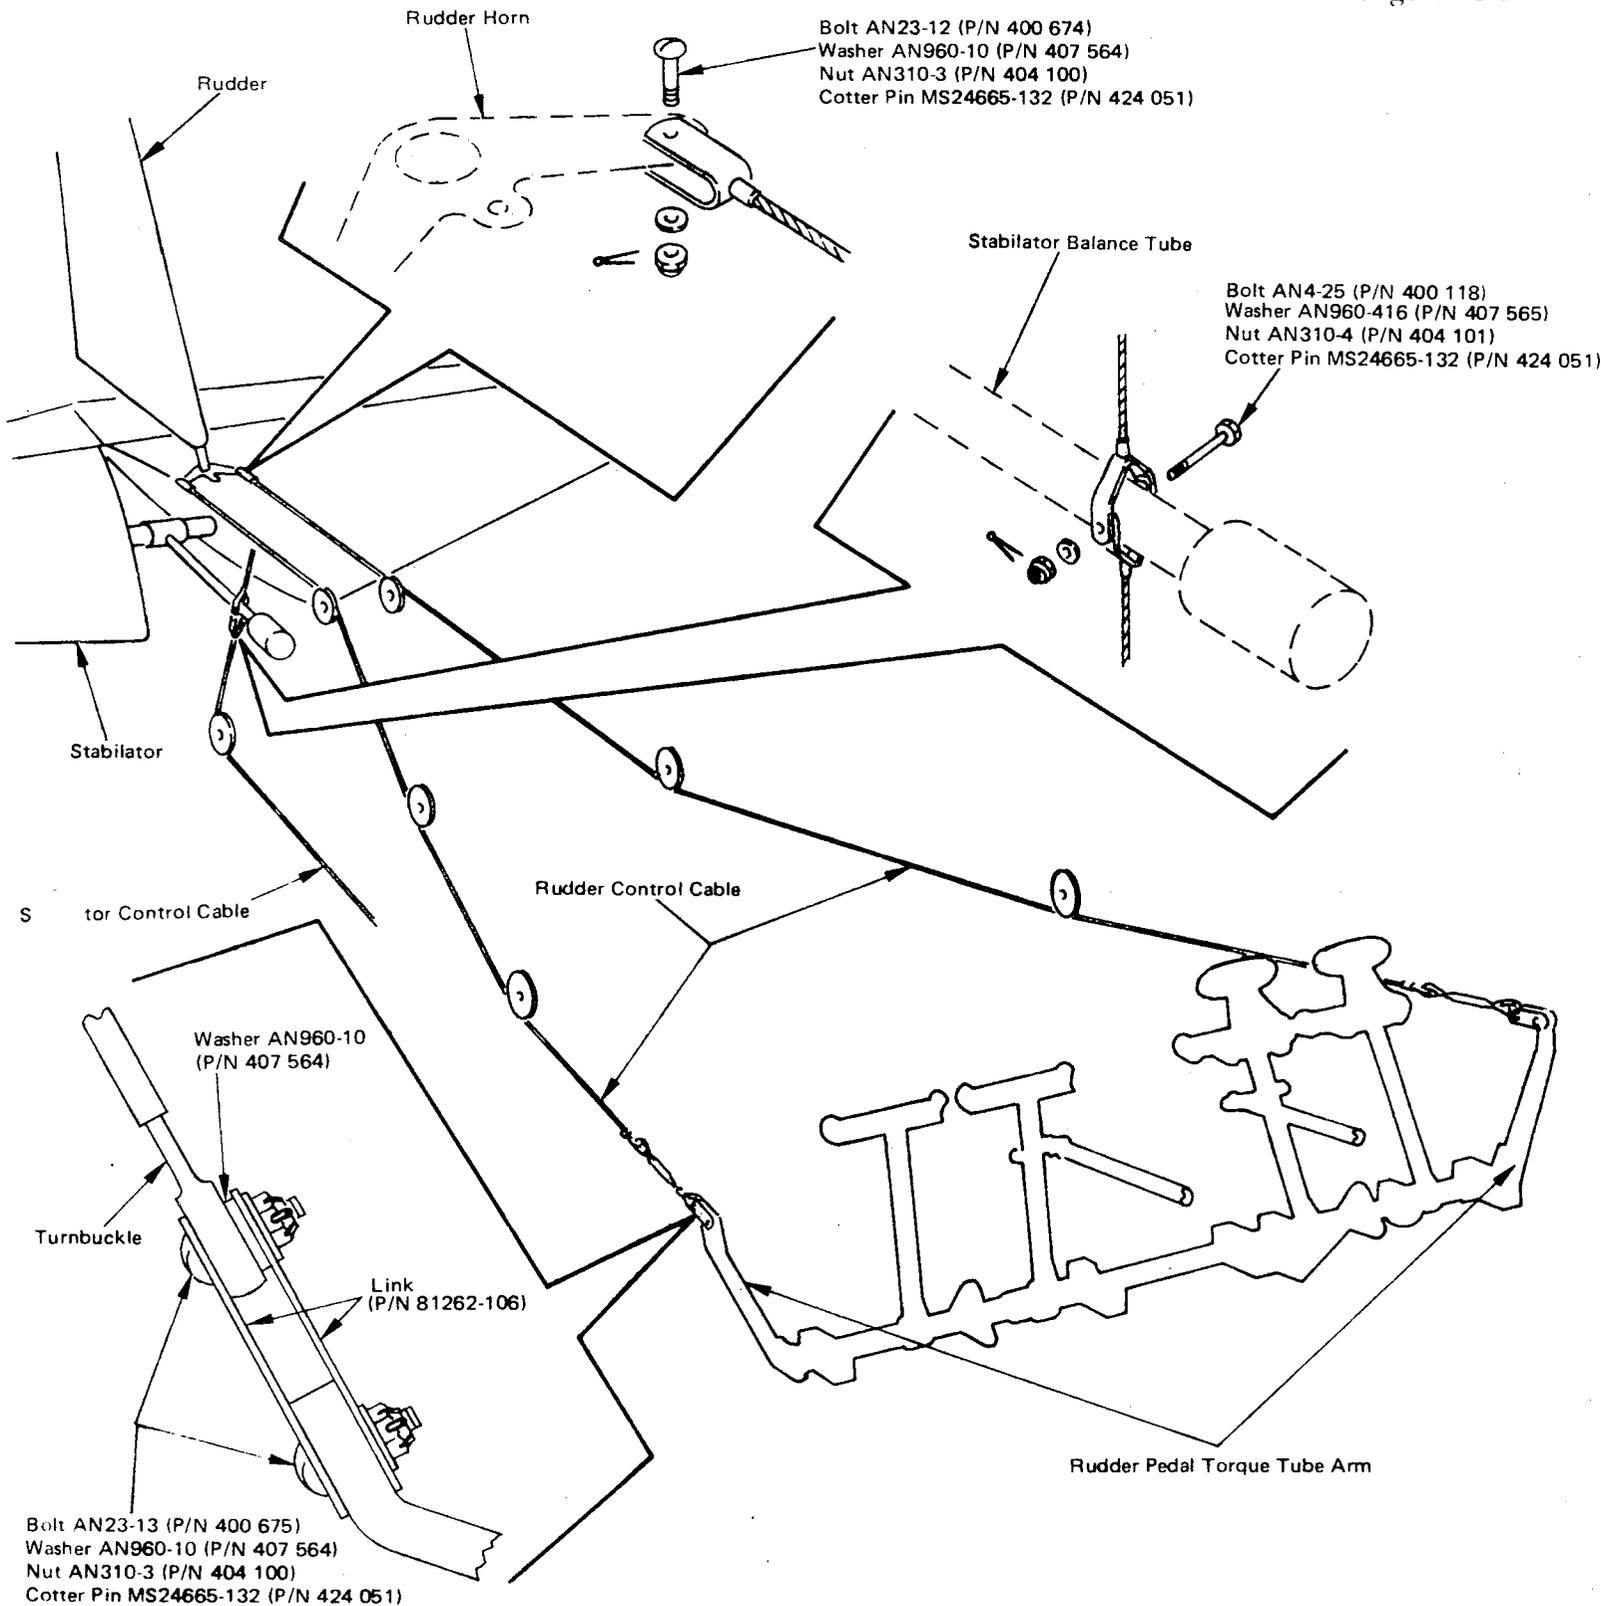
1. Remove left and right side panels from rear of forward fuselage to gain access to the rudder pedal torque tube arms.
  - a. Inspect rudder control cable attachment at rudder pedal torque tube arms to ensure that the bolt, washers, nut and cotter pin are properly installed.

- a. Inspect rudder control cable attachment at rudder horn (both sides) to ensure that the bolt, washer, nut and cotter pin are properly installed.
  - b. Make corrections, if required. Check cable fittings for freedom of movement and reinstall access cover.

3. Remove left side access panel from aft fuselage to gain access to the stabilator balance tube.
  - a. Inspect stabilator control cable attachment at balance tube to ensure that the bolt, washer, nut and cotter pin are properly installed.

- b. Make corrections, if required. Check cable fittings for freedom of movement and reinstall side panels.
2. Remove the most rearward access cover from top of fuselage aft section to gain access to rudder horn.

- b. Make corrections, if required. Check cable fittings for freedom of movement and reinstall access panel.
