Piper Aircraft Corporation

SERVICE LETTER

No. 641

Subject: Exhaust Stack Support Assembly Replacement

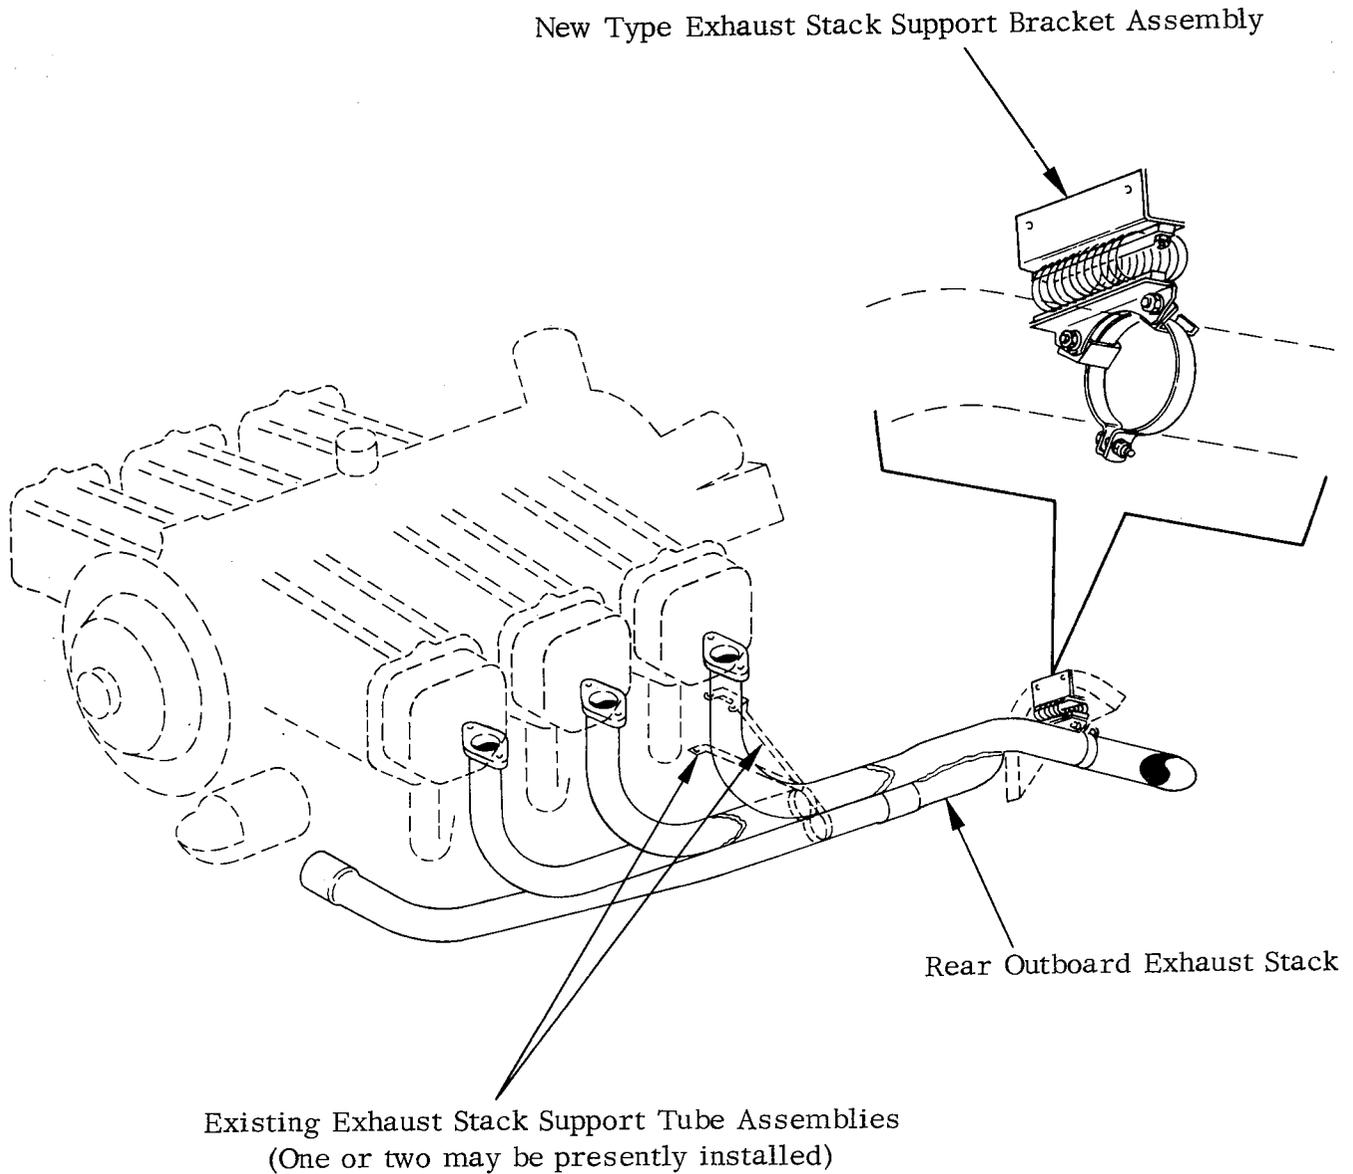
LEFT ENGINE SHOWN - RIGHT ENGINE OPPOSITE

Purpose: To provide a field replacement kit containing material and instructions to replace the existing exhaust stack support tube assemblies on normally aspirated Aztecs with a new improved exhaust stack support bracket. These new support brackets have been designed to minimize the effects of possible stack vibration, thus improving the service life of the engine exhaust system. (Refer to sketch on reverse side of this letter for a pictorial description.)

Instructions: Contained in Exhaust Stack Support Assembly Replacement Kit, Piper Part No. 760 702.

Material Required: Two (2) each per aircraft (i.e., one each per engine) Exhaust Stack Support Assembly Replacement Kit, Piper Part No. 760 702 @ suggested unit list price \$32.35A.
