# SERVICE BULLETIN

No. 385

Piper Aircraft Corporation

Wing Leading Edge Modification

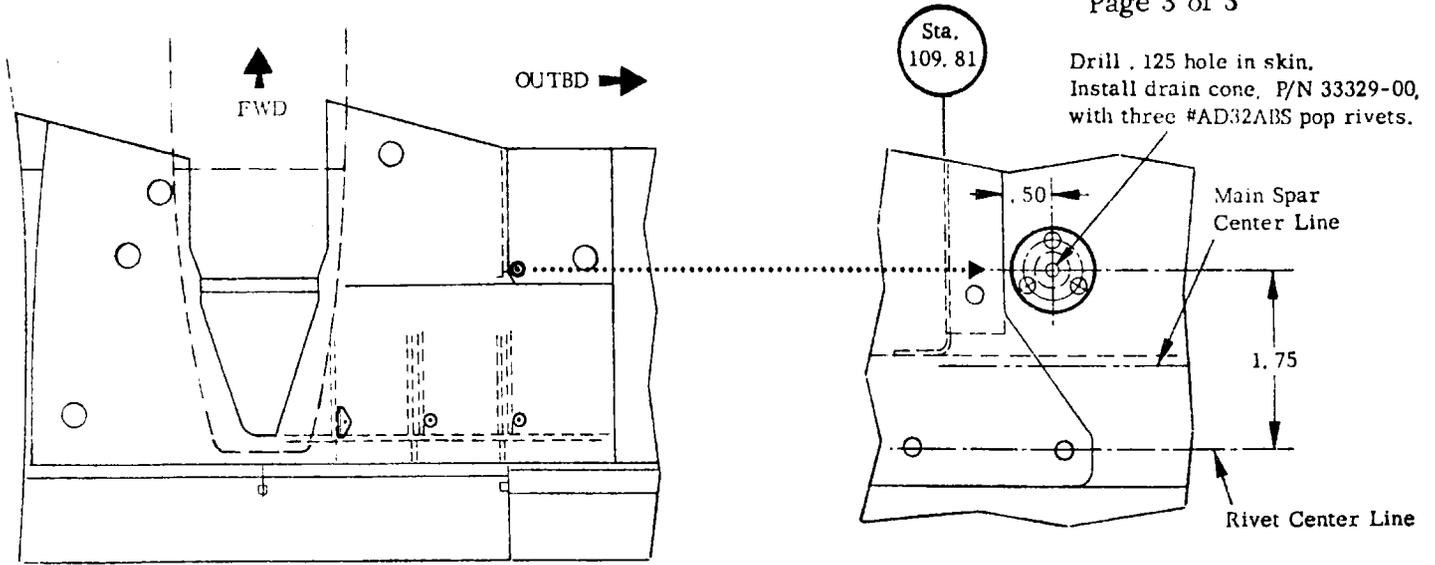
BOTTOM VIEW OF LEFT WING SHOWN-RIGHT WING OPPOSITE

To provide material and instructions to install a vent drain cone outboard of wing leading edge station 109.81 and forward of the main spar, and to apply a sealer compound to the wing leading edge cavity on the above referenced aircraft. Refer to attached sketch/instruction sheet for an illustrated view of this area.

1. Vent drain cone installation -- applies to Serial Nos. 27-4766 to 27-4780 incl.
  - a. Check for the presence of the vent drain cone (reference attached sketch); if installed as shown, proceed to step 2, below. If not installed as shown, proceed as follows.

- b. Locate and drill a .125 hole in the leading edge bottom skin, outboard of station 109.81 and forward of the main spar as shown on the attached sketch.

- c. Position vent drain cone (Part No. 33329-00) over the .125 hole (center holes aligned) and drill three .096 holes (#41 drill) through the attachment holes in the vent drain cone and wing skin. Attach the cone with three #AD32ABS pop rivets (Piper Part No. 422 987).
