# SERVICE No. 185A BULLETIN

Piper Aircraft Corporation

**SUBJECT:** Wing Ribs Stations 95 and 110 Located Below the Main Wing Fuel Cell

**MODELS AFFECTED:** PA-23 and PA-23-160 Apache Aircraft of Foreign Registry  
Serial Nos. 23-1 to 23-1883 inclusive

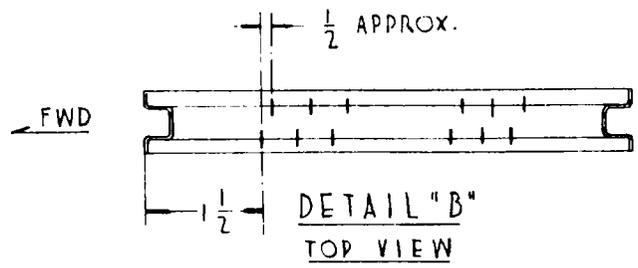
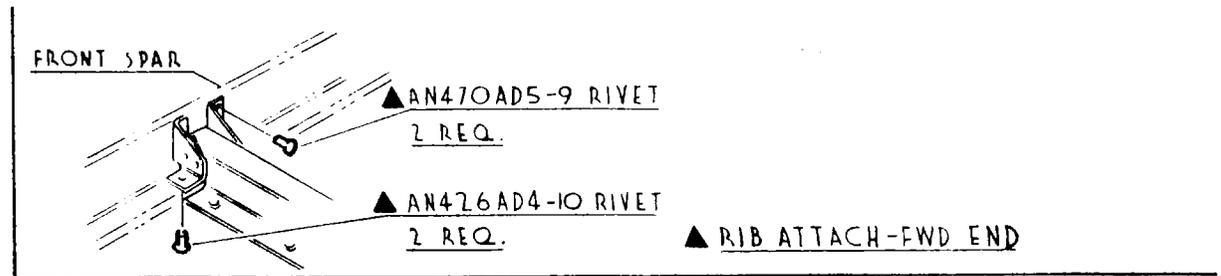
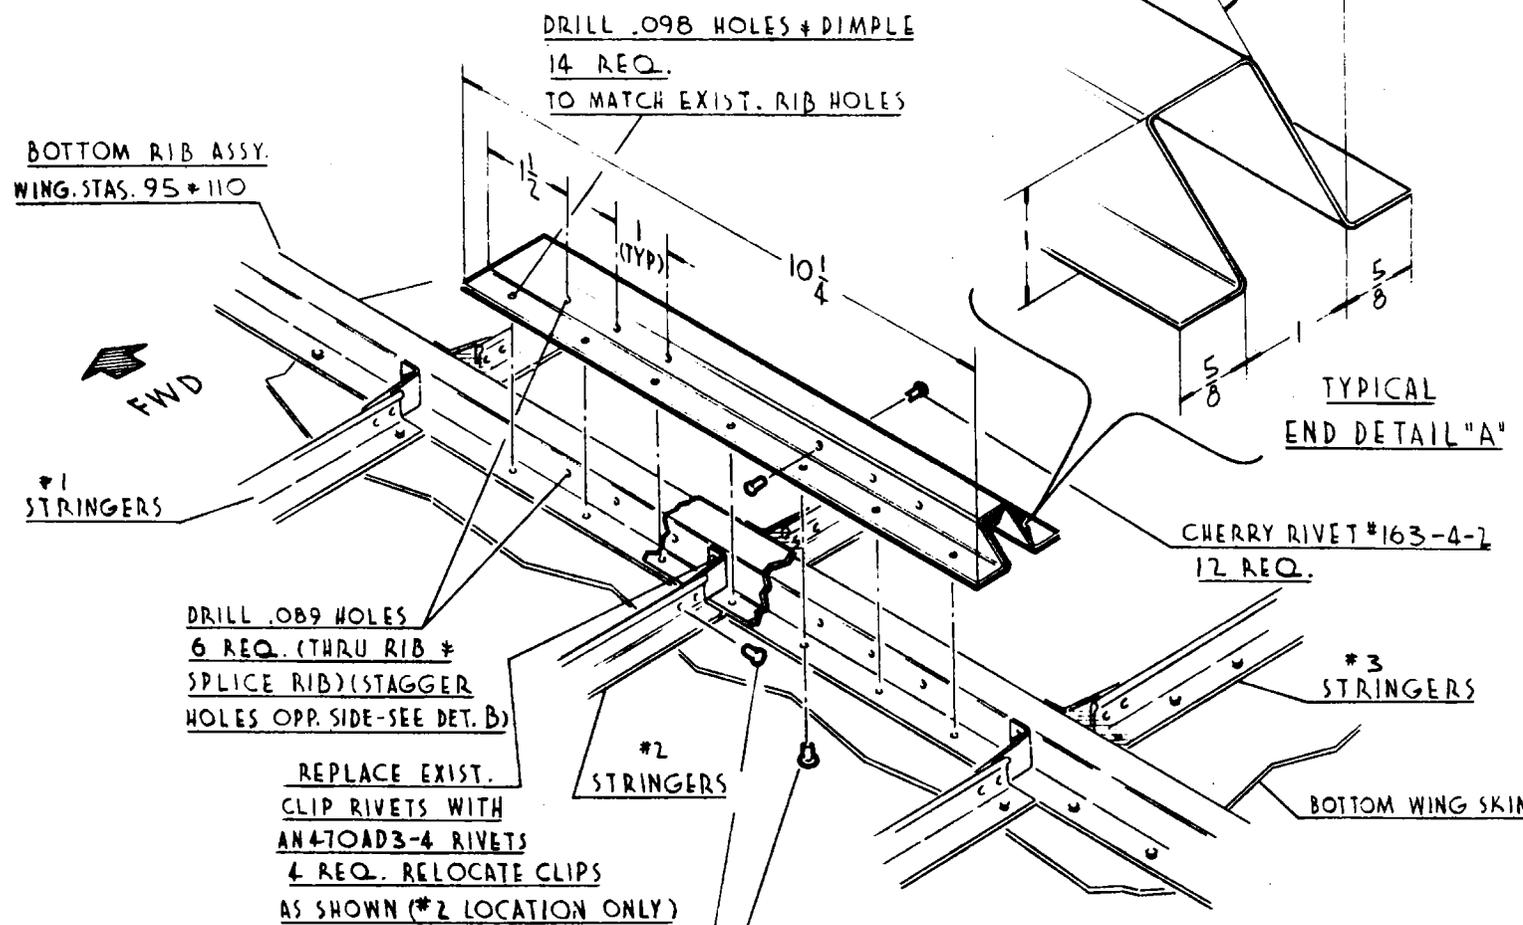
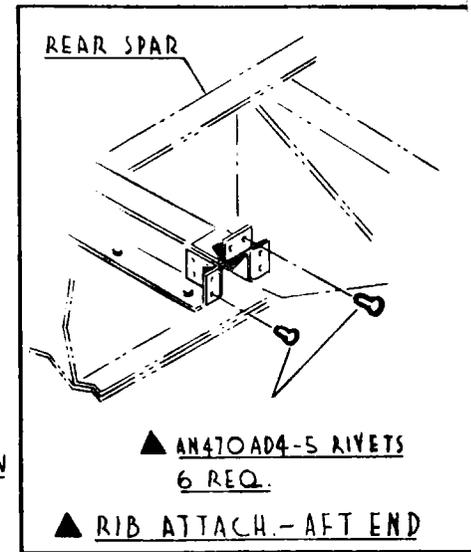
PA-23  
RIB REPAIR  
OR  
▲ RIB INSTALLATION  
BOTTOM WING RIBS  
AT  
MAIN FUEL CELL COMPARTMENT

We have received reports from various sources outside the Continental Limits of the United States concerning cracks in the subject wing ribs.

From this inspection, it is felt that the cracking of the main wing fuel cell ribs was due to landings on extreme rough terrain or from continual hard landings. Providing your airplane is operated from extreme rough terrain or unprepared runways or is subjected to continual hard landings due to student training, etc., it is recommended that the subject ribs be inspected every 500 hours and if cracked ribs are discovered they should either be replaced or repaired in accordance with the attached sketch.

NOTE -  
FORM PART OF .032  
2024T3 ALUM.  
FLAT PATTERN SIZE - 4 1/4 x 10 1/4

RIVET QUANTITIES GIVEN -  
FOR SINGLE REPAIR OR INST. ONLY
