Service Letter No. 354

May 25, 1961

SUBJECT: Reinforcement of Aztec Stabilator Leading Edges

MODELS AFFECTED: PA-23-250 Aztecs, Serial Nos. 27-2 thru 27-481 inclusive
Refer to Note "A"

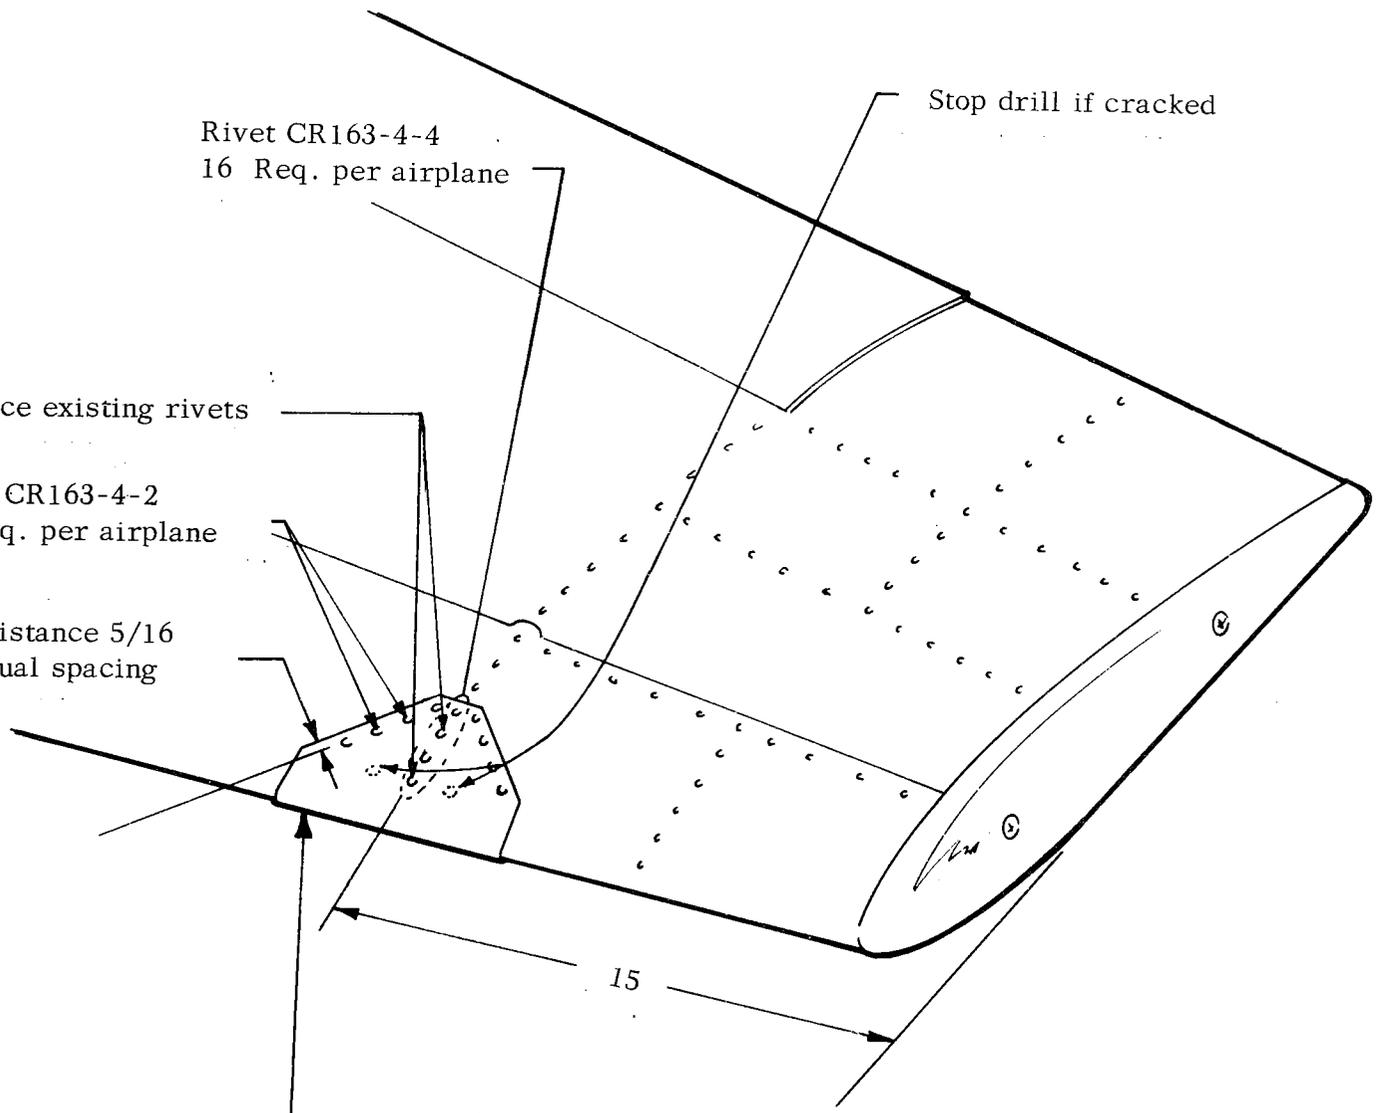
SKETCH A'
SERVICE LETTER 1-354

Skin cracks have occurred in the leading edge of the Aztec stabilator at the first rivet on the outboard stabilator nose rib. (See Sketch "A") These cracks do not materially affect the structural integrity of the stabilator or the airworthiness of the aircraft. However, it is recommended that a reinforcement, Piper Part No. 30334-00, be added to both the left and right stabilators in this area to repair or eliminate this condition.

Stop drill if cracked

Rivet CR163-4-4
16 Req. per airplane

Replace existing rivets

Rivet CR163-4-2
32 Req. per airplane

Edge distance $5/16$
Use equal spacing

Part No. 30334-00
2 Req. per airplane

Press and hold plate firmly
against leading edge of
stabilator before drilling
