Service Letter No. 252

SUBJECT: Primer Pump

MODELS AFFECTED: PA-23, Serials 23-1 to 23-102 inclusive

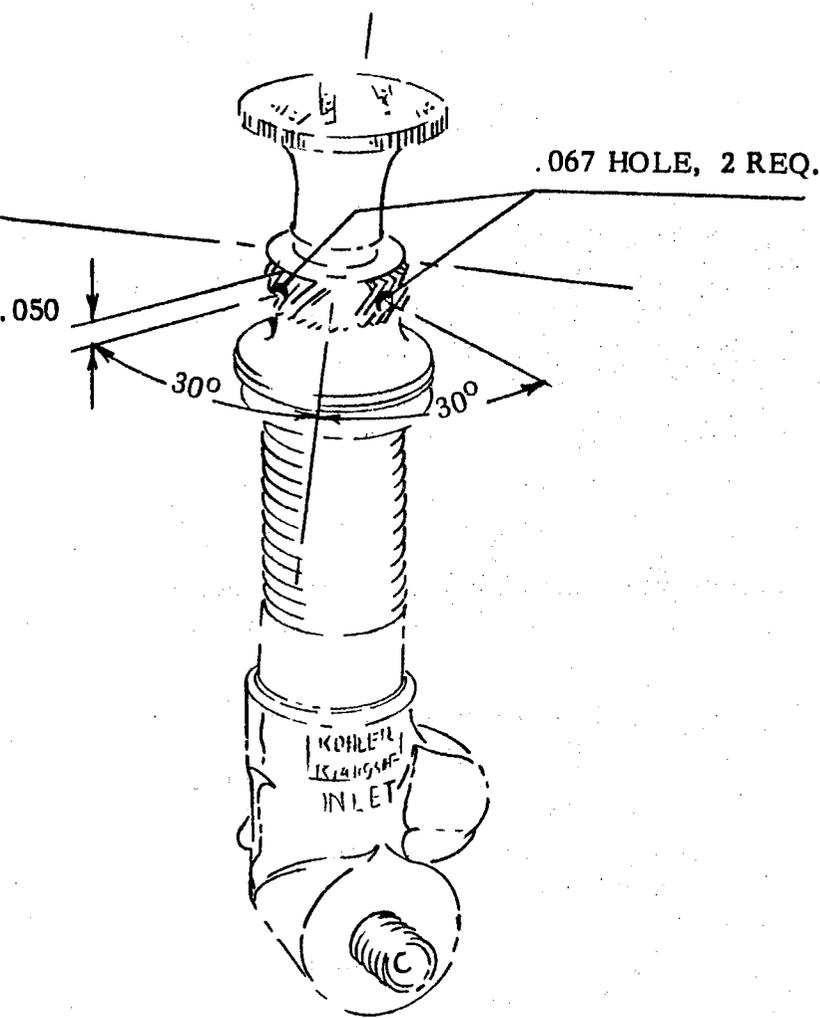
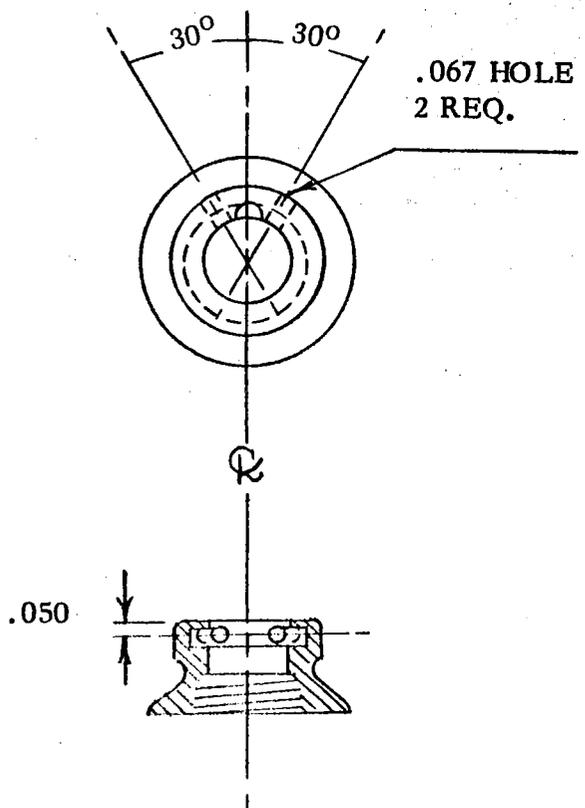
| SKETCH "A" | Service Letter 252 |

We have received reports from the field relative to engine roughness which is caused by the primer pump becoming unlocked and allowing raw gas to enter the intake manifold of the engine, thus disrupting the proper fuel-air mixture.

We recommend that this modification be made and that it be made in accordance with the sketch shown on the reverse side of this letter.

1. Remove the piston from the barrel.
2. Unscrew the "O" ring seal end from the piston assembly so that the knurled nut may be removed.
3. Drill two holes in the knurled nut per sketch.
4. Reassemble - using care that no foreign material adheres to the internal parts.
