NUMBER 125

September 29, 1954

SUBJECT: Fuel System Model PA-23

MODEL AFFECTED: Model PA-23, Serial Numbers listed below

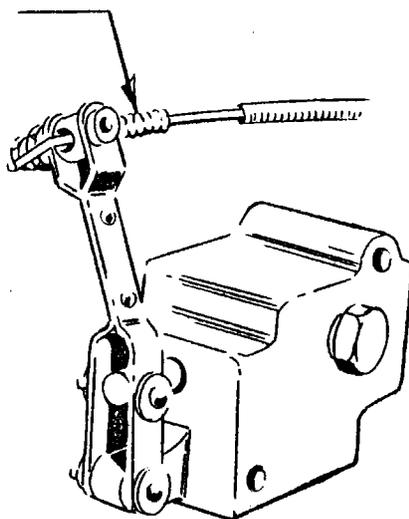
SKETCH "A"

The fuel valves located behind the firewalls under the rear upper engine nacelles are operated from the cabin by a flexible wire control.

If the attachment of the flexible wire to the fuel valve handle should become loose due to the backing off of the set screw and lock nut the wire will slide through the valve handle, thereby making it possible to completely move the cockpit control to the "FUEL ON" position without actually opening the valve. This condition will result in fuel starvation of an engine, and possible engine failure.

Therefore, to positively eliminate this condition, it is necessary to immediately inspect the attachment of the flexible wire to the fuel valve handle to determine if the set screw and lock nut are tight and to rework the end of the flexible wire in accordance with the Sketch "A" shown on the reverse side of this Bulletin. The Models affected are Serial Numbers 23-1 to 23-32 inclusive and 23-37.

SOLDER SEVERAL
TURNS OF SAFETY WIRE
TO CONTROL CABLE TO
PREVENT SLIPPAGE

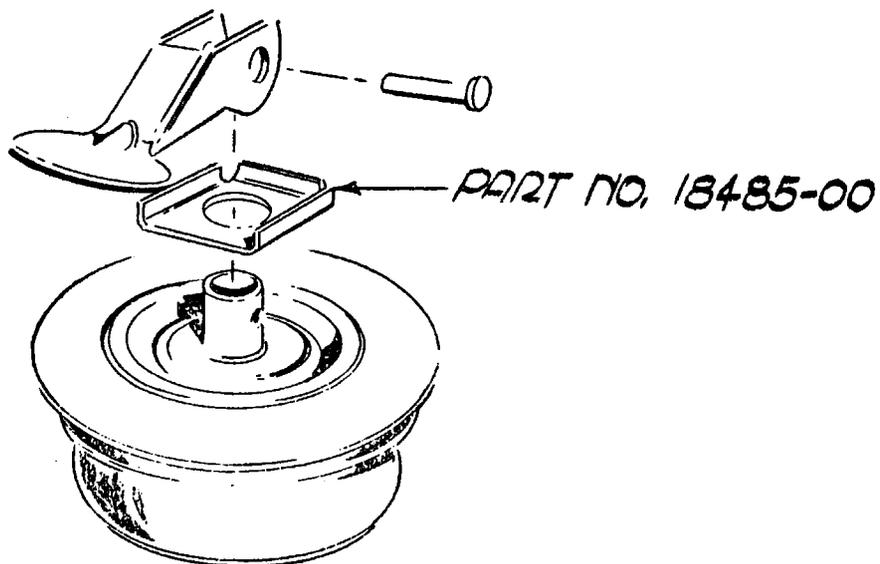
SKETCH "B"

The fuel cell caps, Part Number 17672-00, should be modified to preclude the possibility of an airport attendant pushing the locking lever of the cap in the wrong direction, thus having an unlocked condition when the cap is supposed to be locked.

The following aircraft are affected: Serial Numbers 23-2 to 23-4 inclusive, 23-10, 23-13, 23-15 to 23-31 inclusive, 23-37 and 23-38. The cap can be modified by installing Part Number 18485-00 as per Sketch "B" shown on the reverse side of this Bulletin. Parts can be obtained through the Distributor or Dealer in your area at No Charge.
