Service Letter No. 432

SUBJECT: Inspection of Auxiliary Power Plug Solenoid

MODELS AFFECTED: PA-23-250 (6 place) Aztecs - Serials 27-2420, 27-2422, 27-2434, 27-2439, 27-2455, 27-2460, 27-2472, 27-2486, 27-2491, 27-2493, 27-2502, 27-2511 to 27-2515 incl., 27-2517, 27-2519 to 27-2522 incl., 27-2524, 27-2531, 27-2533, 27-2534, 27-2538, 27-2542, 27-2544, 27-2546, 27-2550, 27-2554 to 27-2560 incl., 27-2563.

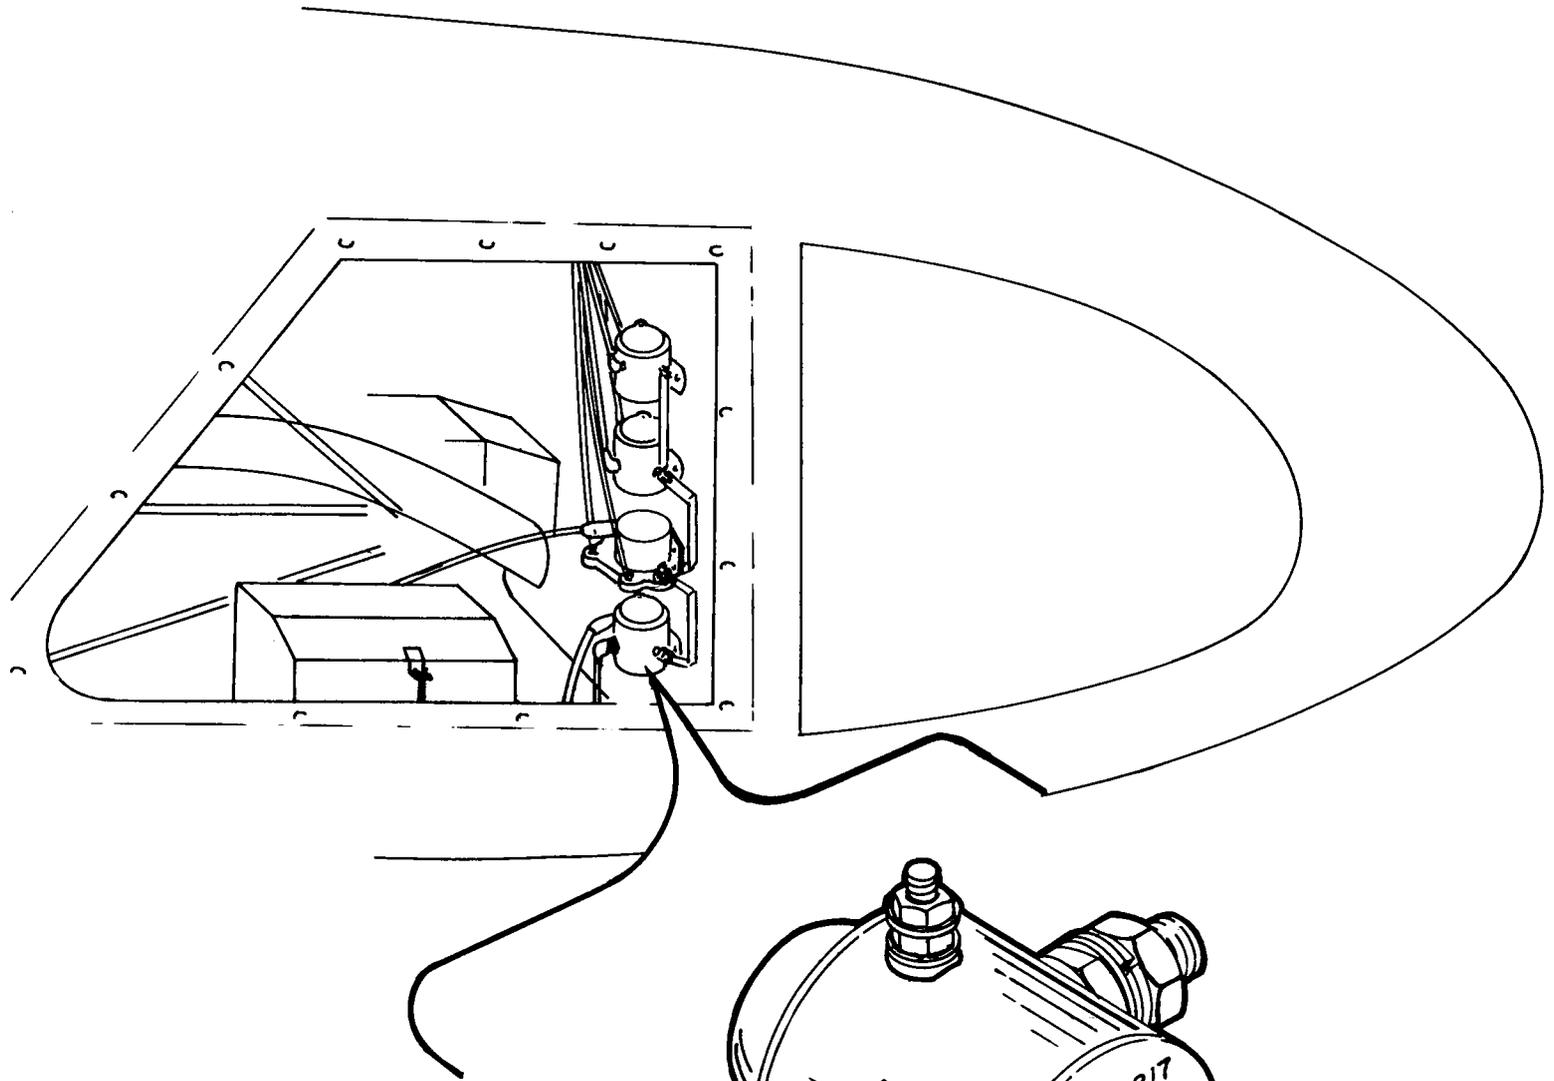
It is possible that the solenoid used in the auxiliary power plug installation in the above aircraft may be the wrong type. The solenoid may be identified by a part number stamped on the bottom. See sketch on the reverse side of this letter.

A solenoid with part number 001464 at this point should be replaced with Piper part number 487 153 (1114217).
