SERVICE BULLETIN

No. 564

Piper Aircraft Corporation

Subject: Inspection of Emergency Gear Extension Control

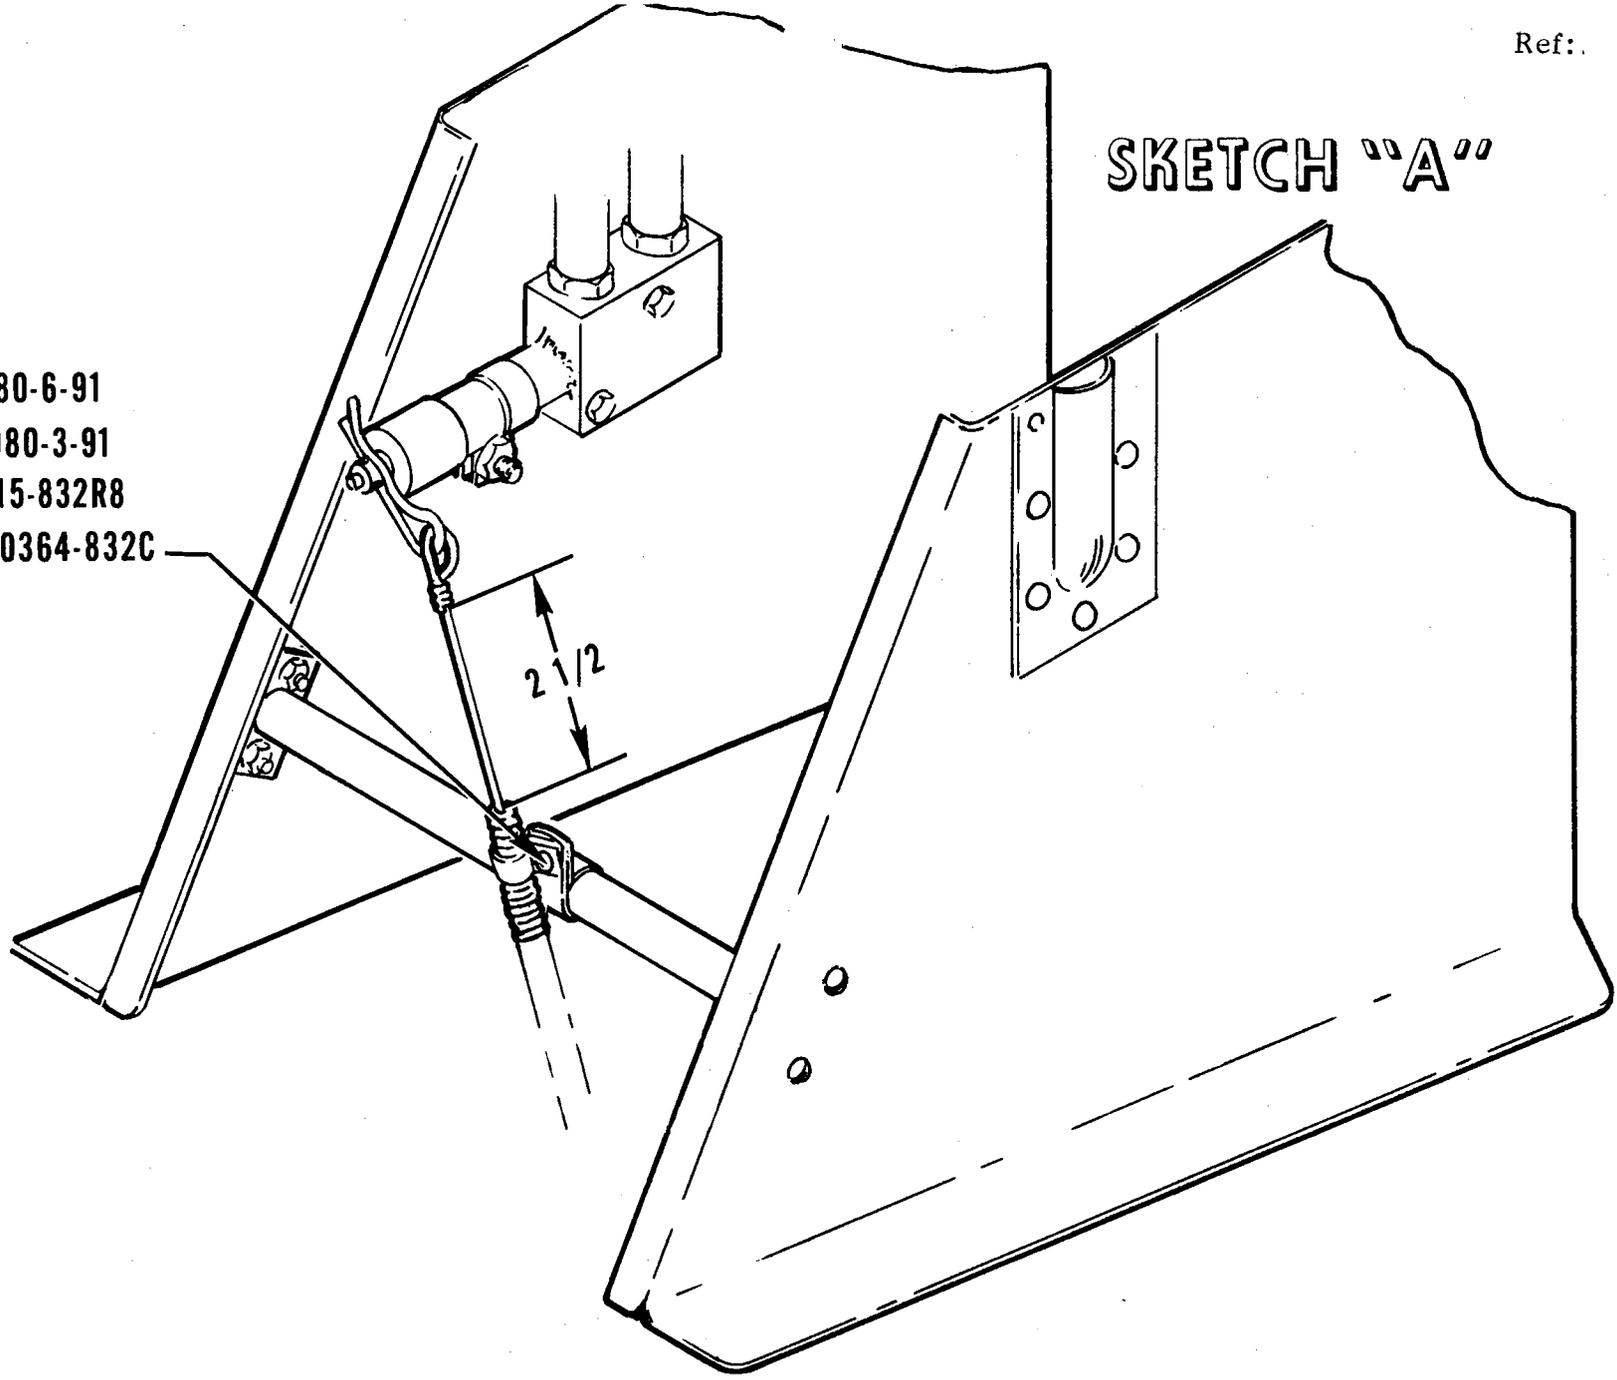
SKETCH "A"

Purpose: A few field reports have been received indicating that the emergency gear extension actuator control system (CO₂ actuator) was improperly rigged. Normal operation involves pulling the emergency gear extender ring (located beneath a small cover plate under the pilot's seat) which causes the priority valve to open followed by discharge of the CO₂ bottle. This sequence is controlled by two different length cables attached to and routed from the pull ring to the priority valve and CO₂ unit (refer to attached Sketch B).

1. Remove CO₂ bottle from discharge unit.
2. Reference attached Sketch "A"; inspect for the two and one half inch dimension on the priority valve actuating cable. If necessary, loosen the clamp and cut the end of flexible housing as required, as the dimension of two and one half inches must be strictly maintained. Tighten clamp.
3. Reference attached Sketch "B"; lift emergency gear extension cover located under the pilot's seat; gently pull on the ring until slack in the priority valve actuating cable is removed.
4. Gently remove the slack from the CO₂ discharge unit cable so that it will slide up the ring as shown in attached Sketch "B"; CO₂ discharge unit cable should extend one inch beyond the priority valve cable at this point.
