SERVICE BULLETIN

No. 507

Piper Aircraft Corporation

Inspection of Fuel System Control Cables at Swivel Fittings.

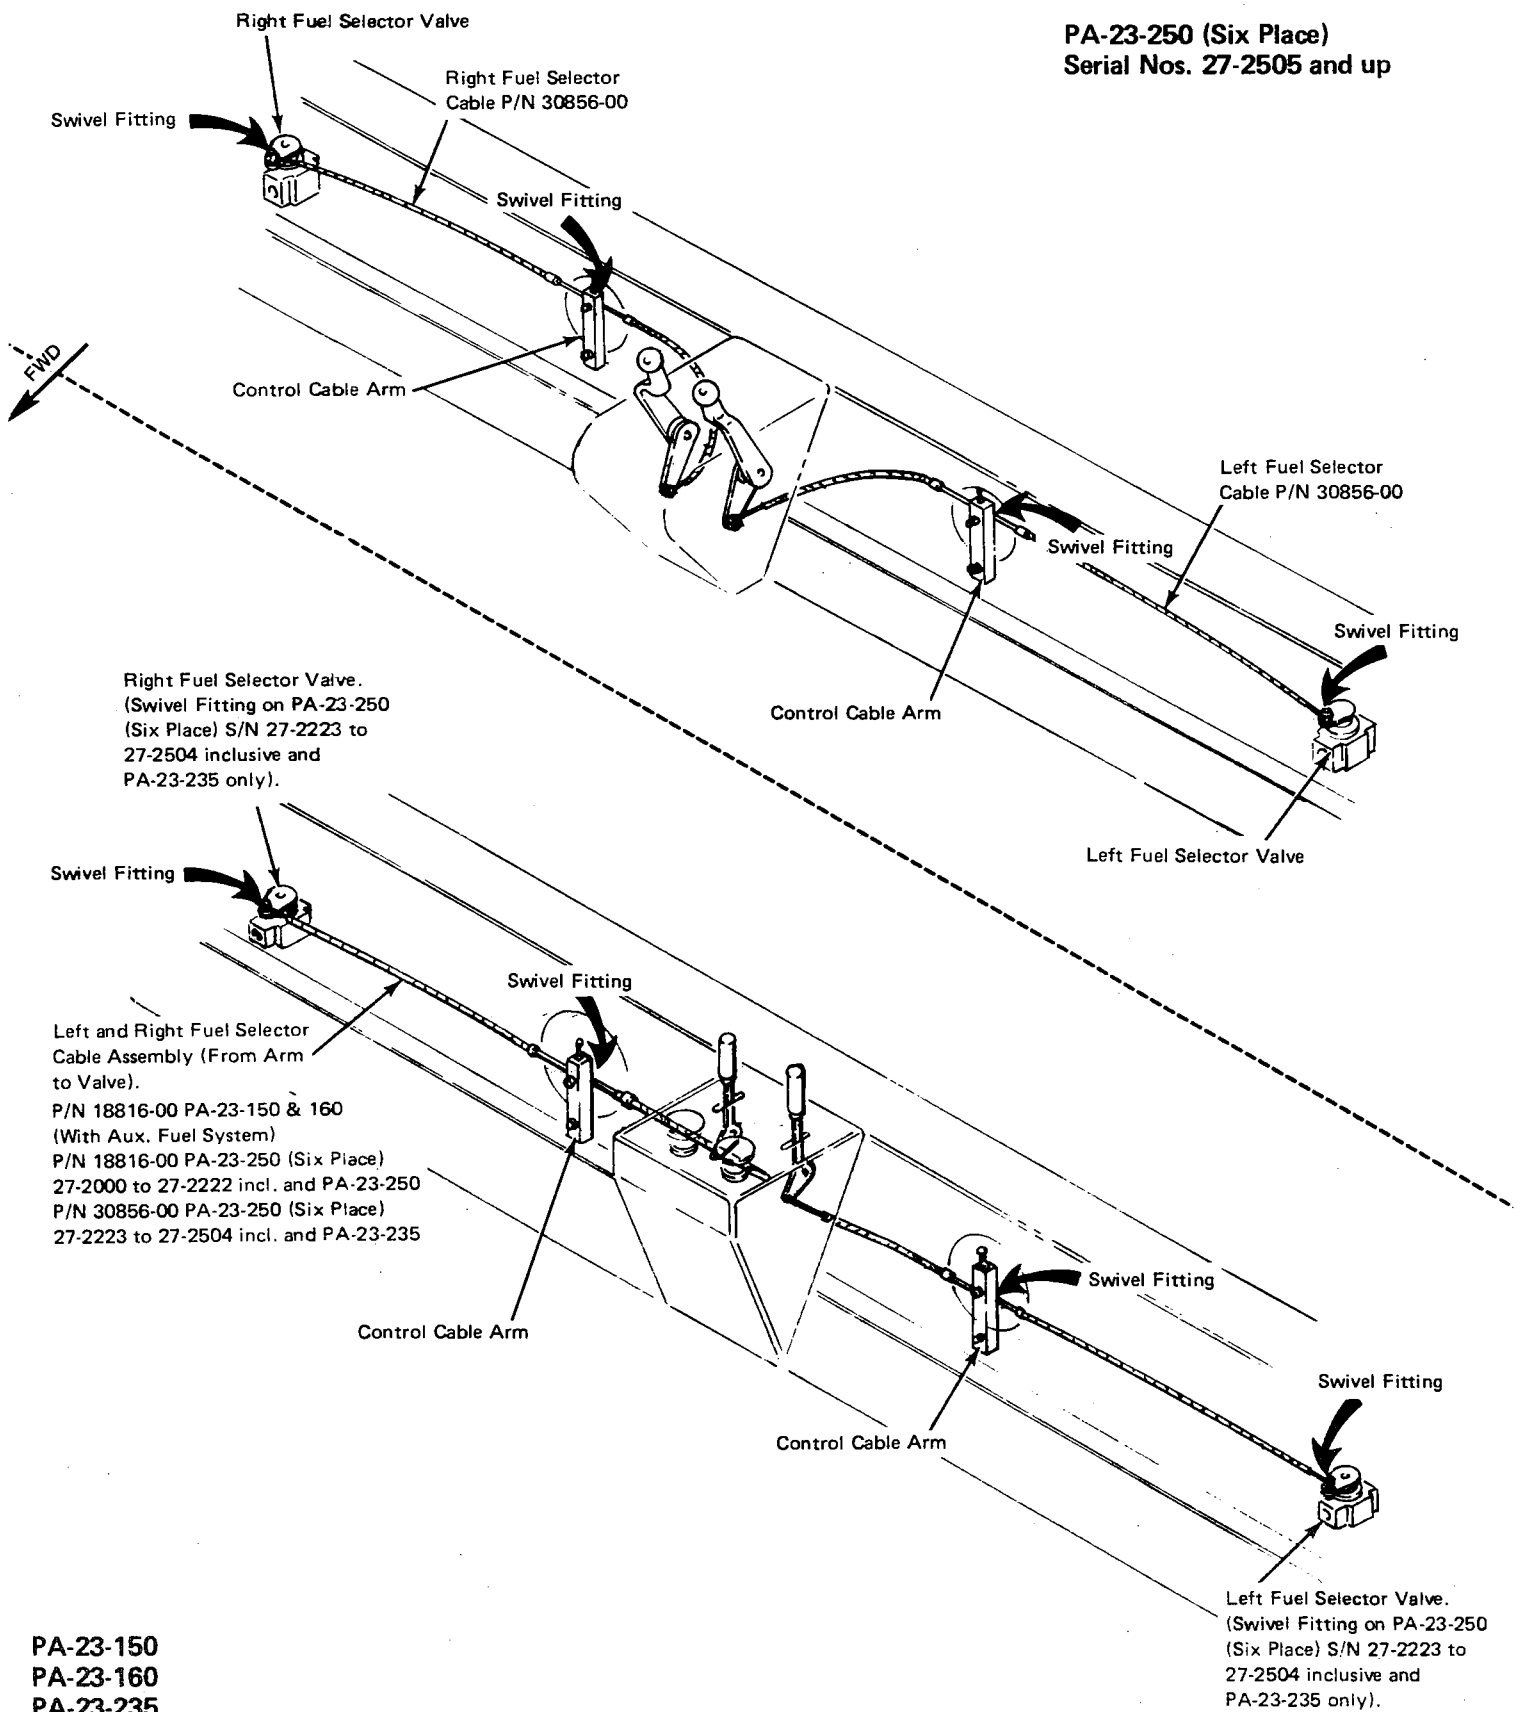
**PA-23-250 (Six Place)
Serial Nos. 27-2505 and up**

This service release provides instructions to inspect the fuel system control cables at the swivel fitting attachment points to detect binding, kinking or bending of the control cable inner wire, and to replace cable(s) exhibiting these conditions at the swivel fitting attachments. Note: PA-23, PA-23-235 and PA-23-250 Series - Left and Right Fuel Selector Cable Assembly (From Arm to Valve) only affected; refer to attached illustration.

Refer to attached illustration which depicts locations of affected fuel system control cable/swivel fitting attachment points to be inspected, and identifies control cable assembly/aircraft model application.

1. Refer to appropriate service manual Fuel System section to insure fuel selector valve controls are properly rigged, and to gain access to control cable/swivel fittings.
2. Visually check control cable wires at the related swivel fittings for indications of binding, kinking or bending: have someone in the cockpit operate fuel controls while mechanic inspects the swivel fittings for indications of binding, kinking, and/or bending.
 - a. Replace cables(s) exhibiting any of above conditions.
 - b. Check system rigging per service manual, make proper log book entry indicating compliance with this bulletin and prepare aircraft for return to service.
 - c. If no binding, kinking or bending appears at the cable attachment points, check rigging per service manual, make proper log book entry indicating compliance with this bulletin and prepare aircraft for return to service.
