SERVICE LETTER

No. 645

Piper Aircraft Corporation

Starter Vibrator Wiring Inspection

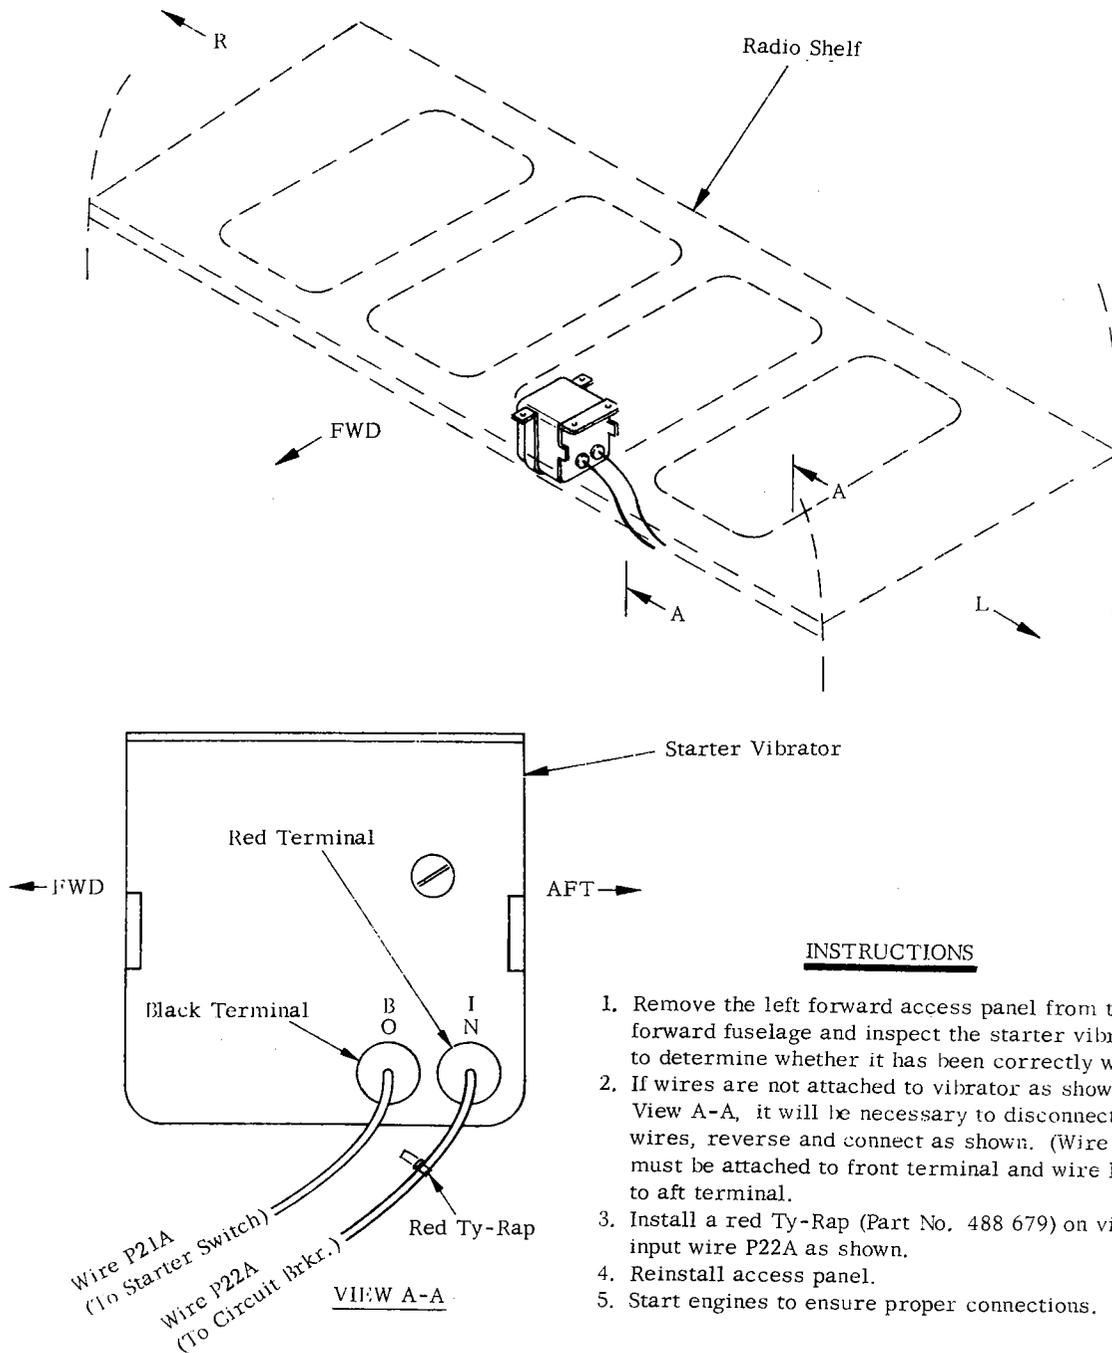
A product condition exists which could allow reversal of the starter vibrator wires at the starter vibrator connection point. Should the starter vibrator wires be reversed on the above mentioned aircraft, hard starting and/or starter vibrator damage may result.

1. Remove the left forward access panel from the forward fuselage and inspect the starter vibrator to determine whether it has been correctly wired.
2. If wires are not attached to vibrator as shown on View A-A, it will be necessary to disconnect wires, reverse and connect as shown. (Wire P21A must be attached to front terminal and wire P22A to aft terminal.)
3. Install a red Ty-Rap (Part No. 488 679) on vibrator input wire P22A as shown.
4. Reinstall access panel.
5. Start engines to ensure proper connections.
