SERVICE LETTER

No. 520

Subject: Inspection of Turbocharger Plenum Exhaust Welds
(See attached AiResearch Service Bulletin No. 14.1.9)

INSPECTION OF TURBOCHARGER PLENUM EXHAUST WELDS

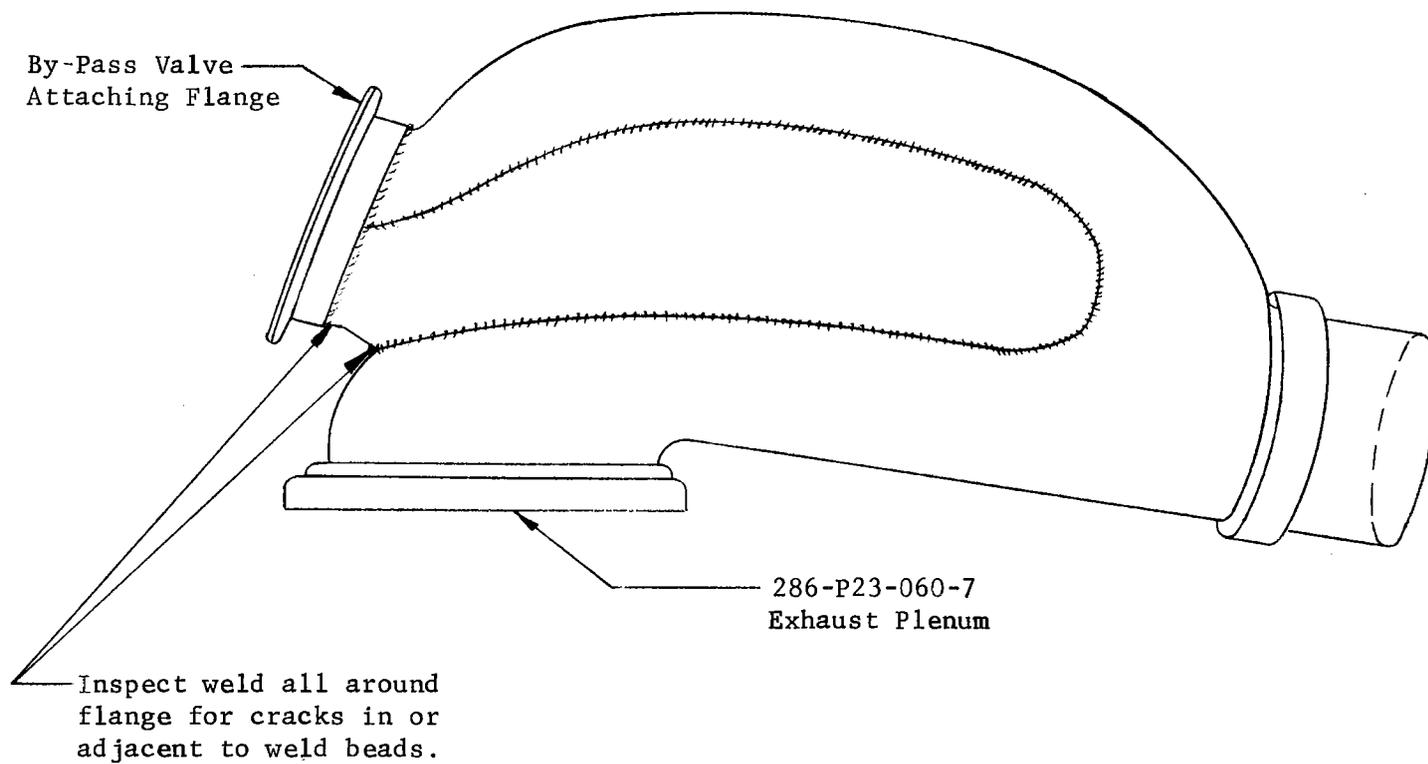
FIGURE 1

To inspect Exhaust Plenum, P/N 286-P23-060-7, for cracked welds at by-pass valve attaching flange.

Inspect Exhaust Plenum Weld Beads, paying particular attention to the area noted in Figure I, Page 2.

Prior to further flight, visually inspect the Exhaust Plenum weld bead for cracks at the by-pass valve attaching flange. If cracking in the weld is evident, replace the Plenum immediately. If no cracking is evident during inspection, continue the Plenum in service. If aircraft time is 100 hours or more, no further special inspection is necessary. If aircraft time is less than 100 hours inspect every 25 hours until 100 hours is reached.
