Service Letter No. 363

November 30, 1961

SUBJECT: Inspection and Modification of Flaps

MODELS AFFECTED: PA-23-250 Aztec and Navy UO-1 Aircraft - Serial Nos. 27-1 to 27-451 inclusive and 27-453 to 27-504 inclusive

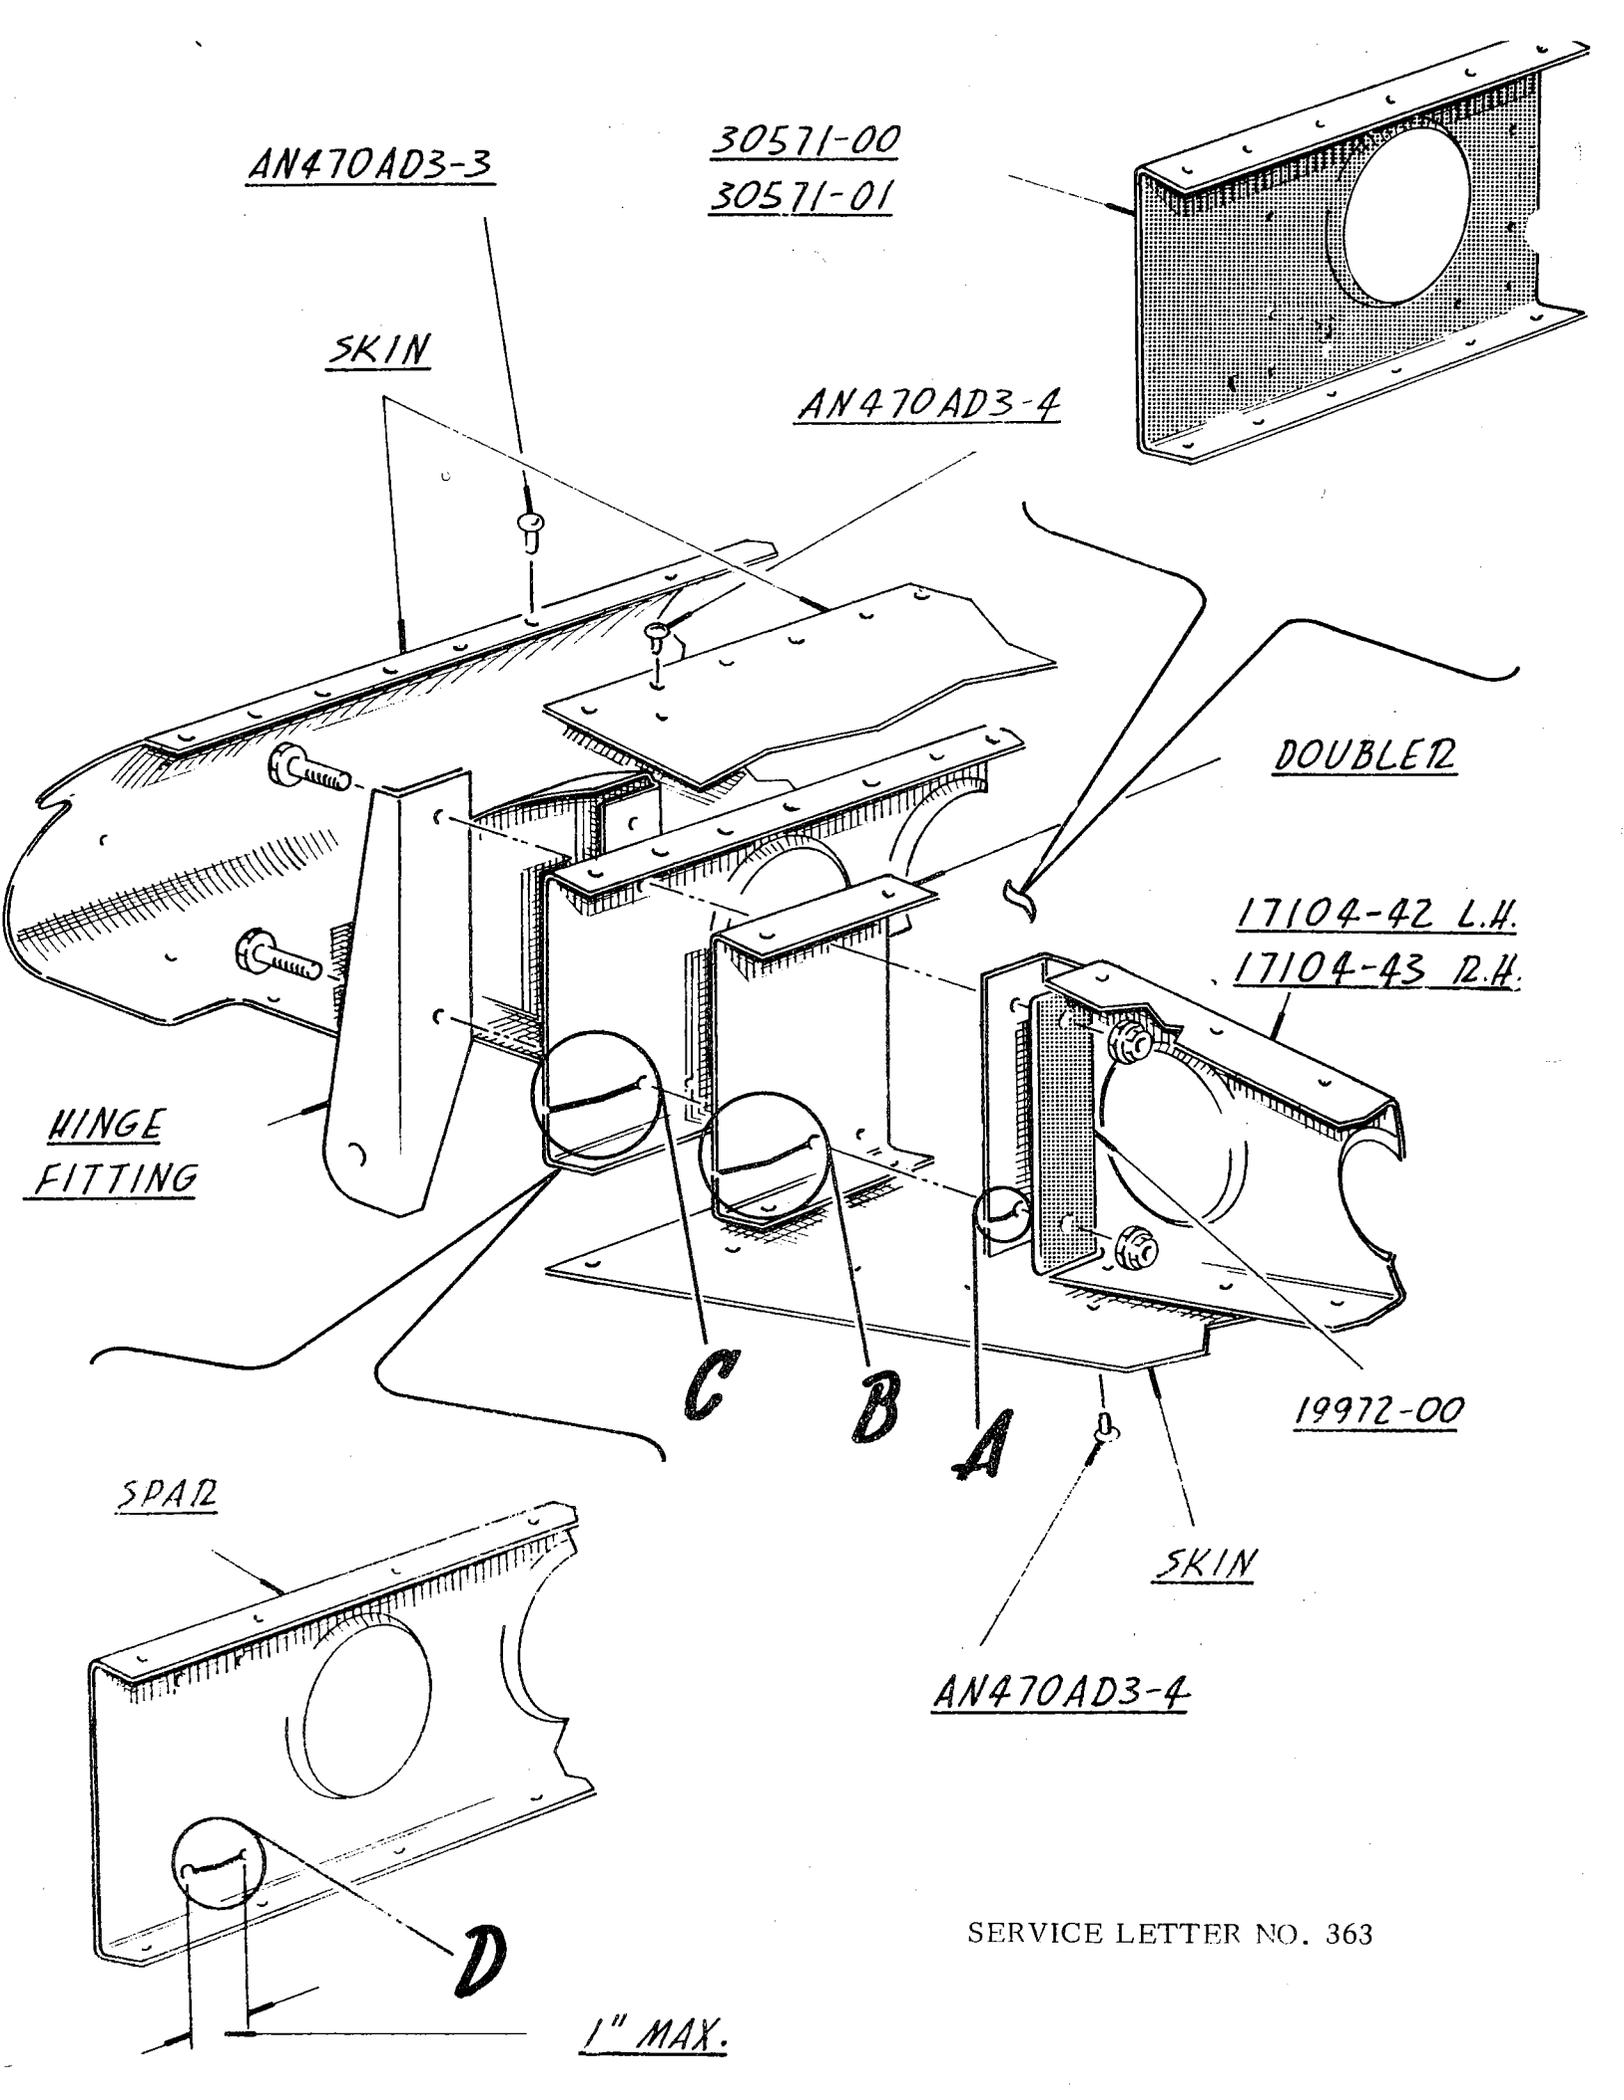
SERVICE LETTER NO. 363

Service reports indicate that cracks have been noted in the outboard area of the subject flaps. These cracks may be observed in the spar, doubler or rib. It is requested that an inspection be made of these flaps to determine if cracks have developed in any one of the three components indicated. See the attached sketch.

3. For cracks found in Area "A". If cracks are found in the rib flange, replace the rib (Part #17104-42 L.H. or 17104-43 R.H.) and install stiffener.
4. For cracks found in Area "B". If cracks are found in the doubler, replace with new doubler (Part #30571-00 L.H. or 30571-01 R.H.), install new rib and stiffener.

5. For cracks found in Area "C". If cracks are found in the spar from the bolt hole outboard; install new doubler, new rib and stiffener.
6. For cracks found in Area "D". If cracks are found in spar from bolt hole inboard, not over 1"; stop drill with a .082 drill and install new doubler, new rib and stiffener.

7. For cracks found in Area "D" over 1" long. If crack in spar inboard from bolt hole is over 1" replace entire flap.

1. Extend flaps to full down position. Inspect area around outboard fittings for cracks as per included sketch.
2. If no cracks are found, remove and discard the washers from under the nuts on the fitting bolts; install stiffener (Part #19972-00) and replace nuts.

When drilling out rivets, be careful
not to elongate holes.

When installing stiffener Part #19972-00,
locate the stiffener so that the bend radius
is toward the bend radius of the rib.
