SERVICE No. 189 BULLETIN

Piper Aircraft Corporation

SUBJECT: Stabilator Tab Horn Modifications

MODELS AFFECTED: PA -23-250 Aztecs (Navy UO-1)
Serial Nos. 27-2 to 27-5 inclusive, 27-7 to 27-60
inclusive, 27-62 to 27-215 inclusive

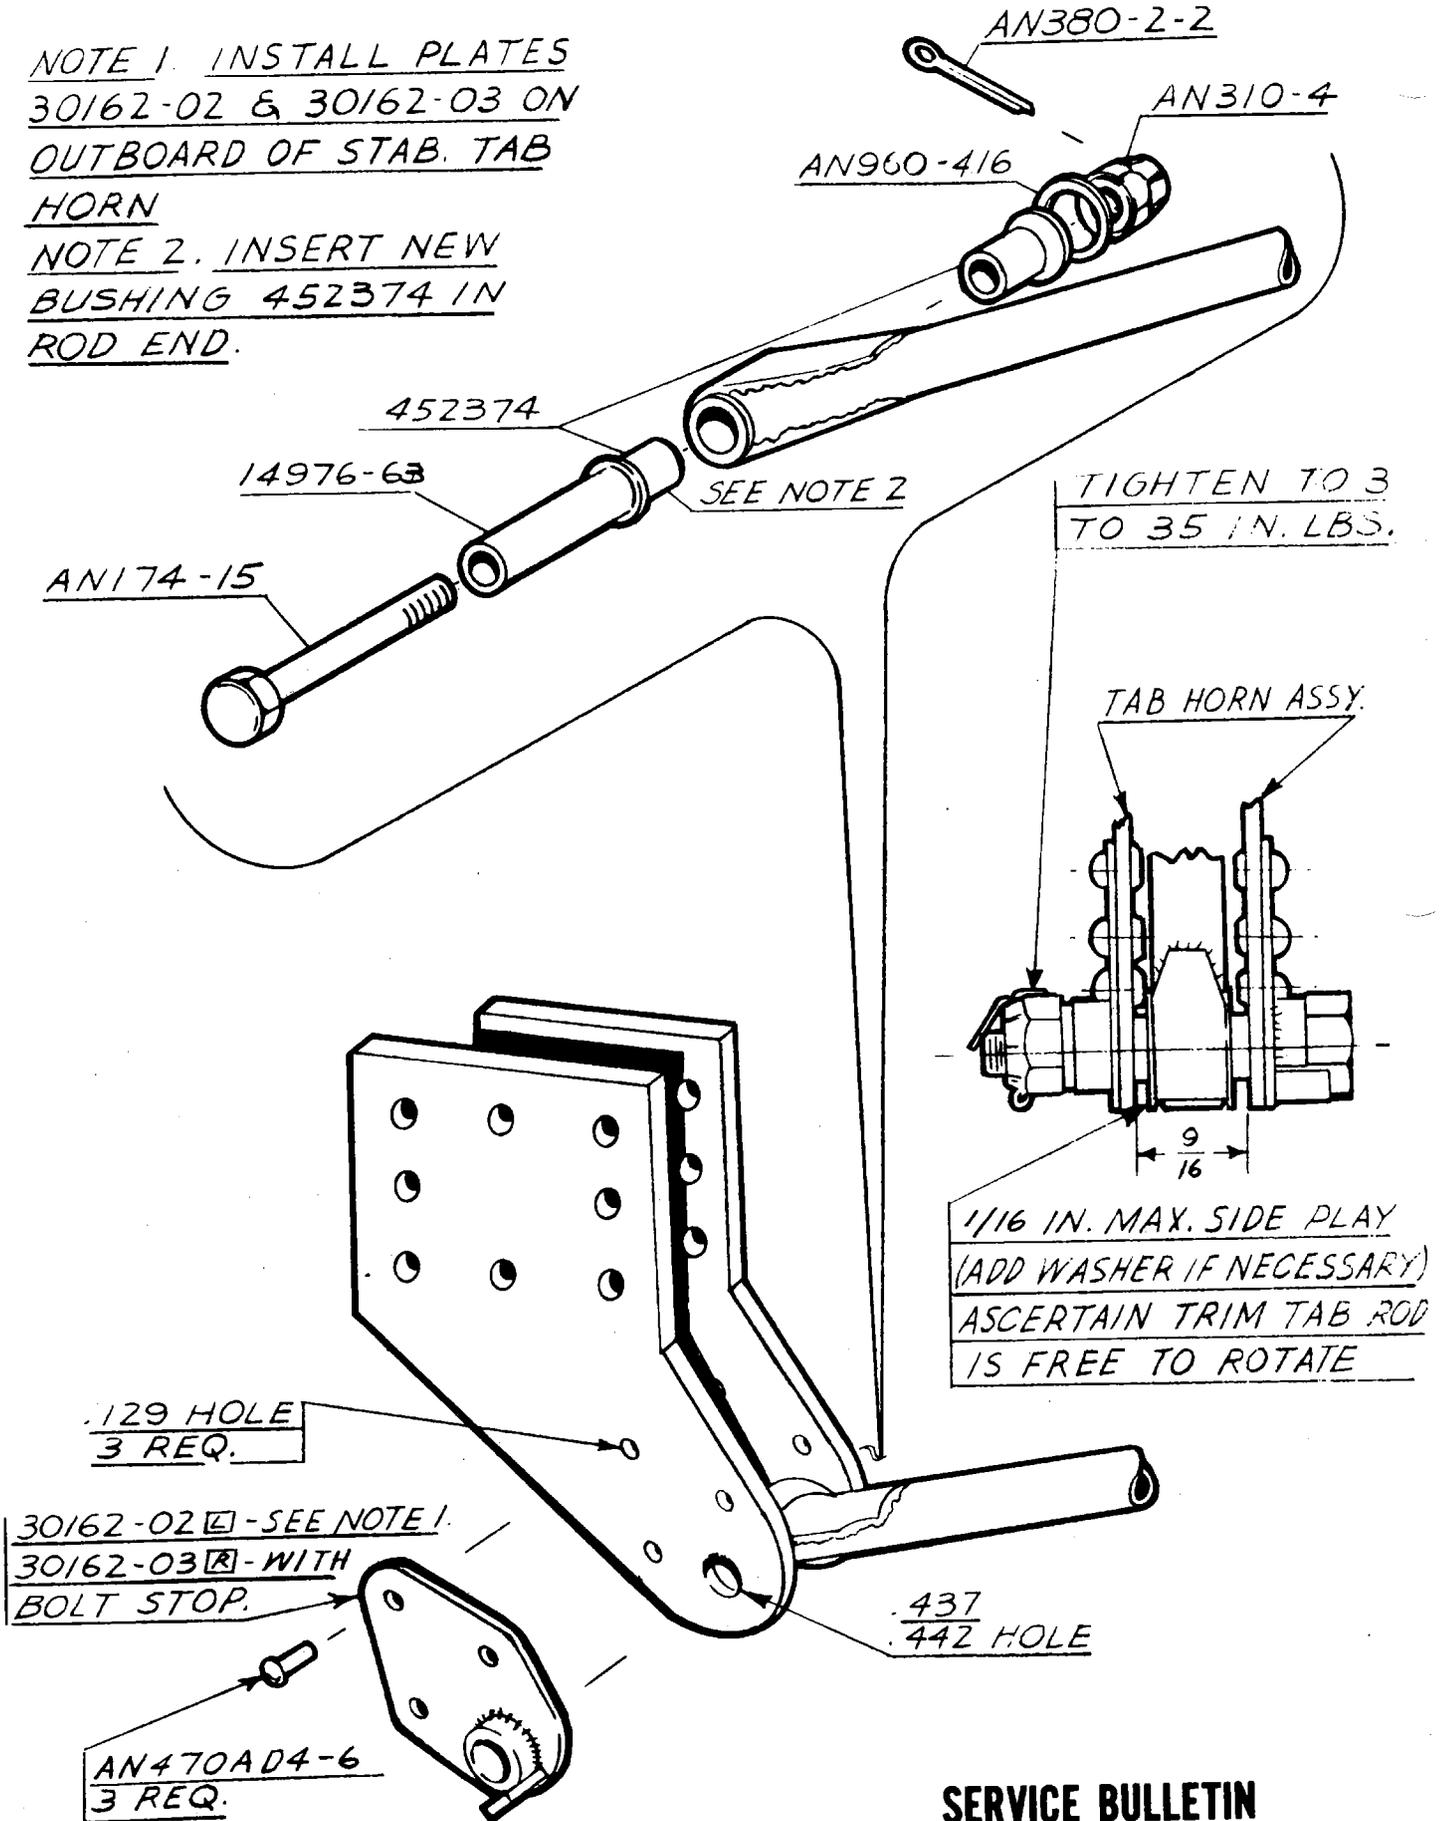
TAB HORN ASSY.

The Service Department has been advised that the stabilator tab horn actuating bolt has shown evidence of wear in service. The aircraft indicated by the above serial numbers should be modified as per the sketch on the reverse side of this bulletin.

NOTE 1. INSTALL PLATES 30162-02 & 30162-03 ON OUTBOARD OF STAB. TAB HORN

NOTE 2. INSERT NEW BUSHING 452374 IN ROD END.

TIGHTEN TO 3 TO 35 IN. LBS.

1/16 IN. MAX. SIDE PLAY (ADD WASHER IF NECESSARY) ASCERTAIN TRIM TAB ROD IS FREE TO ROTATE

30162-02 [] - SEE NOTE 1. 30162-03 [] - WITH BOLT STOP.
