SERVICE *No. 822* BULLETIN

Piper Aircraft Corporation
Vero Beach, Florida, U.S.A.

SUBJECT: Special Inspection of Hydraulic Hose,
Piper Part Number 17766-02 (465-138)

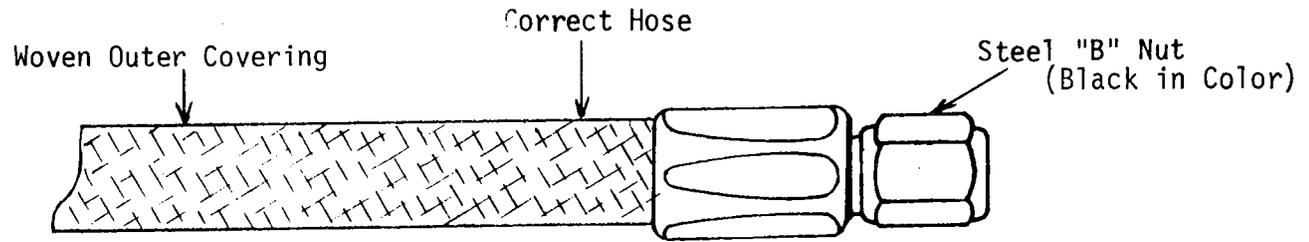
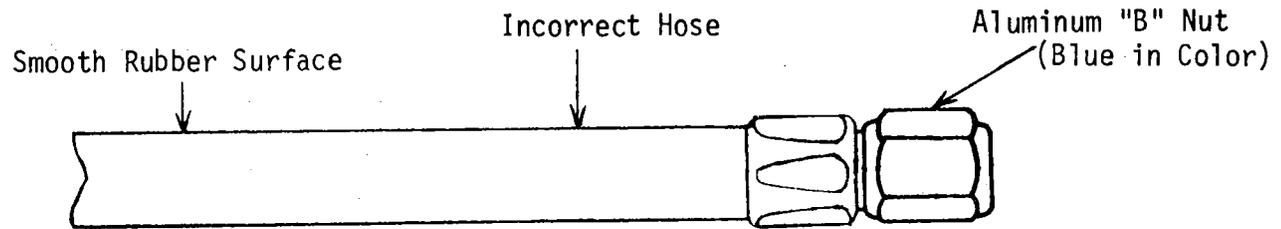
SKETCH "A"

PURPOSE: It has been determined that a group of hydraulic hoses, Piper Part Number 17766-02 (465-138), were manufactured using material that does not meet the pressure requirements for operation in the aircraft hydraulic system. If an installation has been made using these hydraulic hoses, premature failure will result in a loss of hydraulic capabilities.

This Service Bulletin provides an illustration and instructions for identification of the affected hoses.

1. Refer to the appropriate aircraft parts catalog and maintenance manual for location and quantity requirements for specific model application.
2. Gain access as required by model for visual inspection of each affected hose. See Sketch "A" attached.
3. Replace any hose found to be of incorrect material prior to further flight.
4. If replacement is required by inspection, perform a hydraulic systems function check per the appropriate maintenance manual.
5. Make appropriate logbook entry of compliance with this Service Bulletin.
