SERVICE No. 546 BULLETIN

Piper Aircraft Corporation

May 18, 1977

Inspection of Whelen Wing Tip Strobe Lights;
Reference F.A.A. Airworthiness Directive
75-05-04

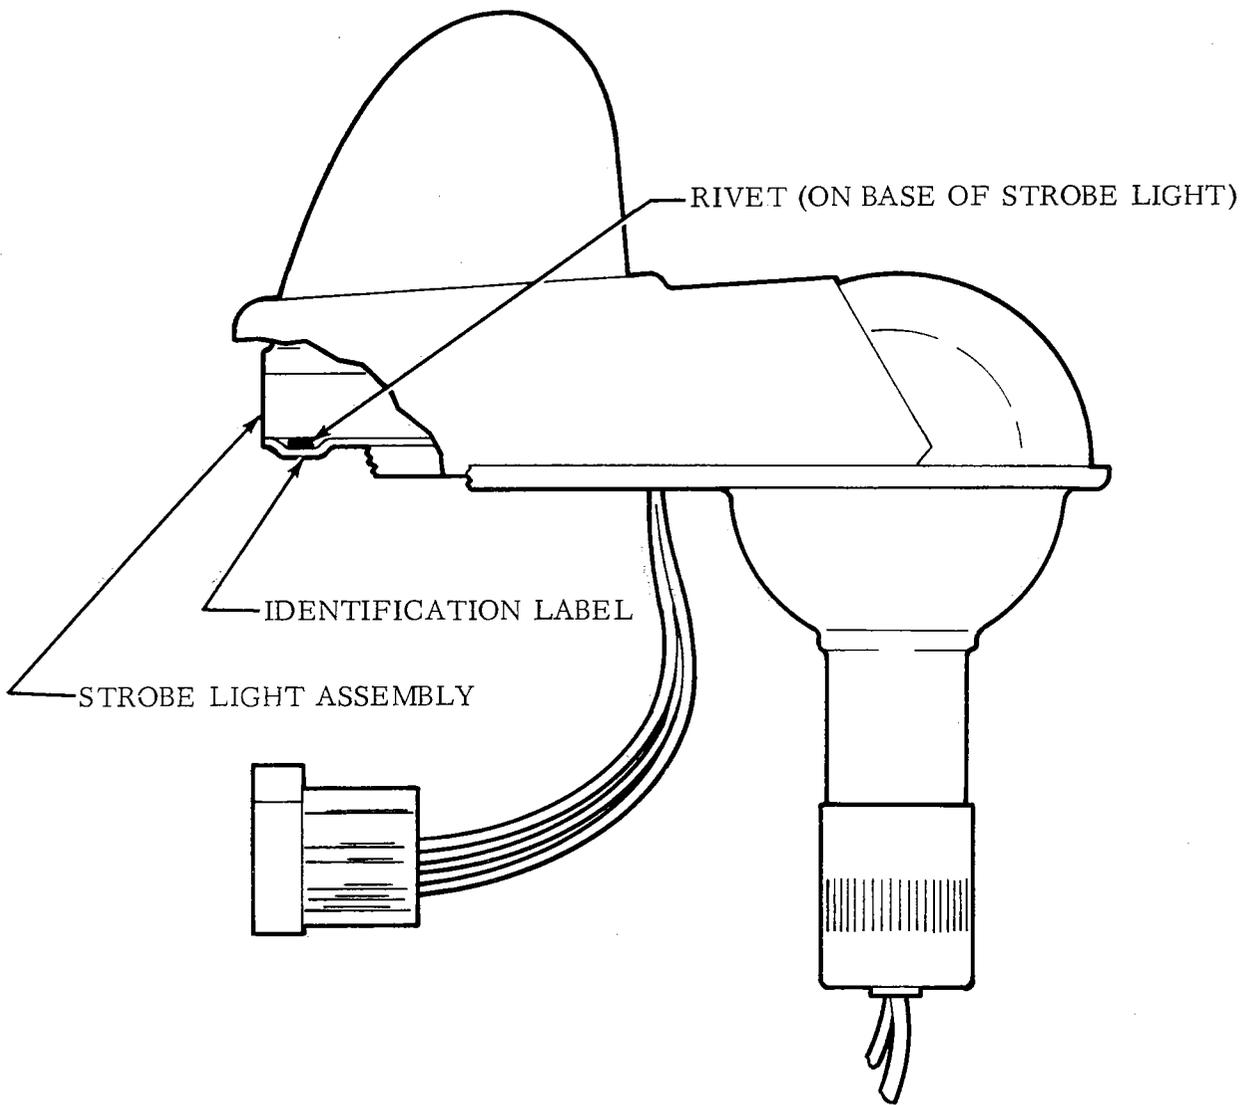
WHELEN NAVIGATION AND STROBE LIGHT ASSEMBLY

Purpose: The subject Airworthiness Directive was issued against the Whelen Engineering Company A-427 Strobe Light Assemblies "to preclude possible ignition of flammable fluids or vapors by arcing at the strobe light flash tube" (quoted from A.D. 75-05-04). The affected strobe light units may be installed as original equipment on the aircraft specified above, and it has been brought to our attention that a number of these strobe light units may not be in accordance with the subject Airworthiness Directive.

1. Expose wing tip strobe light assembly to view (refer to attached sketch for a typical strobe light assembly illustrated view).
2. If the following modification has already been accomplished, no further action is required; make appropriate entry in aircraft log book re compliance with this Service Release.

3. If the following modification has not been accomplished, proceed as follows:
 - a. Install on the base of the Whelen A-427 Flash Tube Assembly a pressure sensitive vinyl label conforming to Whelen drawing no. A-30052, Revision 1 dated October 15, 1974 or later F.A.A. approved revision.

1. Scotch Brand Type 33+ Vinyl Plastic electrical tape or equivalent tape - approved by an F.A.A. Maintenance/Avionics Inspector may be used in lieu of the vinyl label (if any plastic tape is used, it must be formed to cover the rivet at the rear of the flash tube without covering the identifying part number).

3. b. If the flash tube incorporates a label, the new label or tape may be installed directly over the old label.
- c. Install label or tape only when the label or tape and the flash tube are at a temperature above 50 degrees F.
4. Make appropriate service release compliance entry in aircraft log book.
