# SERVICE BULLETIN

No. 296

Piper Aircraft Corporation  
"FAA DOA EA-1 Approved"

Subject: Inspection of Fuselage Aft Section Assembly

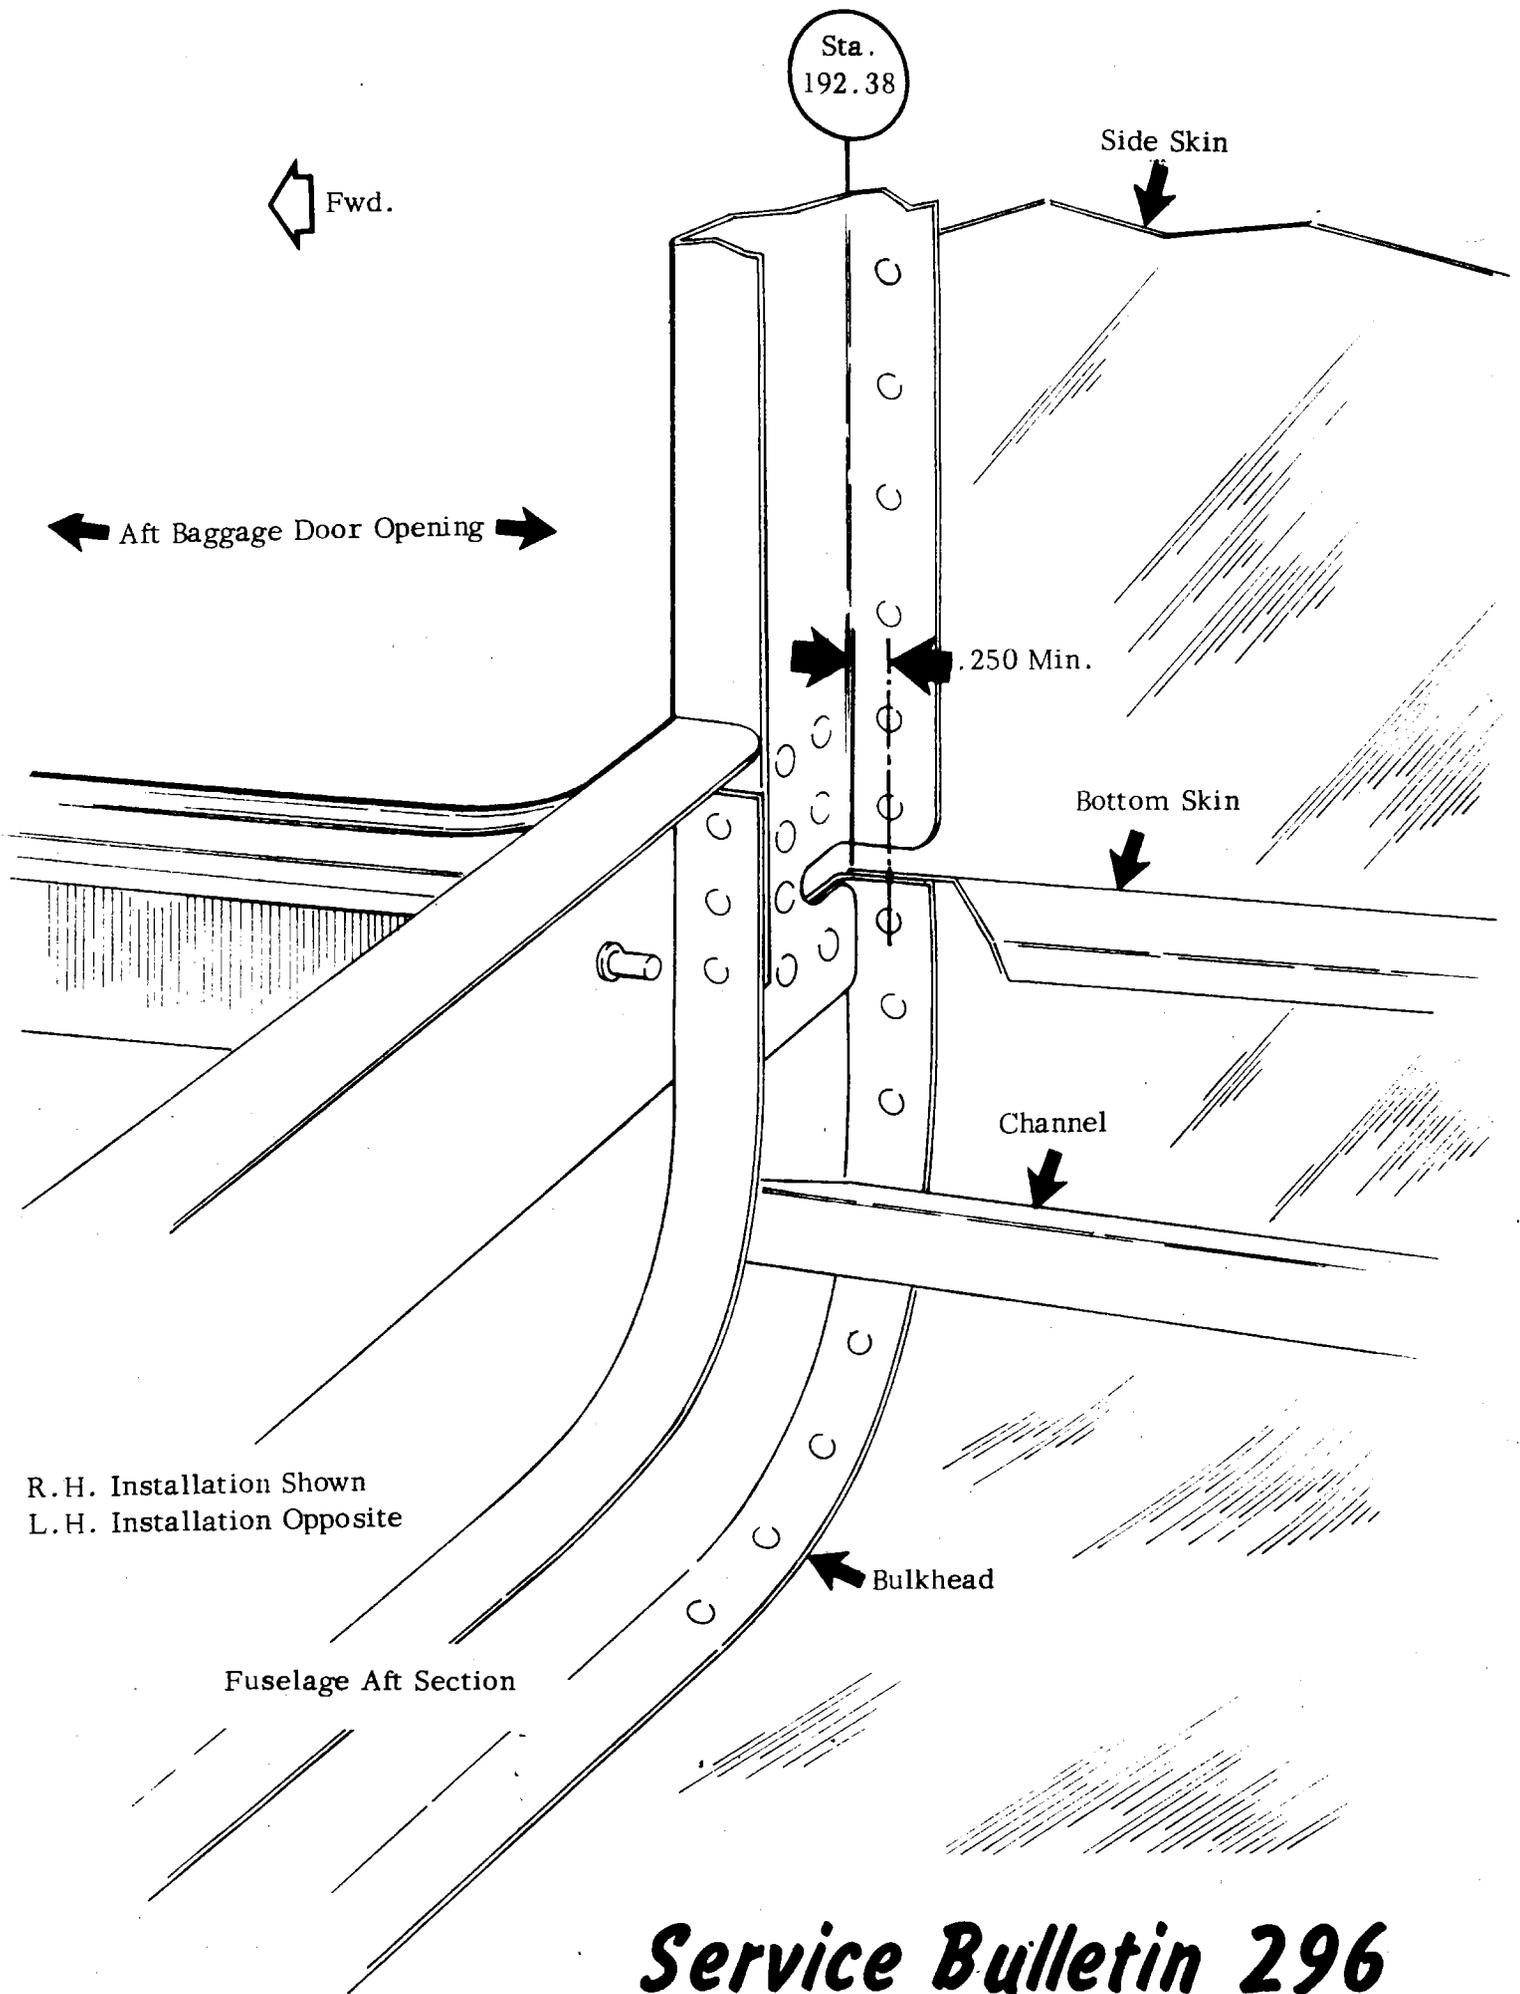
Instructions: Inspect fuselage aft section assembly bottom center skin to ascertain that one quarter inch (.250) minimum rivet edge distance has been maintained at the forward end (station 192.38).

If the rivet edge distance is less than one quarter inch (.250), Kit No. 760 324 Fuselage Aft Section Modification, must be installed. Please refer to sketch on reverse side of this bulletin for general information.
