SERVICE No. 196 BULLETIN

Piper Aircraft Corporation

September 9, 1960

SUBJECT: Rudder Tab Horn Bolt Installation

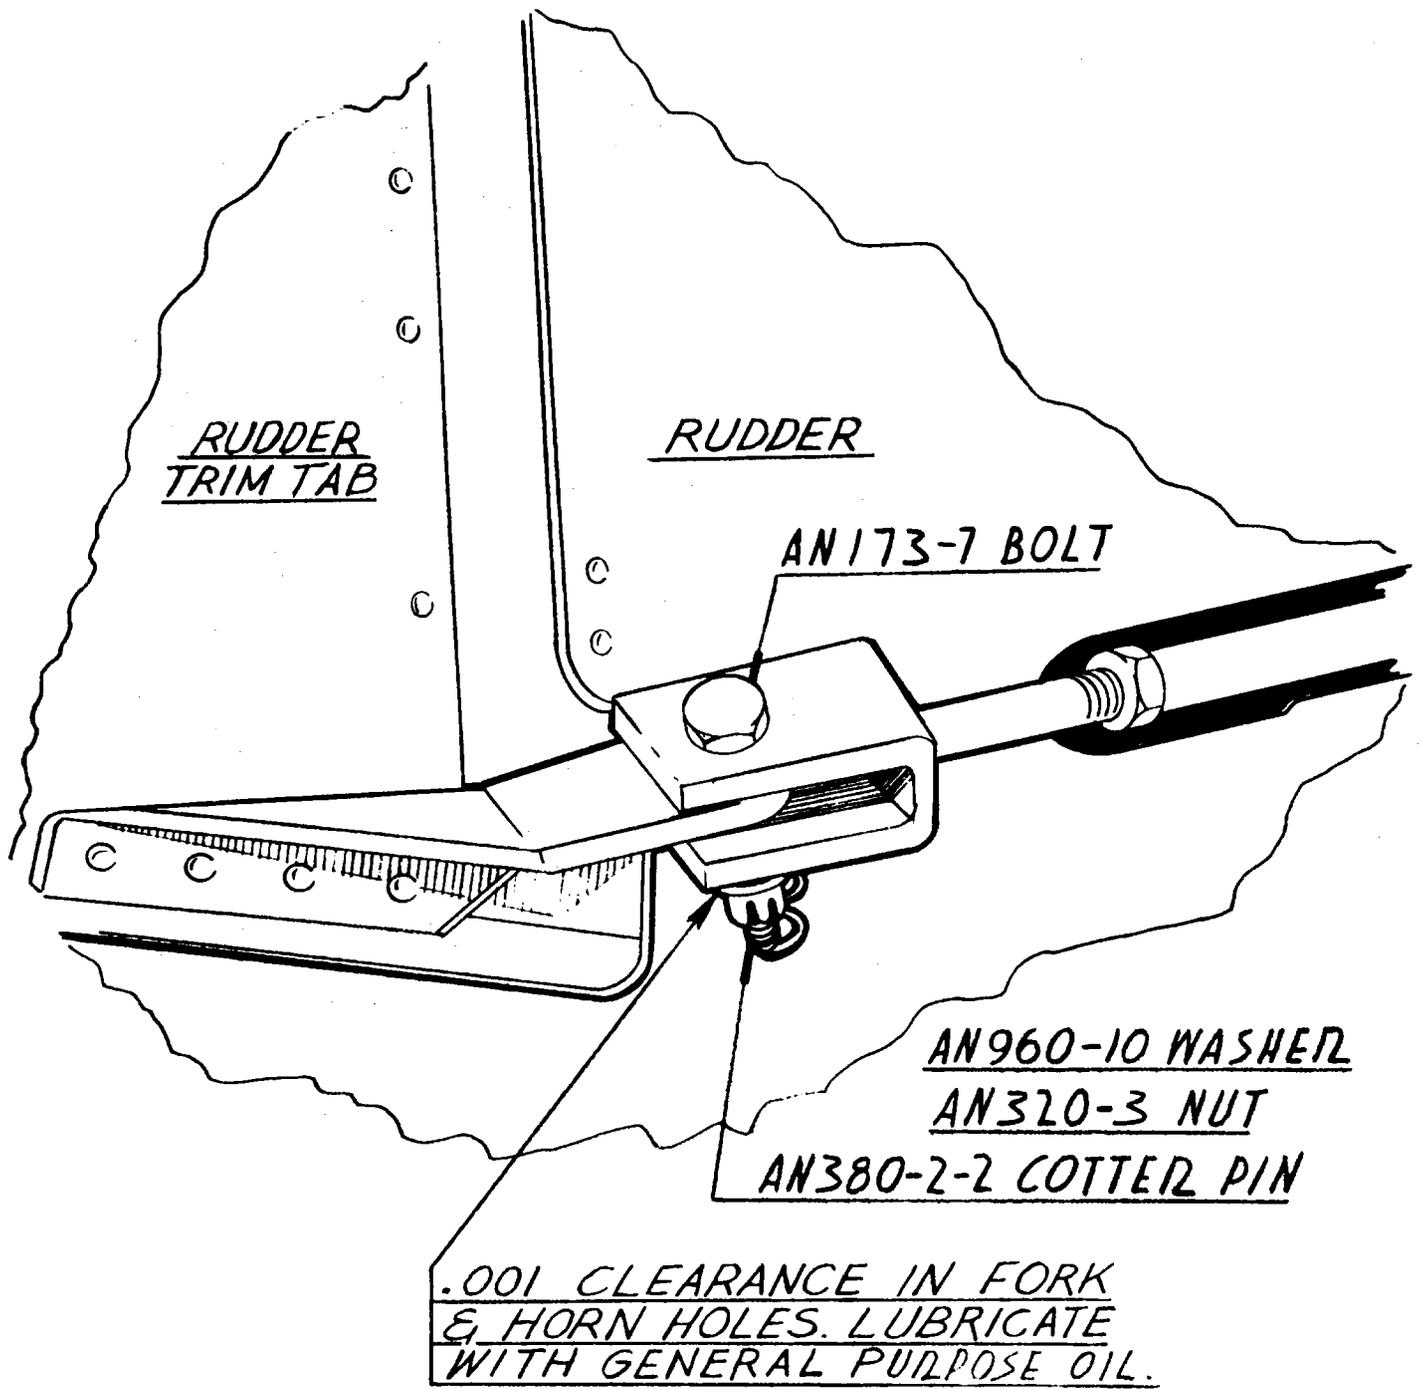
This Bulletin is to advise that there is a possibility the AN173-7 close tolerance bolt used to connect the rudder trim tab rod to the rudder trim tab may bind and restrict the movement of the rudder trim tab.

BOLT SHOULD BE FREE TO ROTATE BY HAND

It is requested that this bolt be removed, discarded and replaced with a new AN173-7 close tolerance bolt. The new bolt shall be installed with .001 clearance in the holes in the fork, part number 16514-00, and horn assembly, part number 16108-00.

The aircraft indicated by the above serial numbers shall be modified by the installation of Kit No. 754 344. The sketch on the reverse side may be referred to for further details.
