# SERVICE BULLETIN

No. 547

Piper Aircraft Corporation

Inspection of Stabilator Tip Rib

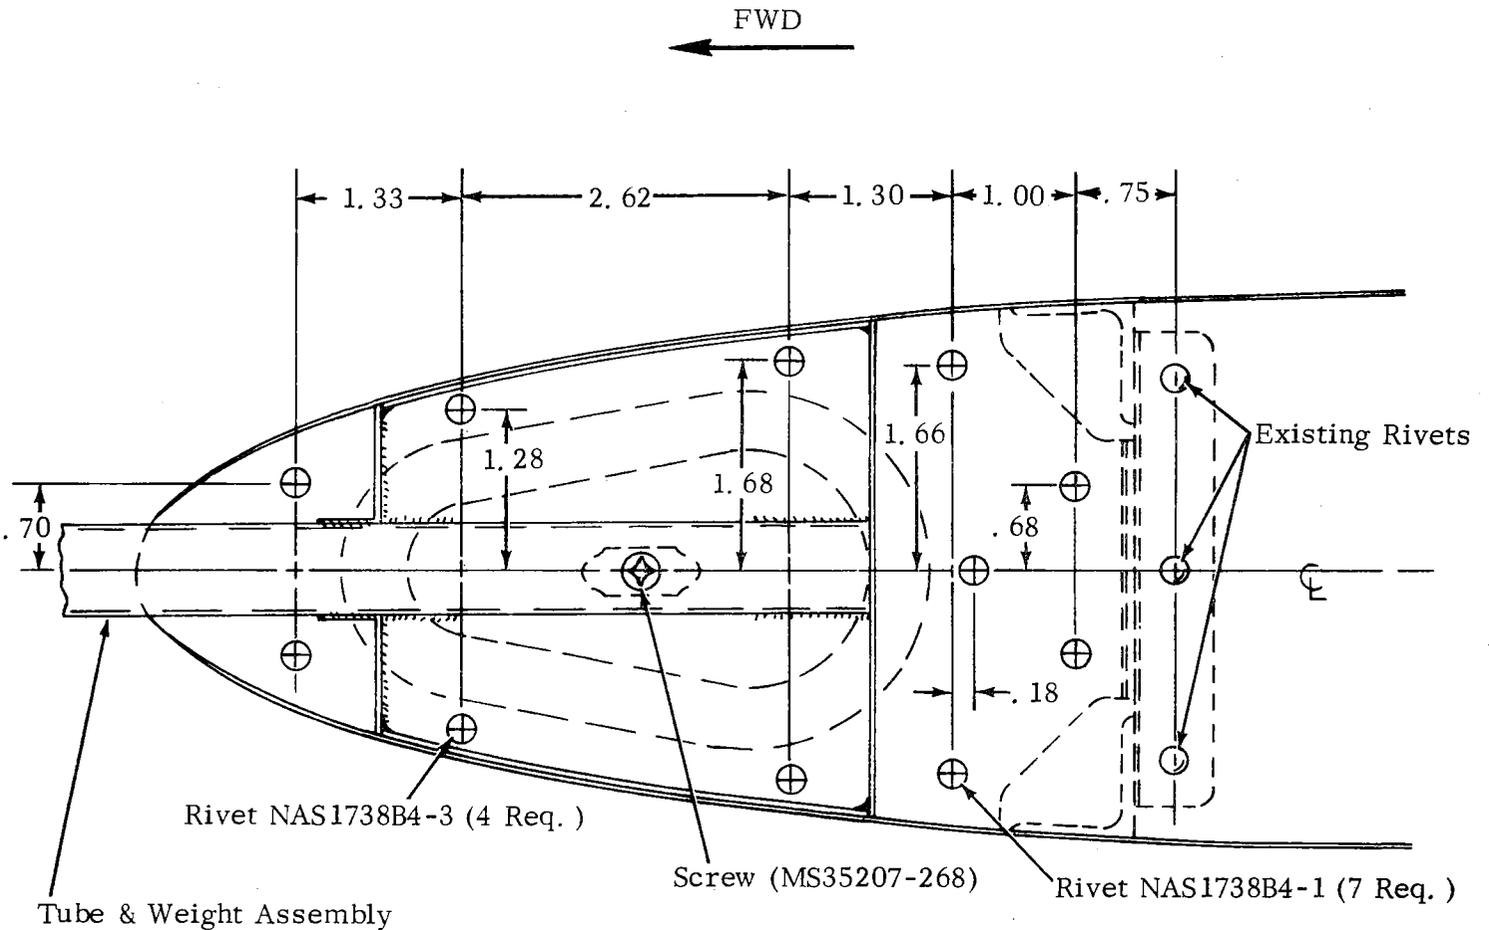
Purpose: Resulting from the inspection specified in Piper Service Bulletin No. 540 dated January 4, 1977, it was found that certain stabilator tip rib rivets and/or the stabilator tip tube and weight assembly attachment screw may be missing. Although no failures have been reported as a result of this condition, inattention to this matter could lead to cracking in the stabilator tip rib area.

1. Remove tip assembly from left and right stabilators.
2. Inspect forward end of stabilator ribs to determine if five rivets are installed aft of the tube & weight assembly attachment plate, two rivets installed forward of the attachment plate and a screw installed thru the square tube welded to the attachment plate.

4. If screw and rivets are missing from either stabilator, install new hardware as follows:
  - a. Install MS35207-268 screw (P/N 411 537) thru the square tube and into the anchor nut as shown.

- b. Locate and drill eleven .144 holes as shown above.
  - c. Install four NAS1738B4-3 blind rivets (P/N 522 883) at the attachment plate and seven NAS1738B4-1 blind rivets (P/N 522 881) aft and forward of the attachment plate.

- d. Reinstall tip assembly and make proper logbook entry of stabilator rivet and screw installation per Service Bulletin 547.
