SERVICE BULLETIN

No.606

Piper Aircraft Corporation

Subject: Stabilator Assembly Lower Surface Rivet and Rib Attachment Inspection

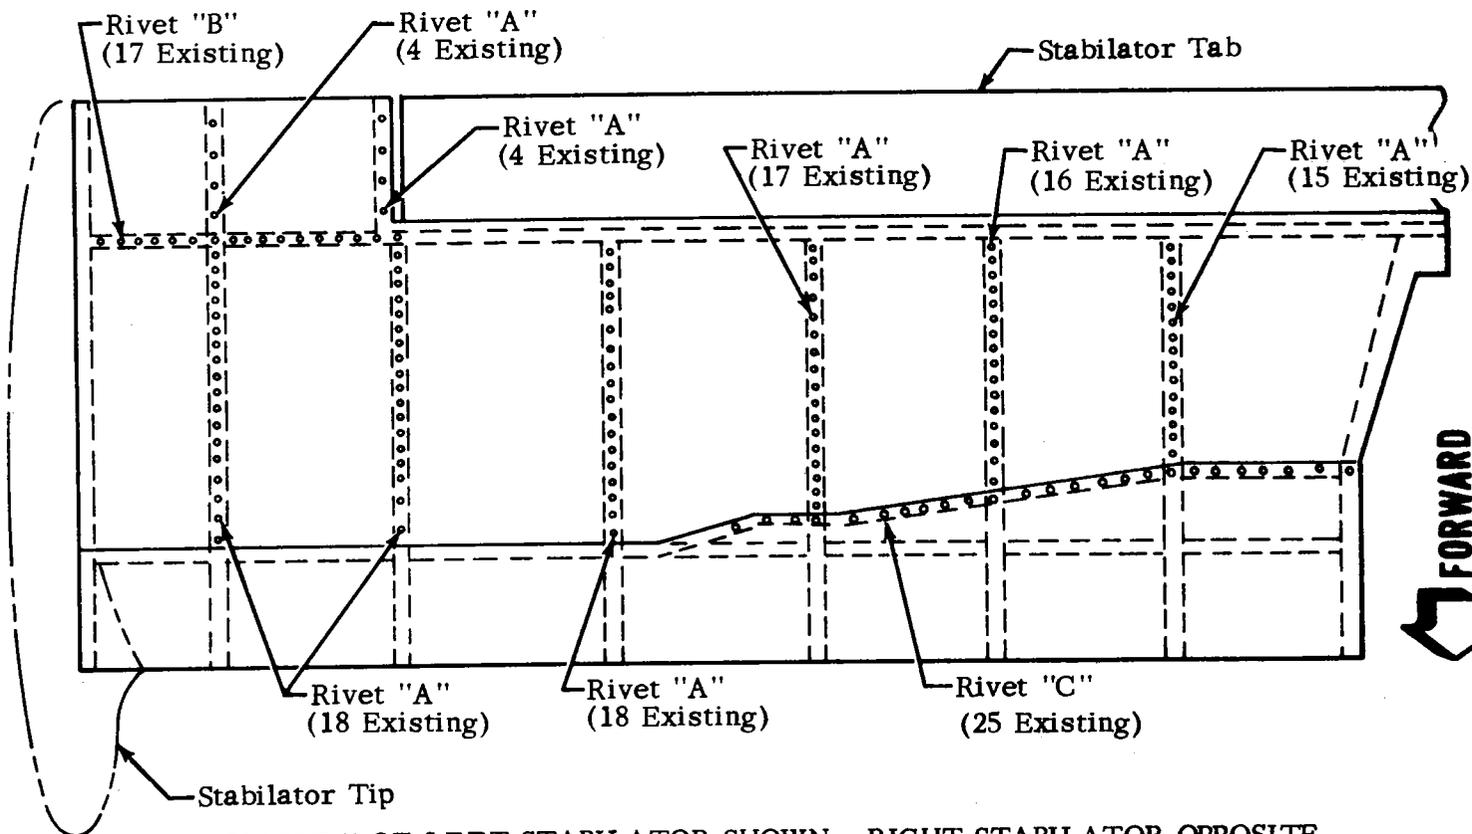
BOTTOM VIEW OF LEFT STABILATOR SHOWN - RIGHT STABILATOR OPPOSITE

It has been determined that the affected stabilator assemblies may not have proper bonding between the ribs and skin, resulting in a possibility of the loosening of blind rivets and relative motion between the ribs and skin on the underside of the stabilator. This condition could cause further loosening of rivets and could lead to cracks developing in the rib flanges.

- A. Inspect the lower surface of the left and right stabilator assemblies for evidence of loose blind rivets. Refer to sketch for location of existing blind rivets. (Loose rivets may be noted by the presence of dark streaks downstream of the rivet heads.)

- B. Remove stabilator tip. With a mirror and a light attached to long rods, inspect the bottom flanges of all ribs for evidence of cracks.
 1. If cracks are found, replace the stabilator assembly with a new assembly.

2. If loose rivets are found, they must be replaced with NAS1738B-4-1, or NAS1738B-4-2, or NAS1738B-4-3 cherry lock rivets. (see sketch for location)
 3. If no cracks are found, and loose rivets are replaced, the stabilator tip may be reinstalled and the aircraft returned to service. THIS INSPECTION IS REQUIRED EVERY 100 HOURS OF OPERATION.

4. If it is desired to relieve the requirement for the 100 hour recurring inspection, install additional cherry lock rivets (see sketch & rivet chart) mid spaced between the existing blind rivets in the ribs and rear spar on the bottom surface of the stabilator. (The new cherry lock rivets must be installed between all existing blind rivets shown as Rivets "A" & "B" on above sketch). Reinstall stabilator tip and rebalance stabilator per the Aztec Service Manual.
