BULLETIN

NUMBER 131

**SUBJECT: Addition of Rubber Extrusion Chafe Strip to Wing
Root Fairings**

MODELS AFFECTED: PA-23, Serial Nos. 23-1 to 23-64 inclusive

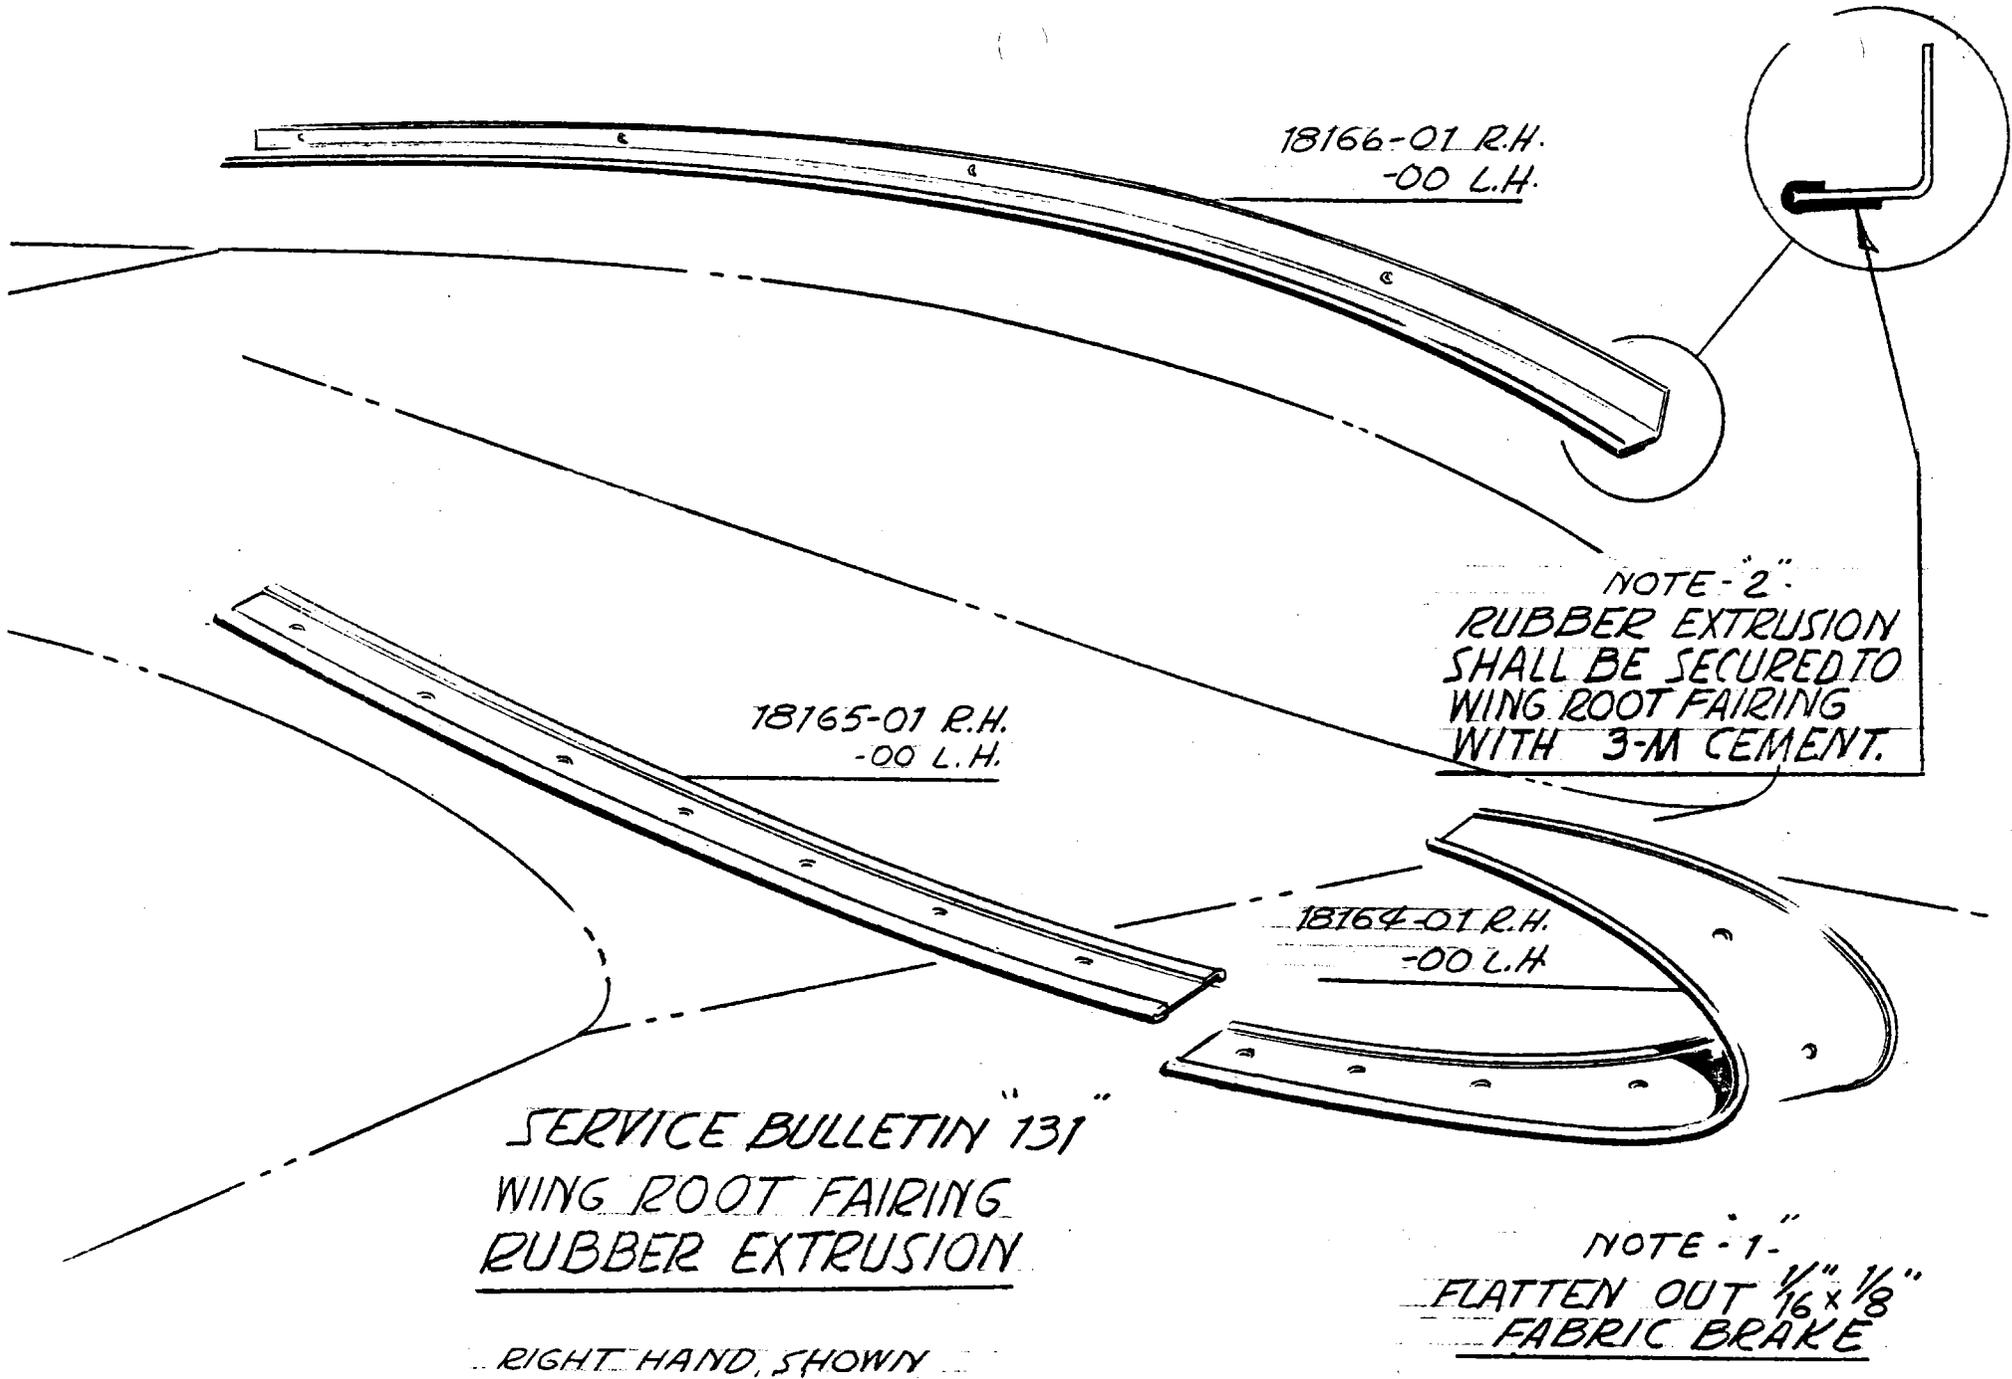
It has been found that there is a tendency of the wing root fairings on the PA-23 to chafe the wing skin.

It is requested that the above listed aircraft be modified in accordance with the following instructions and sketch, as shown on the reverse side of this bulletin.

Twenty-two (22) feet of rubber extrusion, Number 827, Piper code number 187 550, is available, at No Charge, through your nearest distributor or dealer. Two hours warranty labor will be allowed upon receipt of a duly executed warranty claim form, through the distributor.
