Service Letter No. 504

B. F. Goodrich Service Bulletin No. E-67-34  
(Prop De-Icer and Strap Restrainer Installation.)

PA-23-250, PA-E23-250 Aztecs  
PA-31 Navajos

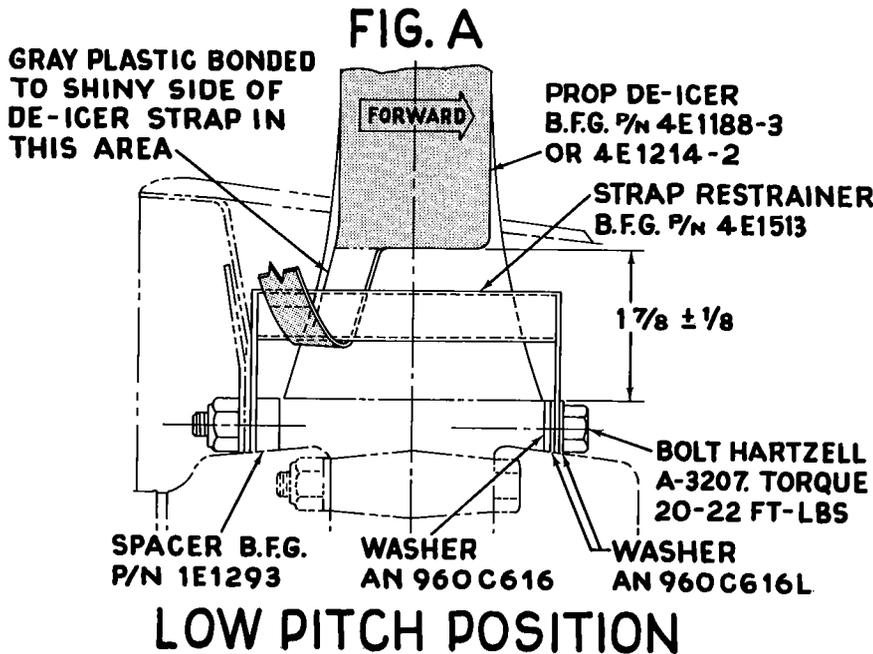
**Discussion:** Two conditions may contribute to premature failure of lead straps on B.F. Goodrich De-Icers installed on referenced aircraft. Check as follows for compliance with correct installation procedures:

- Procedure:**
1. Remove aircraft spinner domes.
  2. The propeller De-Icer, B.F. Goodrich P/N 4E1188-3 or 4E1214-2, should have the gray plastic bonded to shiny side of De-Icer strap. For removal and installation procedures, consult B.F. Goodrich De-Icer Installation Manual, Report No. 59-728C.
  3. If strap restrainers, B.F. Goodrich P/N 4E1513, are not positioned as shown in Fig. B, proceed as follows:
    - a. Loosen propeller hub bolts. Do Not Remove.
    - b. Rotate strap restrainers into correct clearance position as shown in Fig. B.
    - c. Tighten propeller hub bolts to 20-22 ft. lbs. torque.
  4. Replace aircraft spinner domes.
